Remediation Actions

We trust that the above details described appropriately the spill incident that occurred at the Meadowbank on March 12th, 2016 and the cleanup activities. Please contact the undersigned should you have any questions.

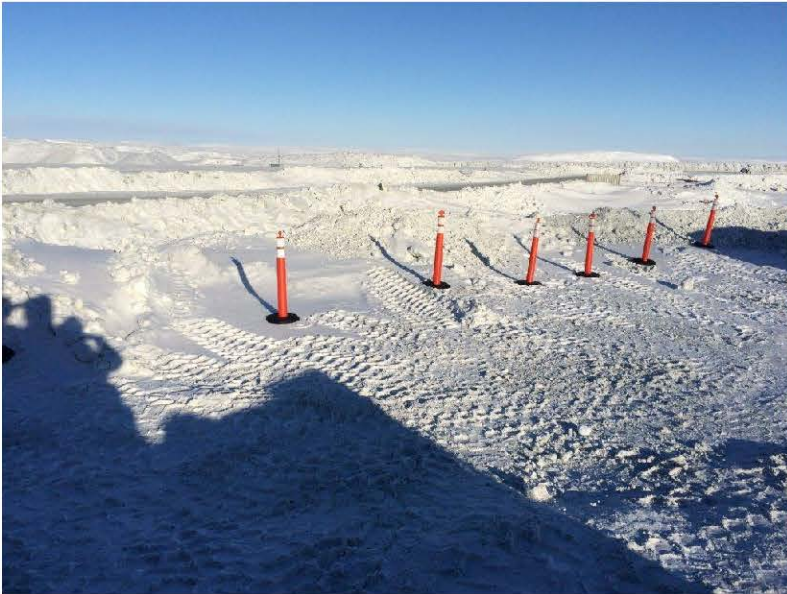
Side blocked for snow

The pipe was fixed and extended further in the pond. As well, snow will not be pushed again on the side of the effluent pipe but rather on the opposite side.

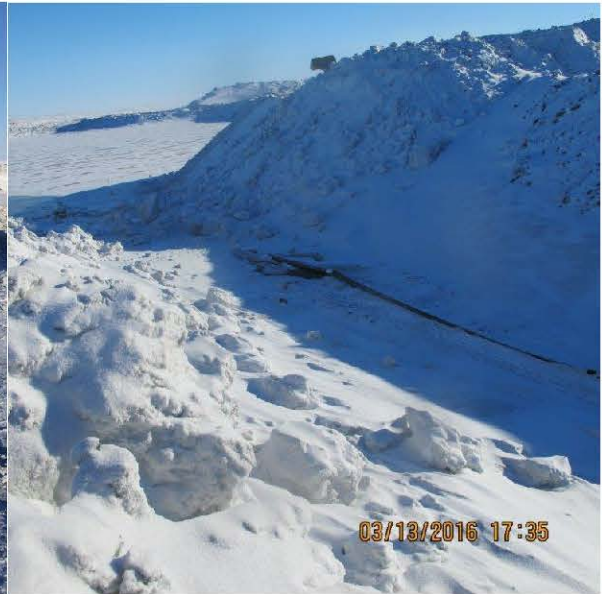
The area was inspected after the repair and no evidence of seeping was found on the north side.

Repaired and extended discharge pipe
