March 12th, 2016 Sewage spill

Please find the following information as a follow up to the Spill report submitted March 13th, 2016 by Agnico Eagle Meadowbank division. This detailed report is submitted to the Inspector in compliance with the conditions under the Nunavut Water Board License 2AM-MEA1525, Part H, Item 8c.

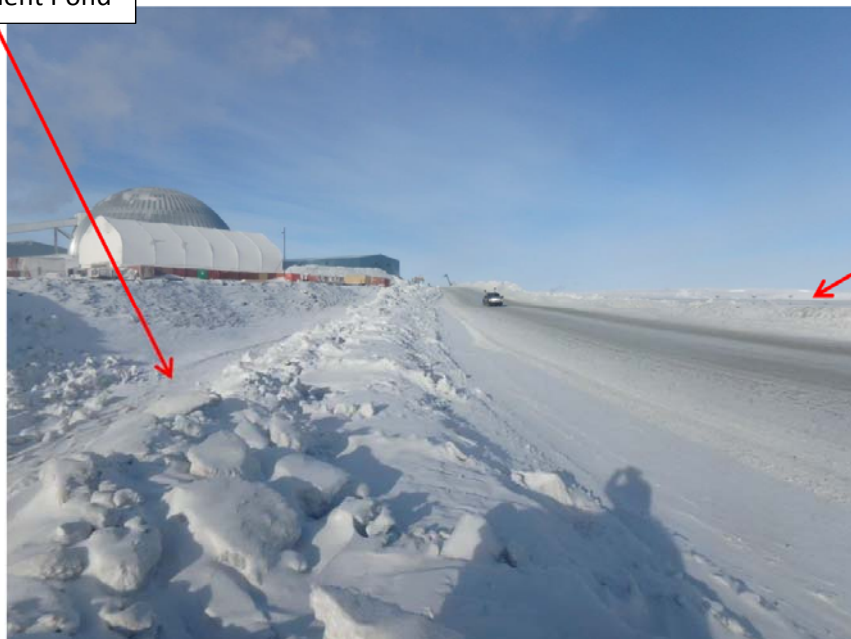
On March 12th, 2016, a fitting on the sewage line bringing treated sewage to the Stormwater Management Pond broke and resulted in sewage being discharge upstream of its usual location. Although the product was still being discharge within the Stormwater pond area, a portion of the sewage went underneath the road and was contained in a section facing north between the airstrip and the road.

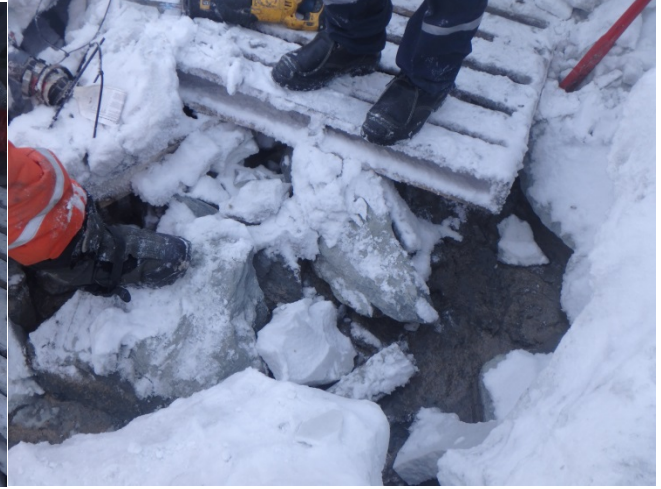
Area of broken line

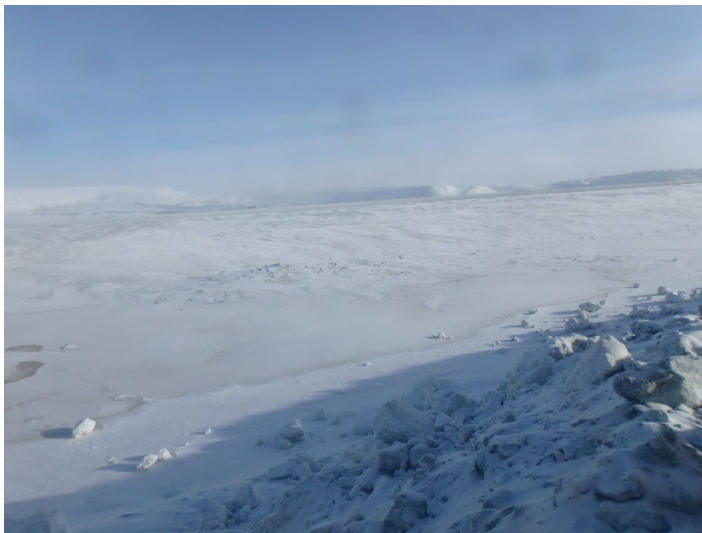
North side

The area was inspected after the repair and no evidence of seeping was found on the north side.

As the sewage was contained in an area enclosed between surrounding roads and the airstrip, and is now frozen, it will be re-assessed in the spring. The water leaving the Sewage Treatment Plant is tested regularly and results meet criteria.

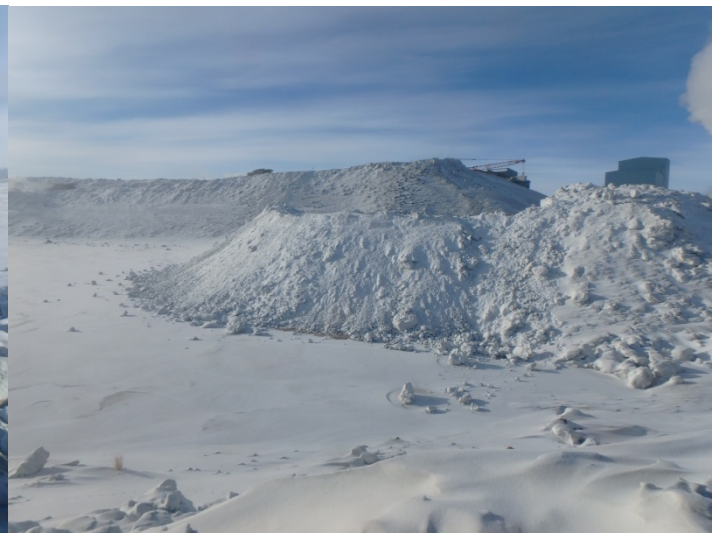
The fitting on the line broke because external pressure was being added to the pipe by snow being pushed over from the iron pad towards the discharge line. The sewage was thus discharge closer to the road. This created a change in the path of the flow, resulting in water being observed on the north side.

Snow bank on Stormwater pond
