March 29th, 2016 Vault oil spill

Please find the following information as a follow up to the Spill report submitted March 31st, 2016 by Agnico Eagle Meadowbank division. This detailed report is submitted to the Inspector in compliance with the conditions under the Nunavut Water Board License 2AM-MEA1525, Part H, Item 8c.

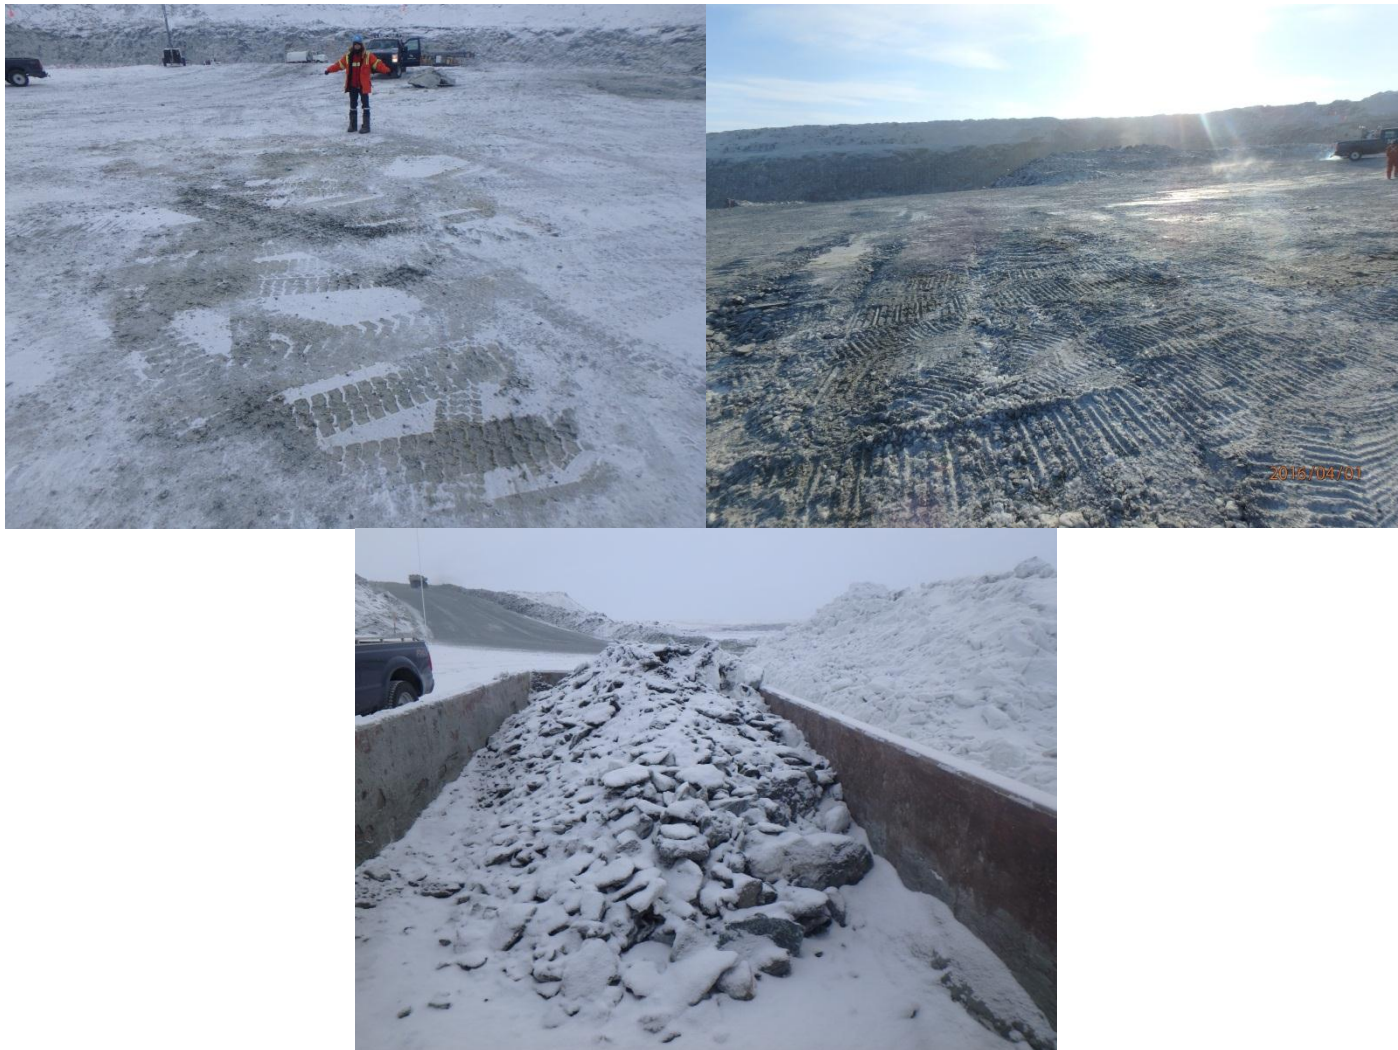
On March 29th, the hydraulic pressure gauge on drill RBD 02 burst and the oil contained in the hydraulic system leaked out of the machine before they could stop the engine.

Mechanical failure as the hydraulic gauge burst.

The machine was turned off and the spill contained with absorbent pads. The contaminated pads were sent to the HAZMAT area and the contaminated soil excavated and disposed at the landfarm. An estimated volume of 12m³ of contaminated material was collected.
