April 12th, 2016 MBK tankfarm fuel spill

Please find the following information as a follow up to the Spill report submitted April 12th, 2016 by Agnico Eagle Meadowbank division. This detailed report is submitted to the Inspector in compliance with the conditions under the Nunavut Water Board License 2AM-MEA1525, Part H, Item 8c.

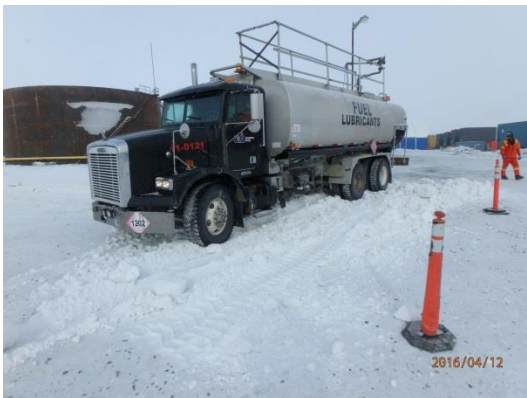
Area with added snow before clean-up

The operator stopped the pump at the tankfarm and started laying absorbent pads on the ground. He then called for assistance. With windy conditions, the absorbent pads were hard to keep on the ground. They were taken out and snow was used as containment and absorbent material. Once the truck was wiped clean and could be safely removed from the area, more snow was added.

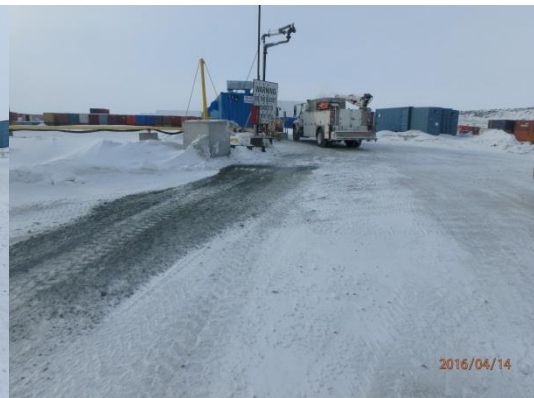
Area after clean-up

The area was then cleaned with a loader. Contaminated snow and soil was brought to the TSF and absorbent pads were properly disposed of.
