Remediation Actions

Closure

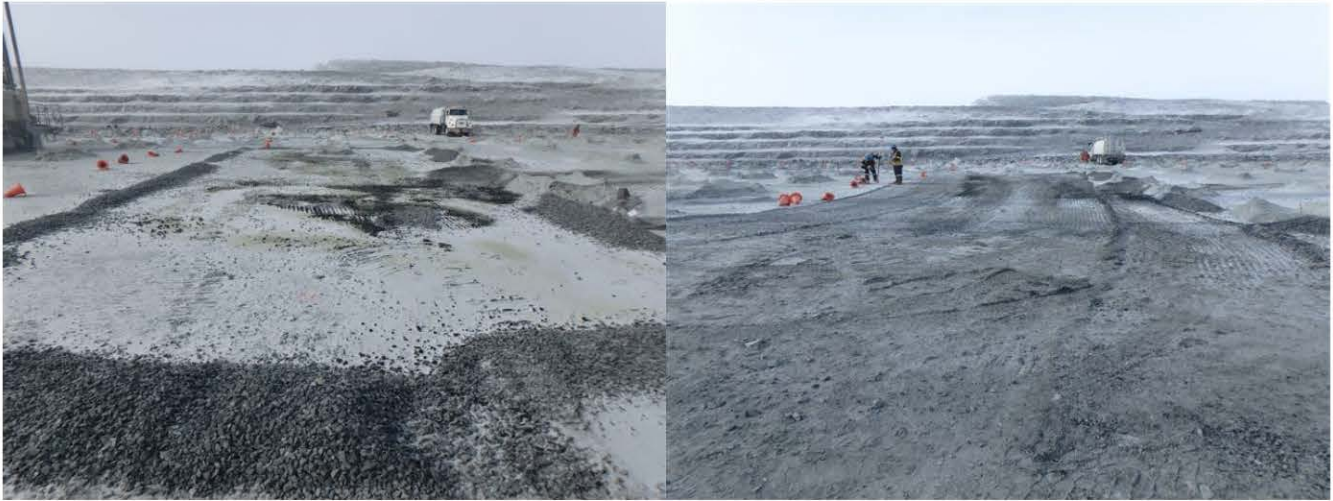
Containment was built using surrounding material from the blast pattern. Absorbent pads were also laid out underneath the drill.

The area was then cleaned with a loader. Caution had to be taken since the area is located in the vicinity of a blast pattern.

Area before clean-up

Area after clean-up

Contaminated material was brought to the Landfarm and absorbent pads were properly disposed of.

An assessment was completed by the Maintenance department at MBK. Since the root cause seems to be related to a defective part, the applied corrective action was that all multi-gauge assemblies were removed and changed on the drilling equipment found at Meadowbank.
