April 12th, 2016 Vault drill spill

Please find the following information as a follow up to the Spill report submitted April 13th, 2016 by Agnico Eagle Meadowbank division. This detailed report is submitted to the Inspector in compliance with the conditions under the Nunavut Water Board License 2AM-MEA1525, Part H, Item 8c.

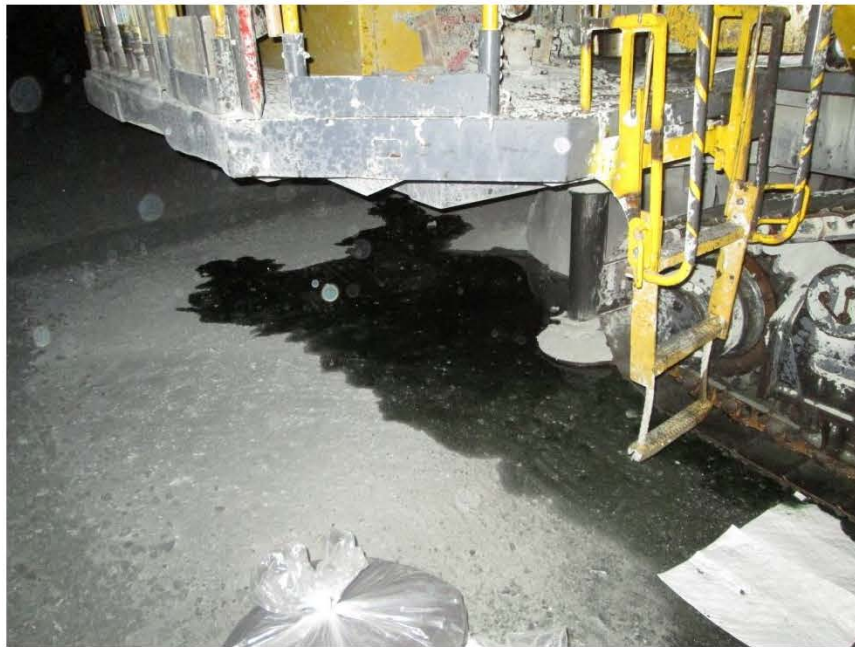
On April 12th, 2016, drill RBD02 was drilling in Vault pit when a control unit on the equipment failed and caused hydraulic oil to be spill on the ground

There were no off site impact or discharge to any receiving watercourses.

The spill was caused by a defective multi-gauge assembly unit on the drill assembly. It is used for testing and adjusting pressures within the drill.
