April 12th, 2016 Vault drill spill

Please find the following information as a follow up to the Spill report submitted April 13th, 2016 by Agnico Eagle Meadowbank division. This detailed report is submitted to the Inspector in compliance with the conditions under the Nunavut Water Board License 2AM-MEA1525, Part H, Item 8c.

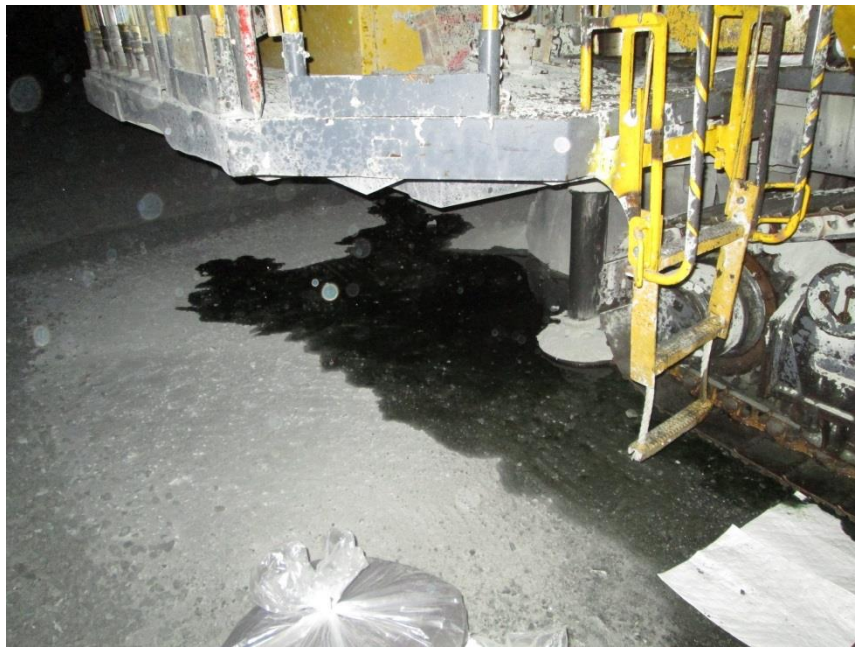
On April 12th, 2016, drill RBD02 was drilling in Vault pit when a control unit on the equipment failed and caused hydraulic oil to be spill on the ground

The spill was caused by a defective multi-gauge assembly unit on the drill assembly. It is used for testing and adjusting pressures within the drill.

An assessment was completed by the Maintenance department at MBK. Since the root cause seems to be related to a defective part, the applied corrective action was that all multi-gauge assemblies were removed and changed on the drilling equipment found at Meadowbank.

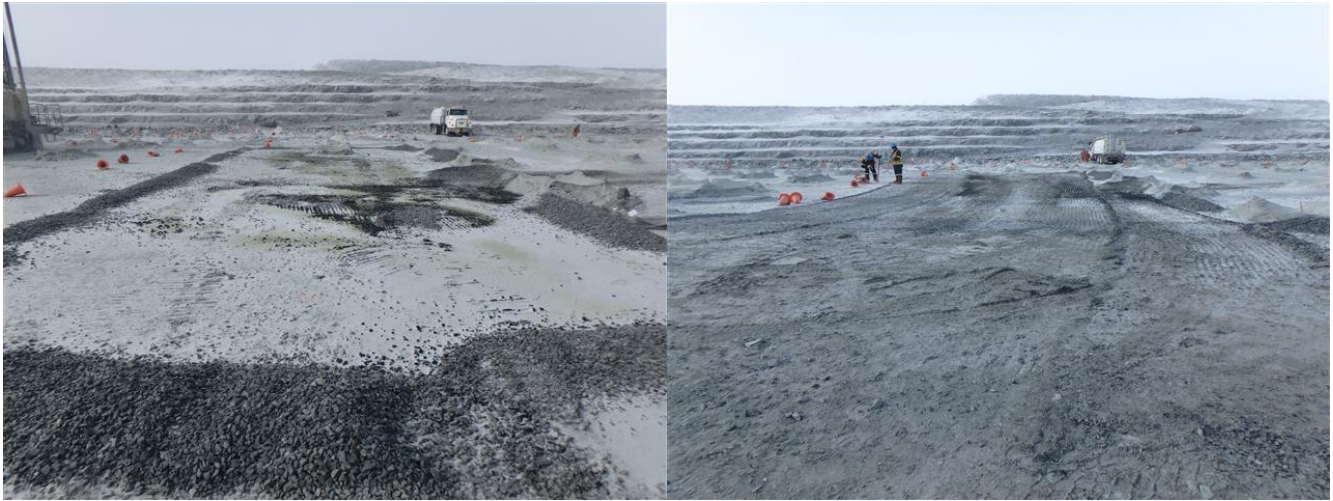
Area before clean-up

Area after clean-up

Containment was built using surrounding material from the blast pattern. Absorbent pads were also laid out underneath the drill.

The area was then cleaned with a loader. Caution had to be taken since the area is located in the vicinity of a blast pattern.

Contaminated material was brought to the Landfarm and absorbent pads were properly disposed of.
