Remediation Actions

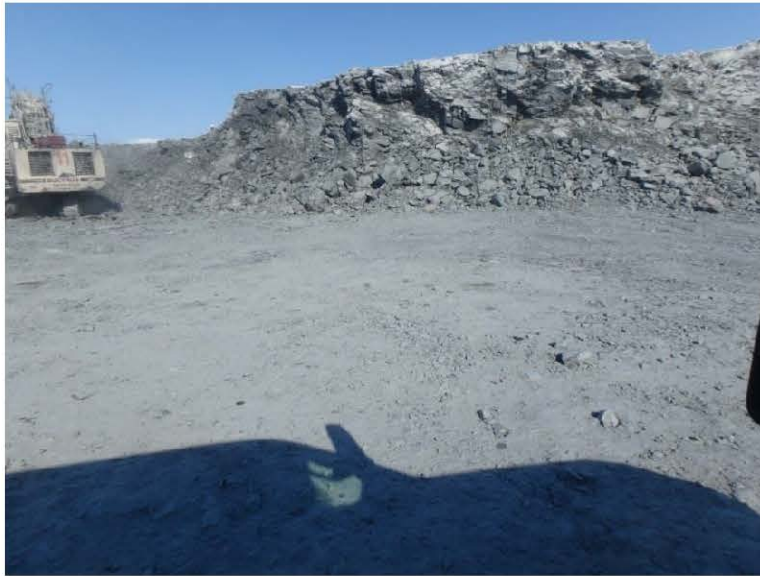
The spill was contained in the area and absorbent pad were also laid out underneath the backhoe. The area was then cleaned with a loader. Contaminated material was brought to the Landfarm and absorbent pads were properly disposed of.

Area after clean-up

Modifications were made in the preventive maintenance log and planning to address specific inspections of hoses on equipment. A visual inspection was already being done on equipment, but a specific item related to hose inspections is now included to PM's executed on those type machinery. The item "Inspect all hydraulic hoses for leaks or potential failures" was added to the planning module and is now part of all hydraulic systems maintenance.
