## April 1st, 2016 BAC 11 oil spill

Please find the following information as a follow up to the Spill report submitted April 3rd, 2016 by Agnico Eagle Meadowbank division. This detailed report is submitted to the Inspector in compliance with the conditions under the Nunavut Water Board License 2AM-MEA1525, Part H, Item 8c.

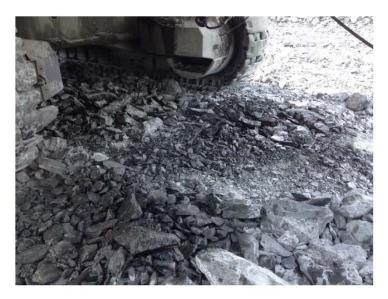
On April 1st, the hydraulic pump on BAC 11 burst and the oil leaked out of the machine.

There were no off site impact or discharge to any receiving watercourses.

Mechanical failure as the hydraulic pump burst.
