Remediation Actions

We trust that the above details described appropriately the spill incident that occurred at the Meadowbank on April 1st, 2016 and the cleanup activities. Please contact the undersigned should you have any questions.

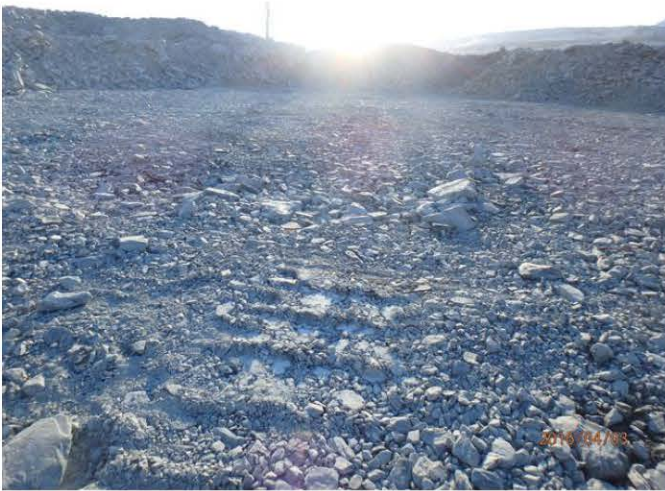
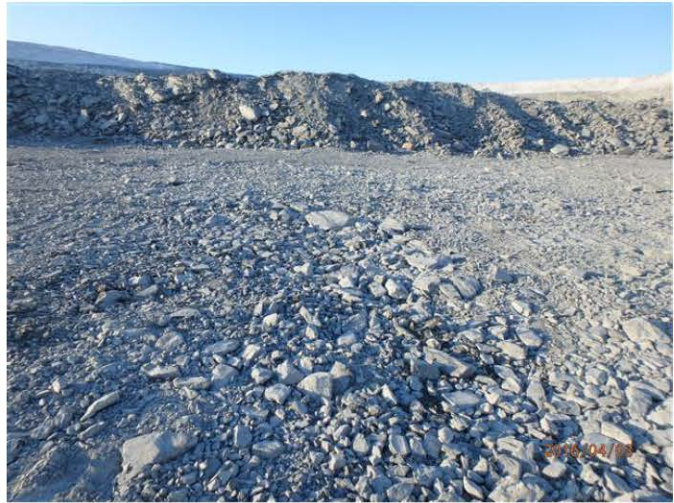
The machine was turned off and the spill contained with absorbent pads. The contaminated pads were sent to the HAZMAT area and the contaminated soil excavated and disposed at the landfarm. An estimated volume of 8m³ of contaminated material was collected.

Meeting with Mine and Maintenance department to evaluate the root cause of the spill. Modifications were made in the preventive maintenance log and planning to address specific inspections of hoses on equipment. A visual inspection was already being done on equipment, but a specific item related to hose inspections is now included to PM's executed on those type machinery. The item "Inspect all hydraulic hoses for leaks or potential failures" was added to the planning module and is now part of all hydraulic systems maintenance.
