April 1st, 2016 BAC 11 oil spill

Please find the following information as a follow up to the Spill report submitted April 3rd, 2016 by Agnico Eagle Meadowbank division. This detailed report is submitted to the Inspector in compliance with the conditions under the Nunavut Water Board License 2AM-MEA1525, Part H, Item 8c.

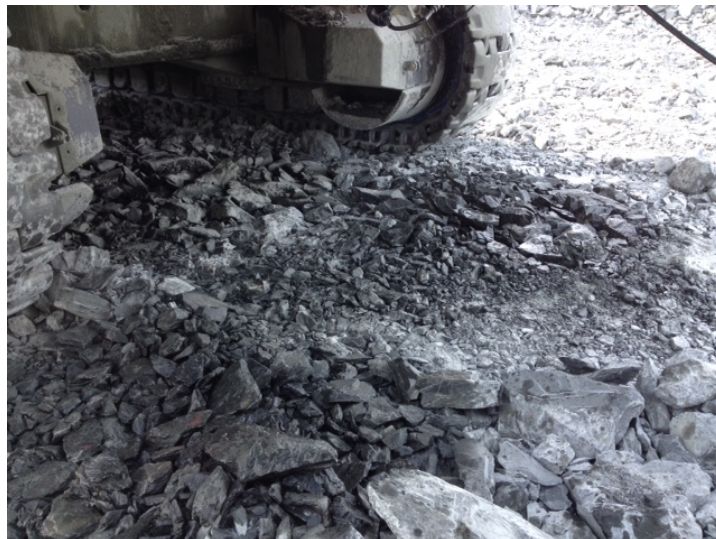
On April 1st, the hydraulic pump on BAC 11 burst and the oil leaked out of the machine.

There were no off site impact or discharge to any receiving watercourses.

Mechanical failure as the hydraulic pump burst.

The machine was turned off and the spill contained with absorbent pads. The contaminated pads were sent to the HAZMAT area and the contaminated soil excavated and disposed at the landfarm. An estimated volume of 8m³ of contaminated material was collected.
