April 2nd, 2016 BAC 10 oil spill

Please find the following information as a follow up to the Spill report submitted April 3rd, 2016 by Agnico Eagle Meadowbank division. This detailed report is submitted to the Inspector in compliance with the conditions under the Nunavut Water Board License 2AM-MEA1525, Part H, Item 8c.

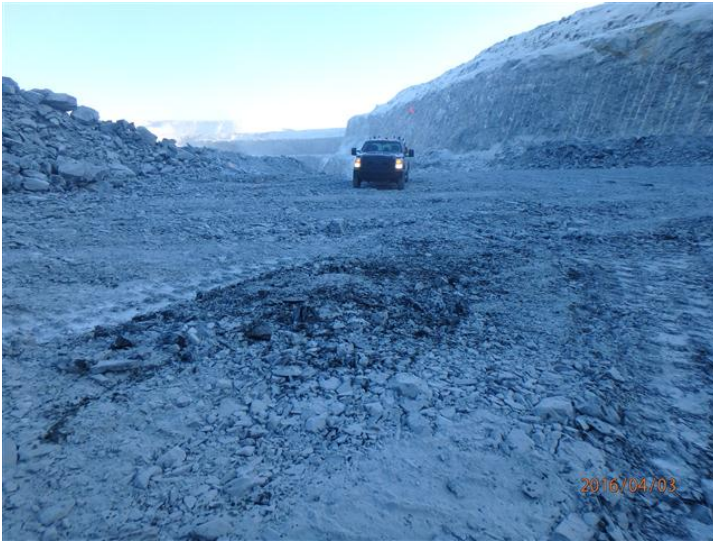
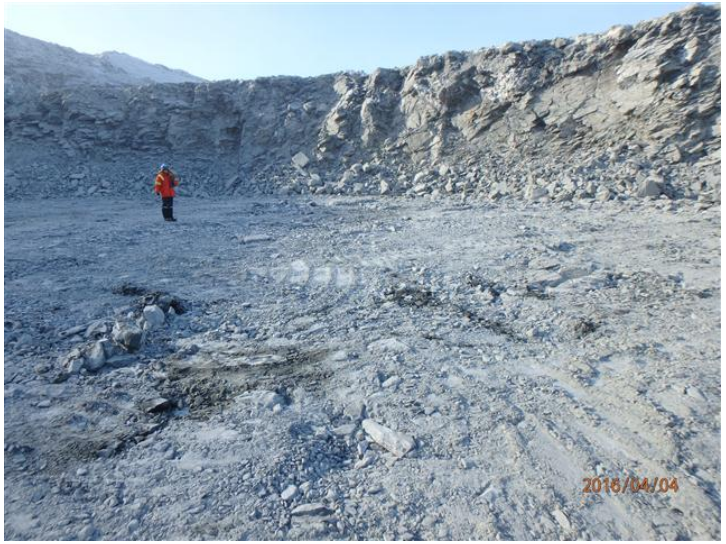
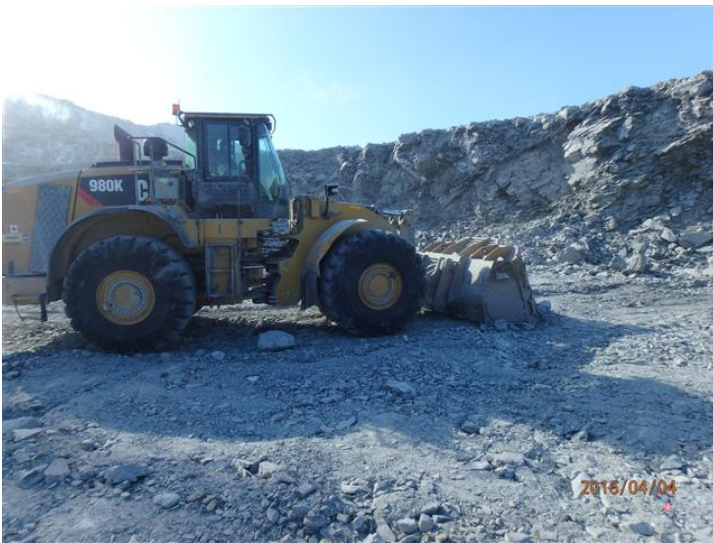
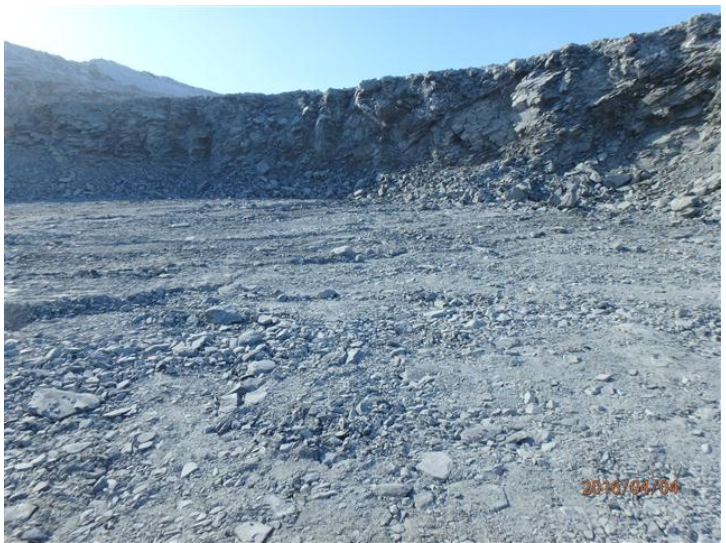
On April 2nd, the O-ring of the hydraulic filter on BAC 10 burst and the oil leaked out of the machine.

Mechanical failure as the hydraulic filter burst.

The machine was turned off and the spill contained with absorbent pads. The contaminated pads were sent to the HAZMAT area and the contaminated soil excavated and disposed at the landfarm. An estimated volume of 6m³ of contaminated material was collected.

A meeting with Mine and Maintenance department was held to evaluate the root cause of the spill. Modifications were made in the preventive maintenance log and planning to address specific inspections of hoses on equipment. A visual inspection was already being done on equipment, but a specific item related to hose inspections is now included to PM's executed on those type machinery. The item "[Inspect all hydraulic hoses for leaks or potential failures](#)" was added to the planning module and is now part of all hydraulic systems maintenance.
