April 3rd, 2016 BAC 13 oil spill

Please find the following information as a follow up to the Spill report submitted April 4th, 2016 by Agnico Eagle Meadowbank division. This detailed report is submitted to the Inspector in compliance with the conditions under the Nunavut Water Board License 2AM-MEA1525, Part H, Item 8c.

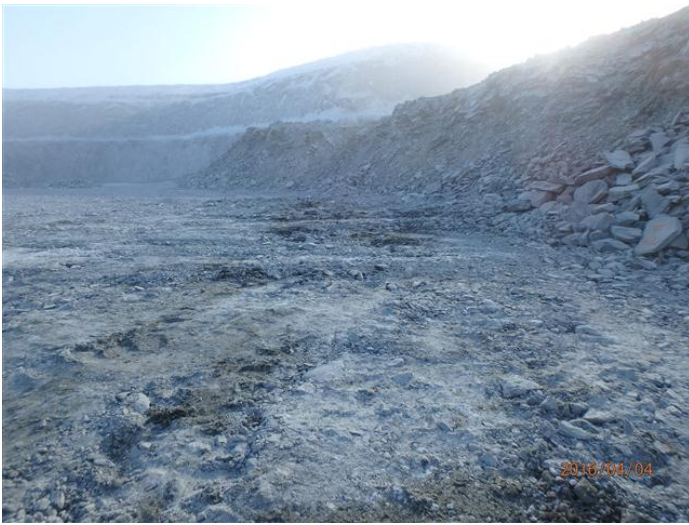
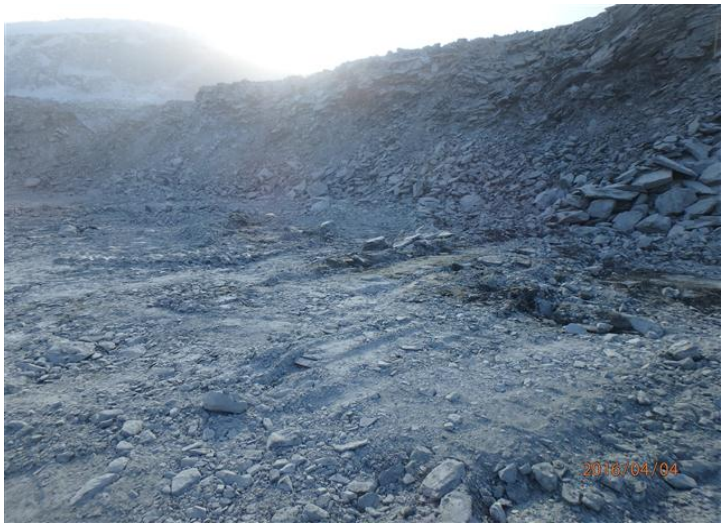
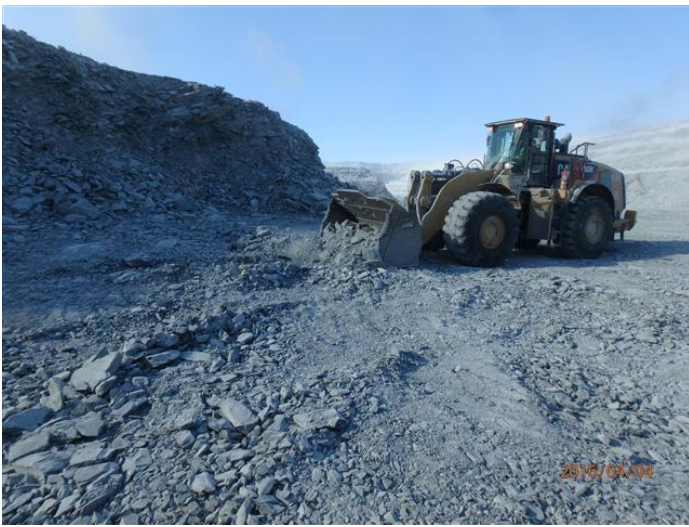
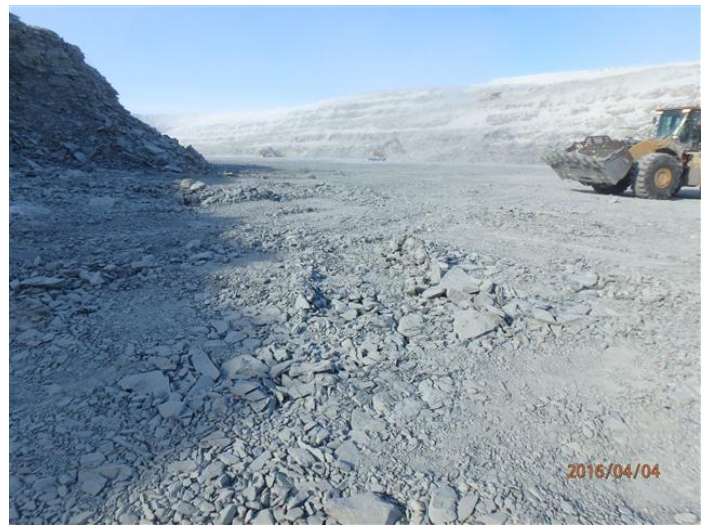
On April 3rd, the hydraulic pump on BAC 13 burst and the oil leaked out of the machine.

Mechanical failure as the hydraulic pump burst.

The machine was turned off and the spill contained with absorbent pads. The contaminated pads were sent to the HAZMAT area and the contaminated soil excavated and disposed at the landfarm. An estimated volume of 10m³ of contaminated material was collected.

A meeting with Mine and Maintenance department was held to evaluate the root cause of the spill. Modifications were made in the preventive maintenance log and planning to address specific inspections of hoses on equipment. A visual inspection was already being done on equipment, but a specific item related to hose inspections is now included to PM's executed on those type machinery. The item "[Inspect all hydraulic hoses for leaks or potential failures](#)" was added to the planning module and is now part of all hydraulic systems maintenance.
