May 11th, 2016 Vault backhoe spill

Please find the following information as a follow up to the Spill report submitted May 12th, 2016 by Agnico Eagle Meadowbank division. This detailed report is submitted to the Inspector in compliance with the conditions under the Nunavut Water Board License 2AM-MEA1525, Part H, Item 8c.

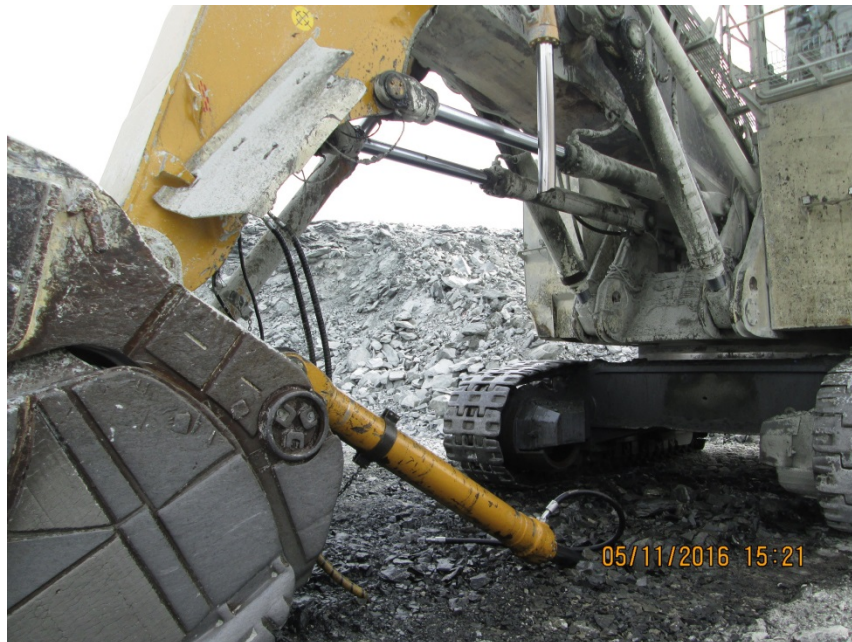
On May 11th, 2016, backhoe 10 was working in Vault pit when a cylinder of the bucket broke apart causing hydraulic oil to be spill on the ground

The spill was caused when the cylinder split apart while loading the bucket with material and resulted in catastrophic failure of the piece.

The cylinders on site are inspected regularly for possible defects and wear. Hours are also tracked for them and they are changed systematically after thresholds are met. For the specific event on the cylinder of backhoe 10, after inspections, there were no visible signs that could have foretold the failure.
