May 15th, 2016 Vault backhoe spill

Please find the following information as a follow up to the Spill report submitted May 16th, 2016 by Agnico Eagle Meadowbank division. This detailed report is submitted to the Inspector in compliance with the conditions under the Nunavut Water Board License 2AM-MEA1525, Part H, Item 8c.

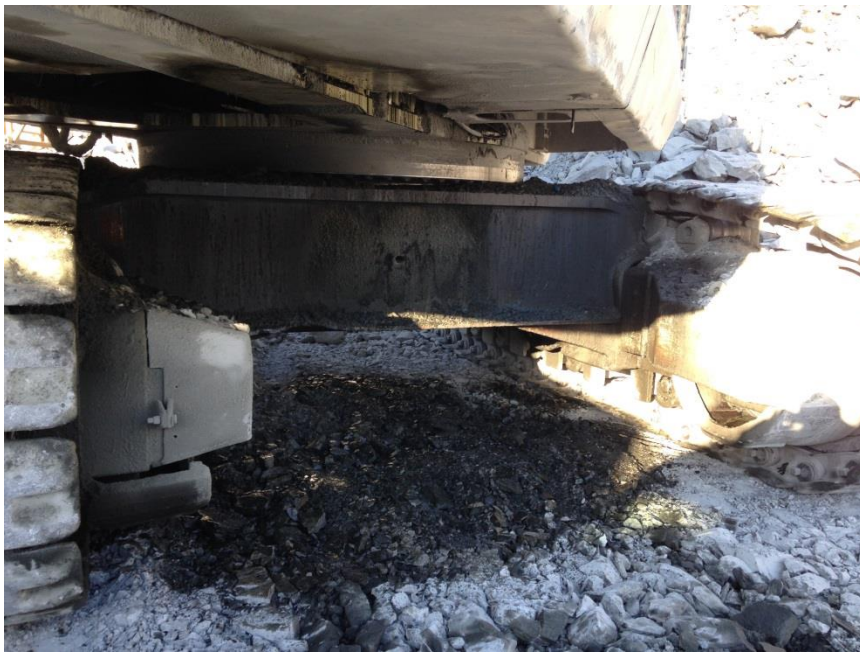
On May 15th, 2016, backhoe #10 was working in Vault pit area when the hydraulic pump seemed to failed causing hydraulic oil to be sprayed on the ground

There were no off site impact or discharge to any receiving watercourses.

The spill was caused when a bolt on a set of half clamps located on a block unit near the hydraulic pump broke. The initial assessment pointed towards pump failure but upon further investigation, the bolt was found to be at the root of the spill.

The defective bolt was changed on the clamps. A visual inspection was done on the other clamp bolts on the backhoe and nothing particular was found. The failed bolt was also checked for stress signs. Nothing out of the ordinary was noted. The bolt type and brand was also found to be the same as usually used on Caterpillar equipment.
