May 19th, 2016 BACKHOE 10 spill

Please find the following information as a follow up to the Spill report submitted May 19th, 2016 by Agnico Eagle Meadowbank division. This detailed report is submitted to the Inspector in compliance with the conditions under the Nunavut Water Board License 2AM-MEA1525, Part H, Item 8c.

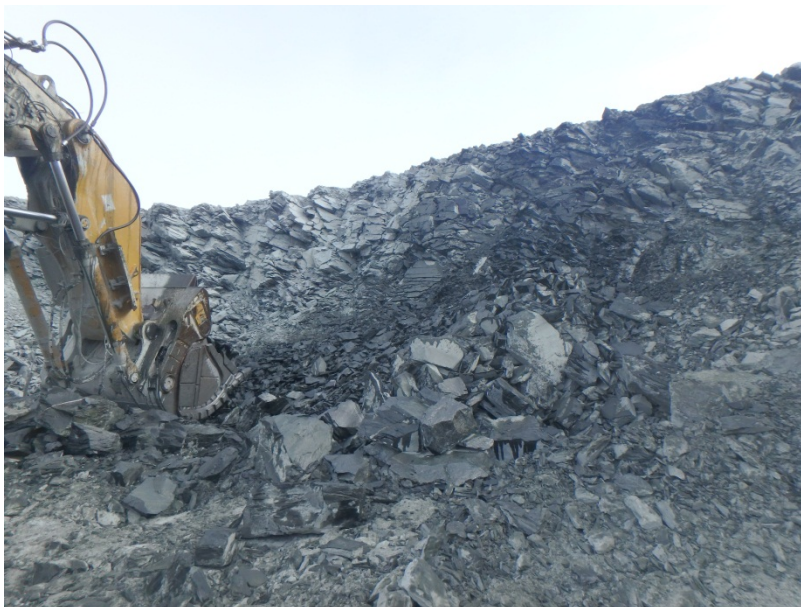
On May 19th, 2016, a main hydraulic hose broke on backhoe #10 causing hydraulic oil to be spilled on the ground and pit wall
