May 14th, 2016 Vault haultruck spill

Please find the following information as a follow up to the Spill report submitted May 14th, 2016 by Agnico Eagle Meadowbank division. This detailed report is submitted to the Inspector in compliance with the conditions under the Nunavut Water Board License 2AM-MEA1525, Part H, Item 8c.

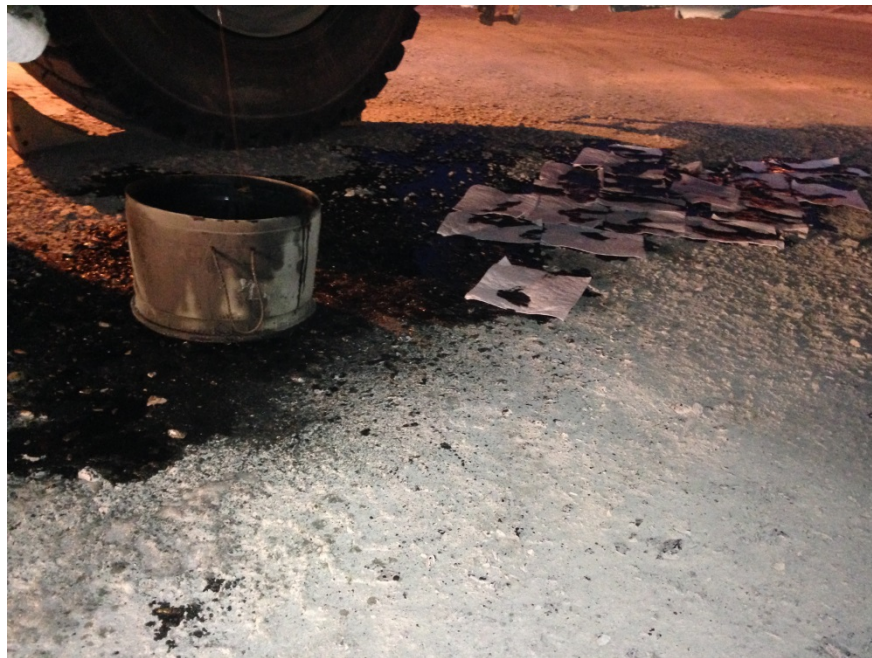
On May 14th, 2016, haul truck #34 was parked at Vault area when the hydraulic pump failed causing hydraulic oil to be sprayed on the ground

The spill was caused when the pump on the haul truck failed. The pump was just previously changed for usual maintenance. When the haul truck started for its hauling work, the new pump case split apart, spraying hydraulic oil.

The haul truck was stopped immediately. A secondary container was put in place to catch the falling hydraulic oil and absorbent pads were laid out on the ground. When the truck was repaired and could be moved, the contaminated soil was collected with a loader.

The pump that failed was just newly installed on the haul truck. Once it was removed from the equipment it was inspected to assess for any defects. Visual inspections could not indicate any issues. A new pump was installed in the haul truck, it worked without any problems.

Replacement pumps in inventory on site are also planned to be inspected to see if any correlation could be found with the failed pump.
