June 12th, 2016 BAC 10 oil spill

Please find the following information as a follow up to the Spill report submitted June 13th, 2016 by Agnico Eagle Meadowbank division. This detailed report is submitted to the Inspector in compliance with the conditions under the Nunavut Water Board License 2AM-MEA1525, Part H, Item 8c.

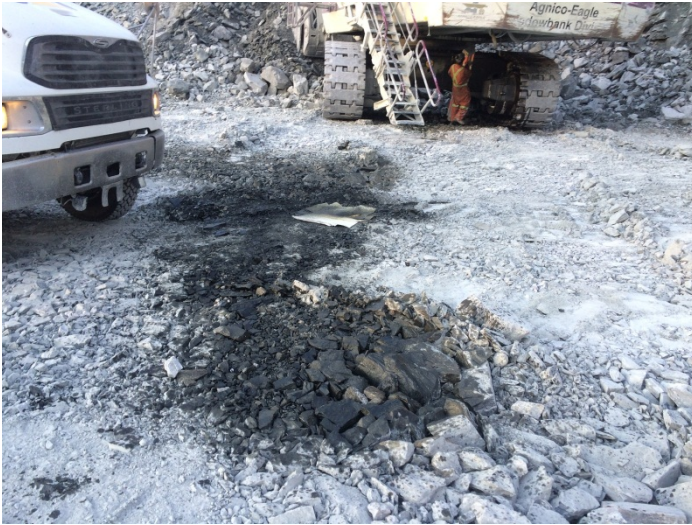
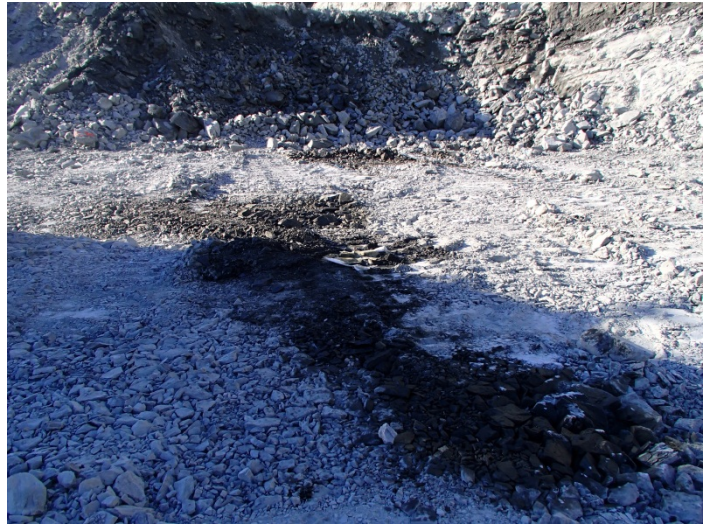
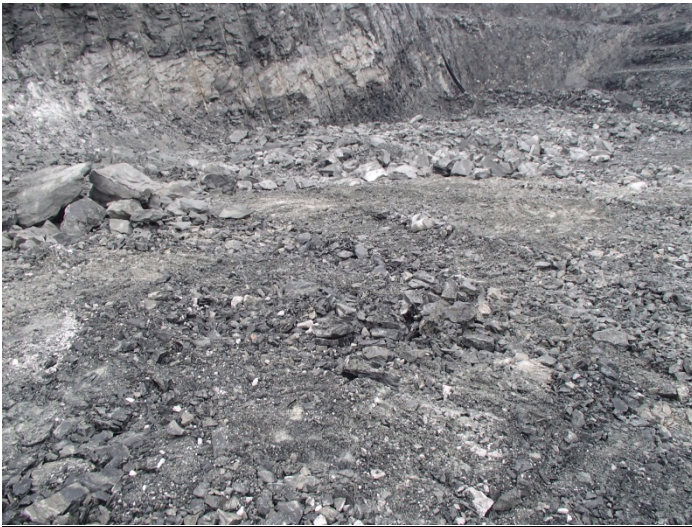
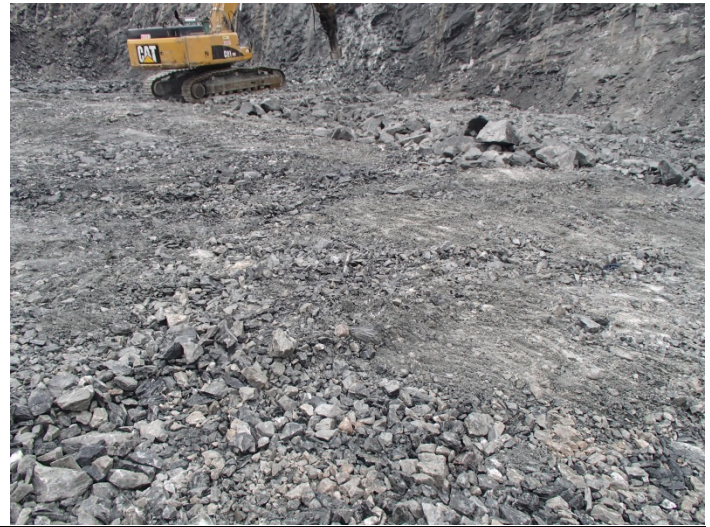
On June 12th, during operations at Vault, an o'ring broke on Backhoe #10, causing hydraulic oil to be spilled on the ground.

Mechanical failure as the o'ring broke.

The machine was turned off and the spill contained with absorbent pads. The contaminated pads were sent to the HAZMAT area and the contaminated soil excavated and disposed at the landfarm. An estimated volume of 8m³ of contaminated material was collected.
