# AGNICO EAGLE

### June 23<sup>rd</sup> Drill #4 Oil spill

Please find the following information as a follow up to the Spill report submitted June 23<sup>rd</sup> 2016 by Agnico Eagle Meadowbank Division. This detailed report is submitted to the Inspector in compliance with the conditions under the Nunavut Water Board License 2AM-MEA1525, Part H, Item 8c.

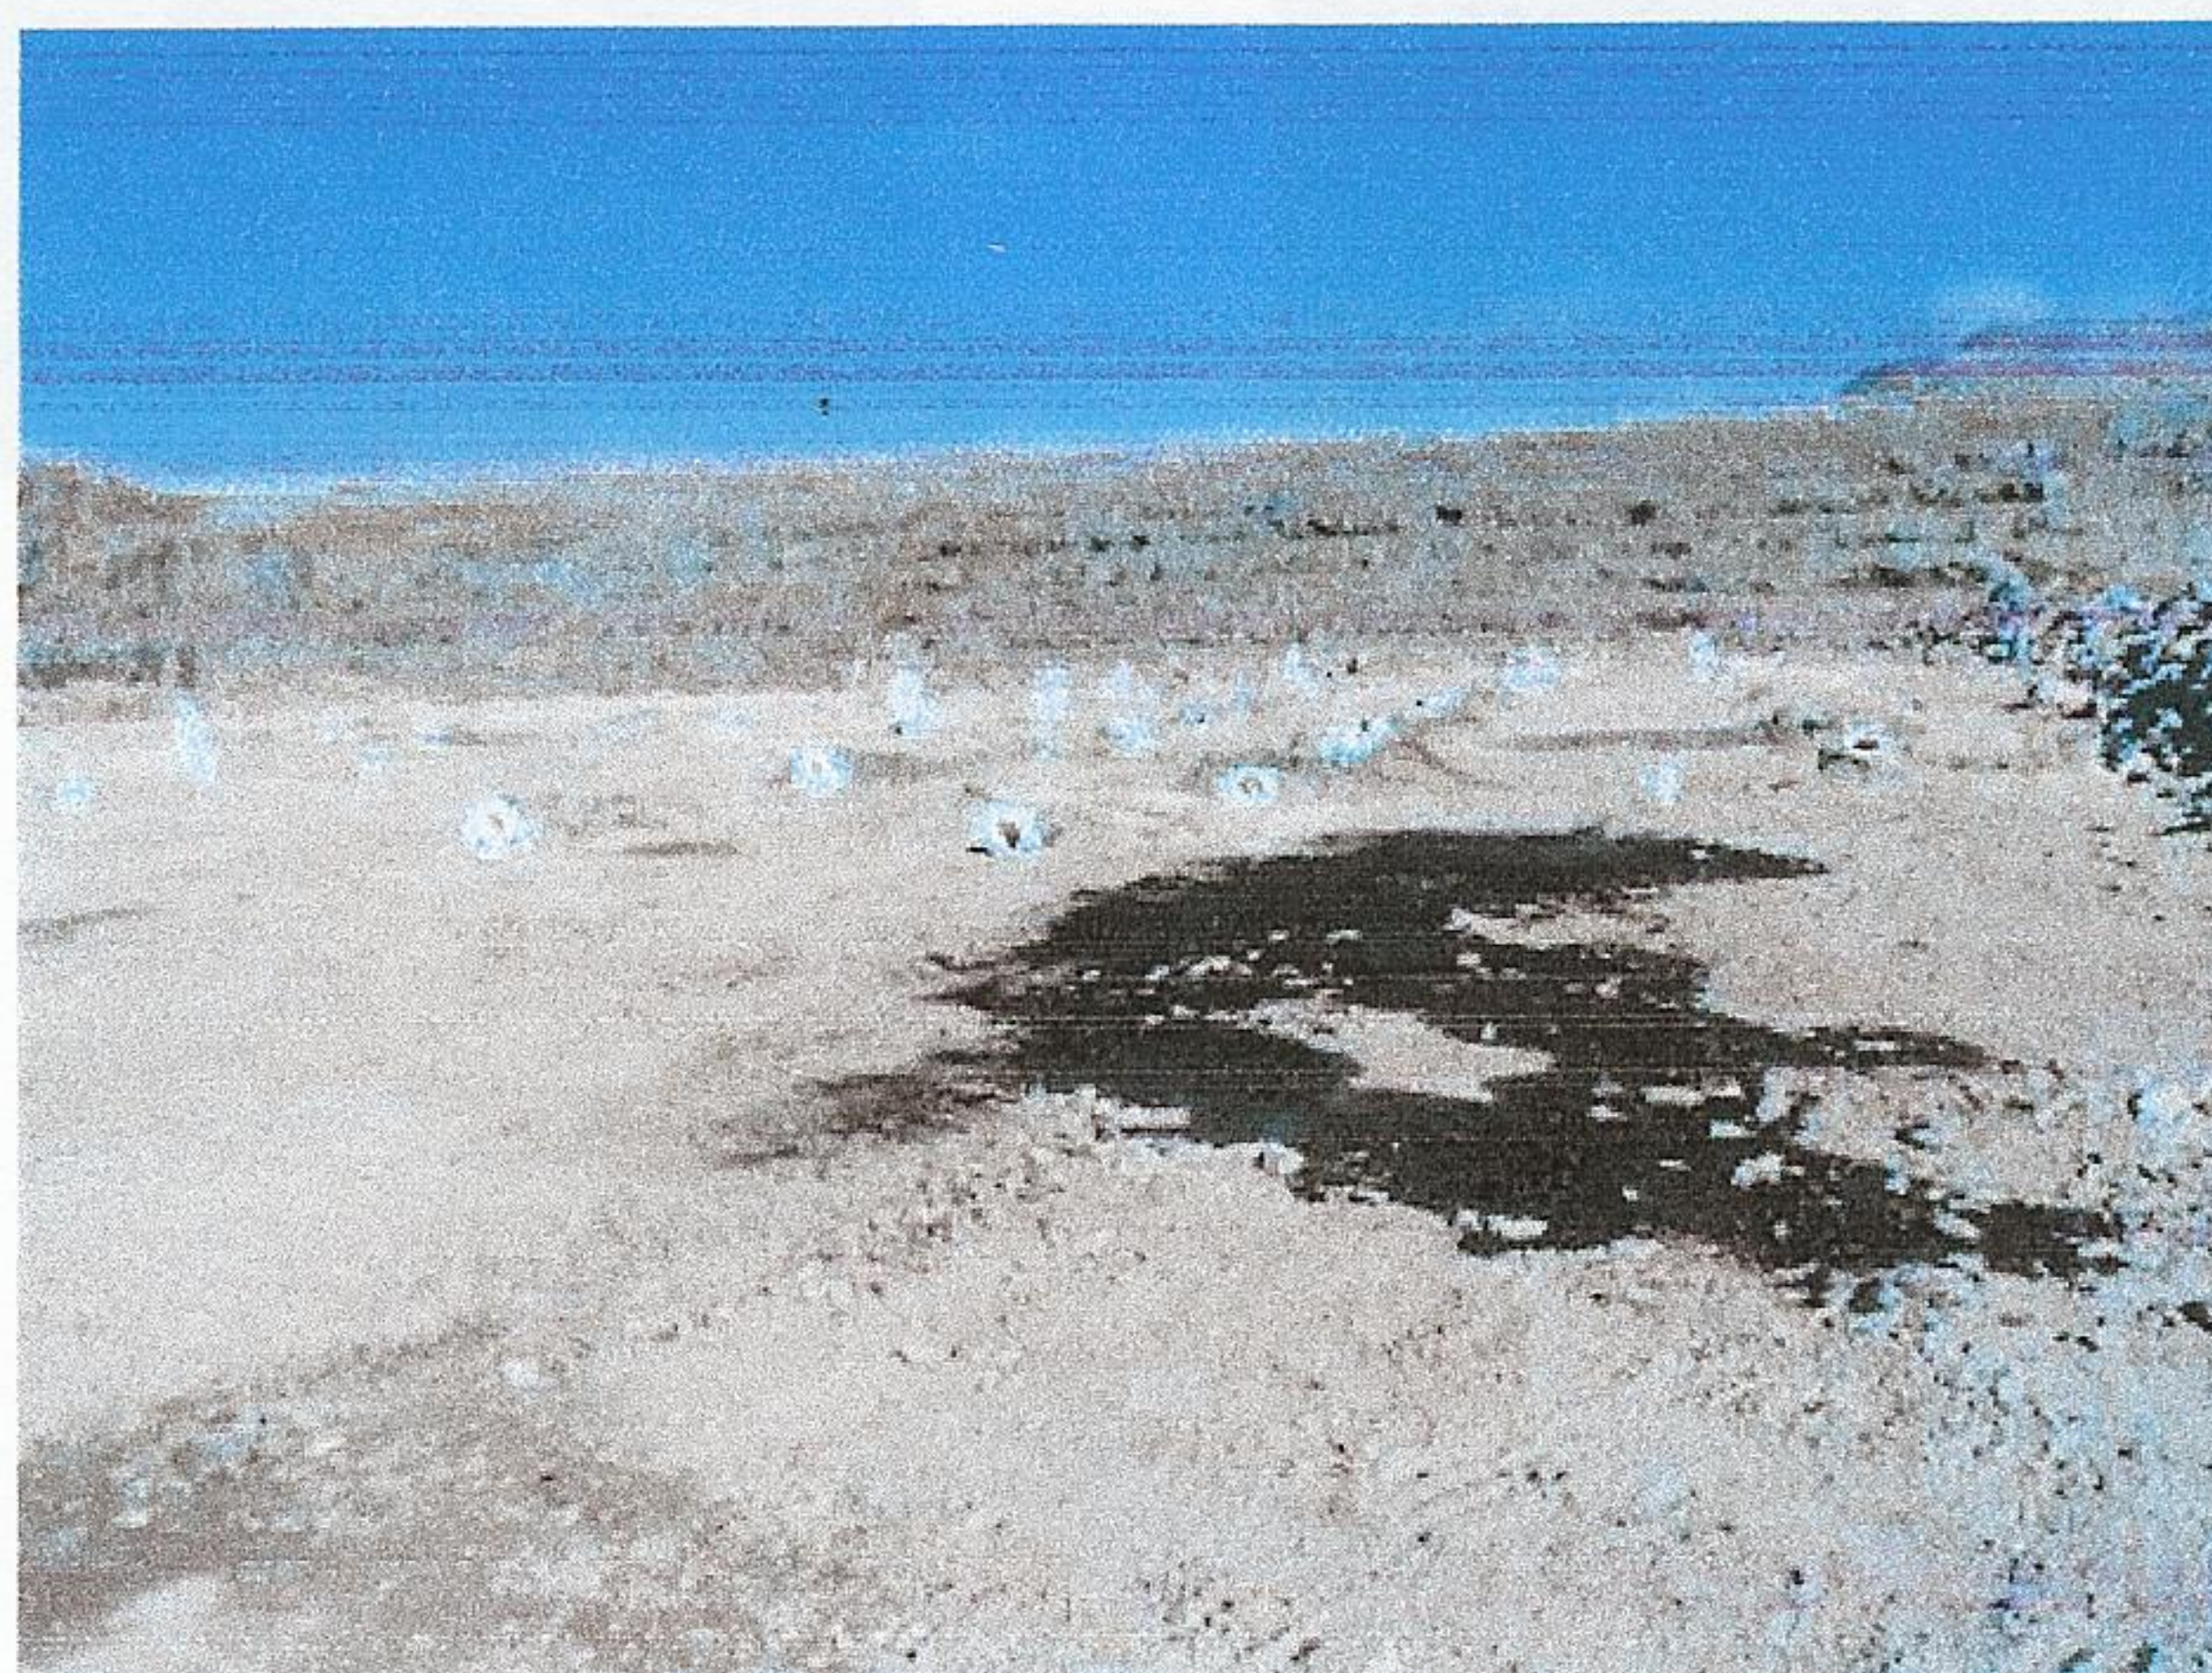
Spill location: Northing 65'04'33" Easting 95'59'98"

On June 23<sup>rd</sup> during operations at Vault pit, a hydraulic hose ruptured on Drill #4 causing oil to be spilled to the ground

There was no off site impacts or discharge to an receiving watercourse

Mechanical failure as the hydraulic hose ruptured on the drill

Operator of the drill stopped the equipment immediately to prevent further contamination. Absorbent pads were placed on the ground and a plastic 2ndary containment under the leak. Once the leak was repaired, absorbent pads were picked up and disposed of appropriately and oil collected in the 2ndary containment was placed in a sealed drum and brought to the HAZMAT area to be disposed of appropriately.
