June 23rd 2016 BAC08 Oil spill

Please find the following information as a follow up to the Spill report submitted June 23rd 2016 by Agnico Eagle Meadowbank Division. This detailed report is submitted to the Inspector in compliance with the conditions under the Nunavut Water Board License 2AM-MEA1525, Part H, Item 8c.

Spill description

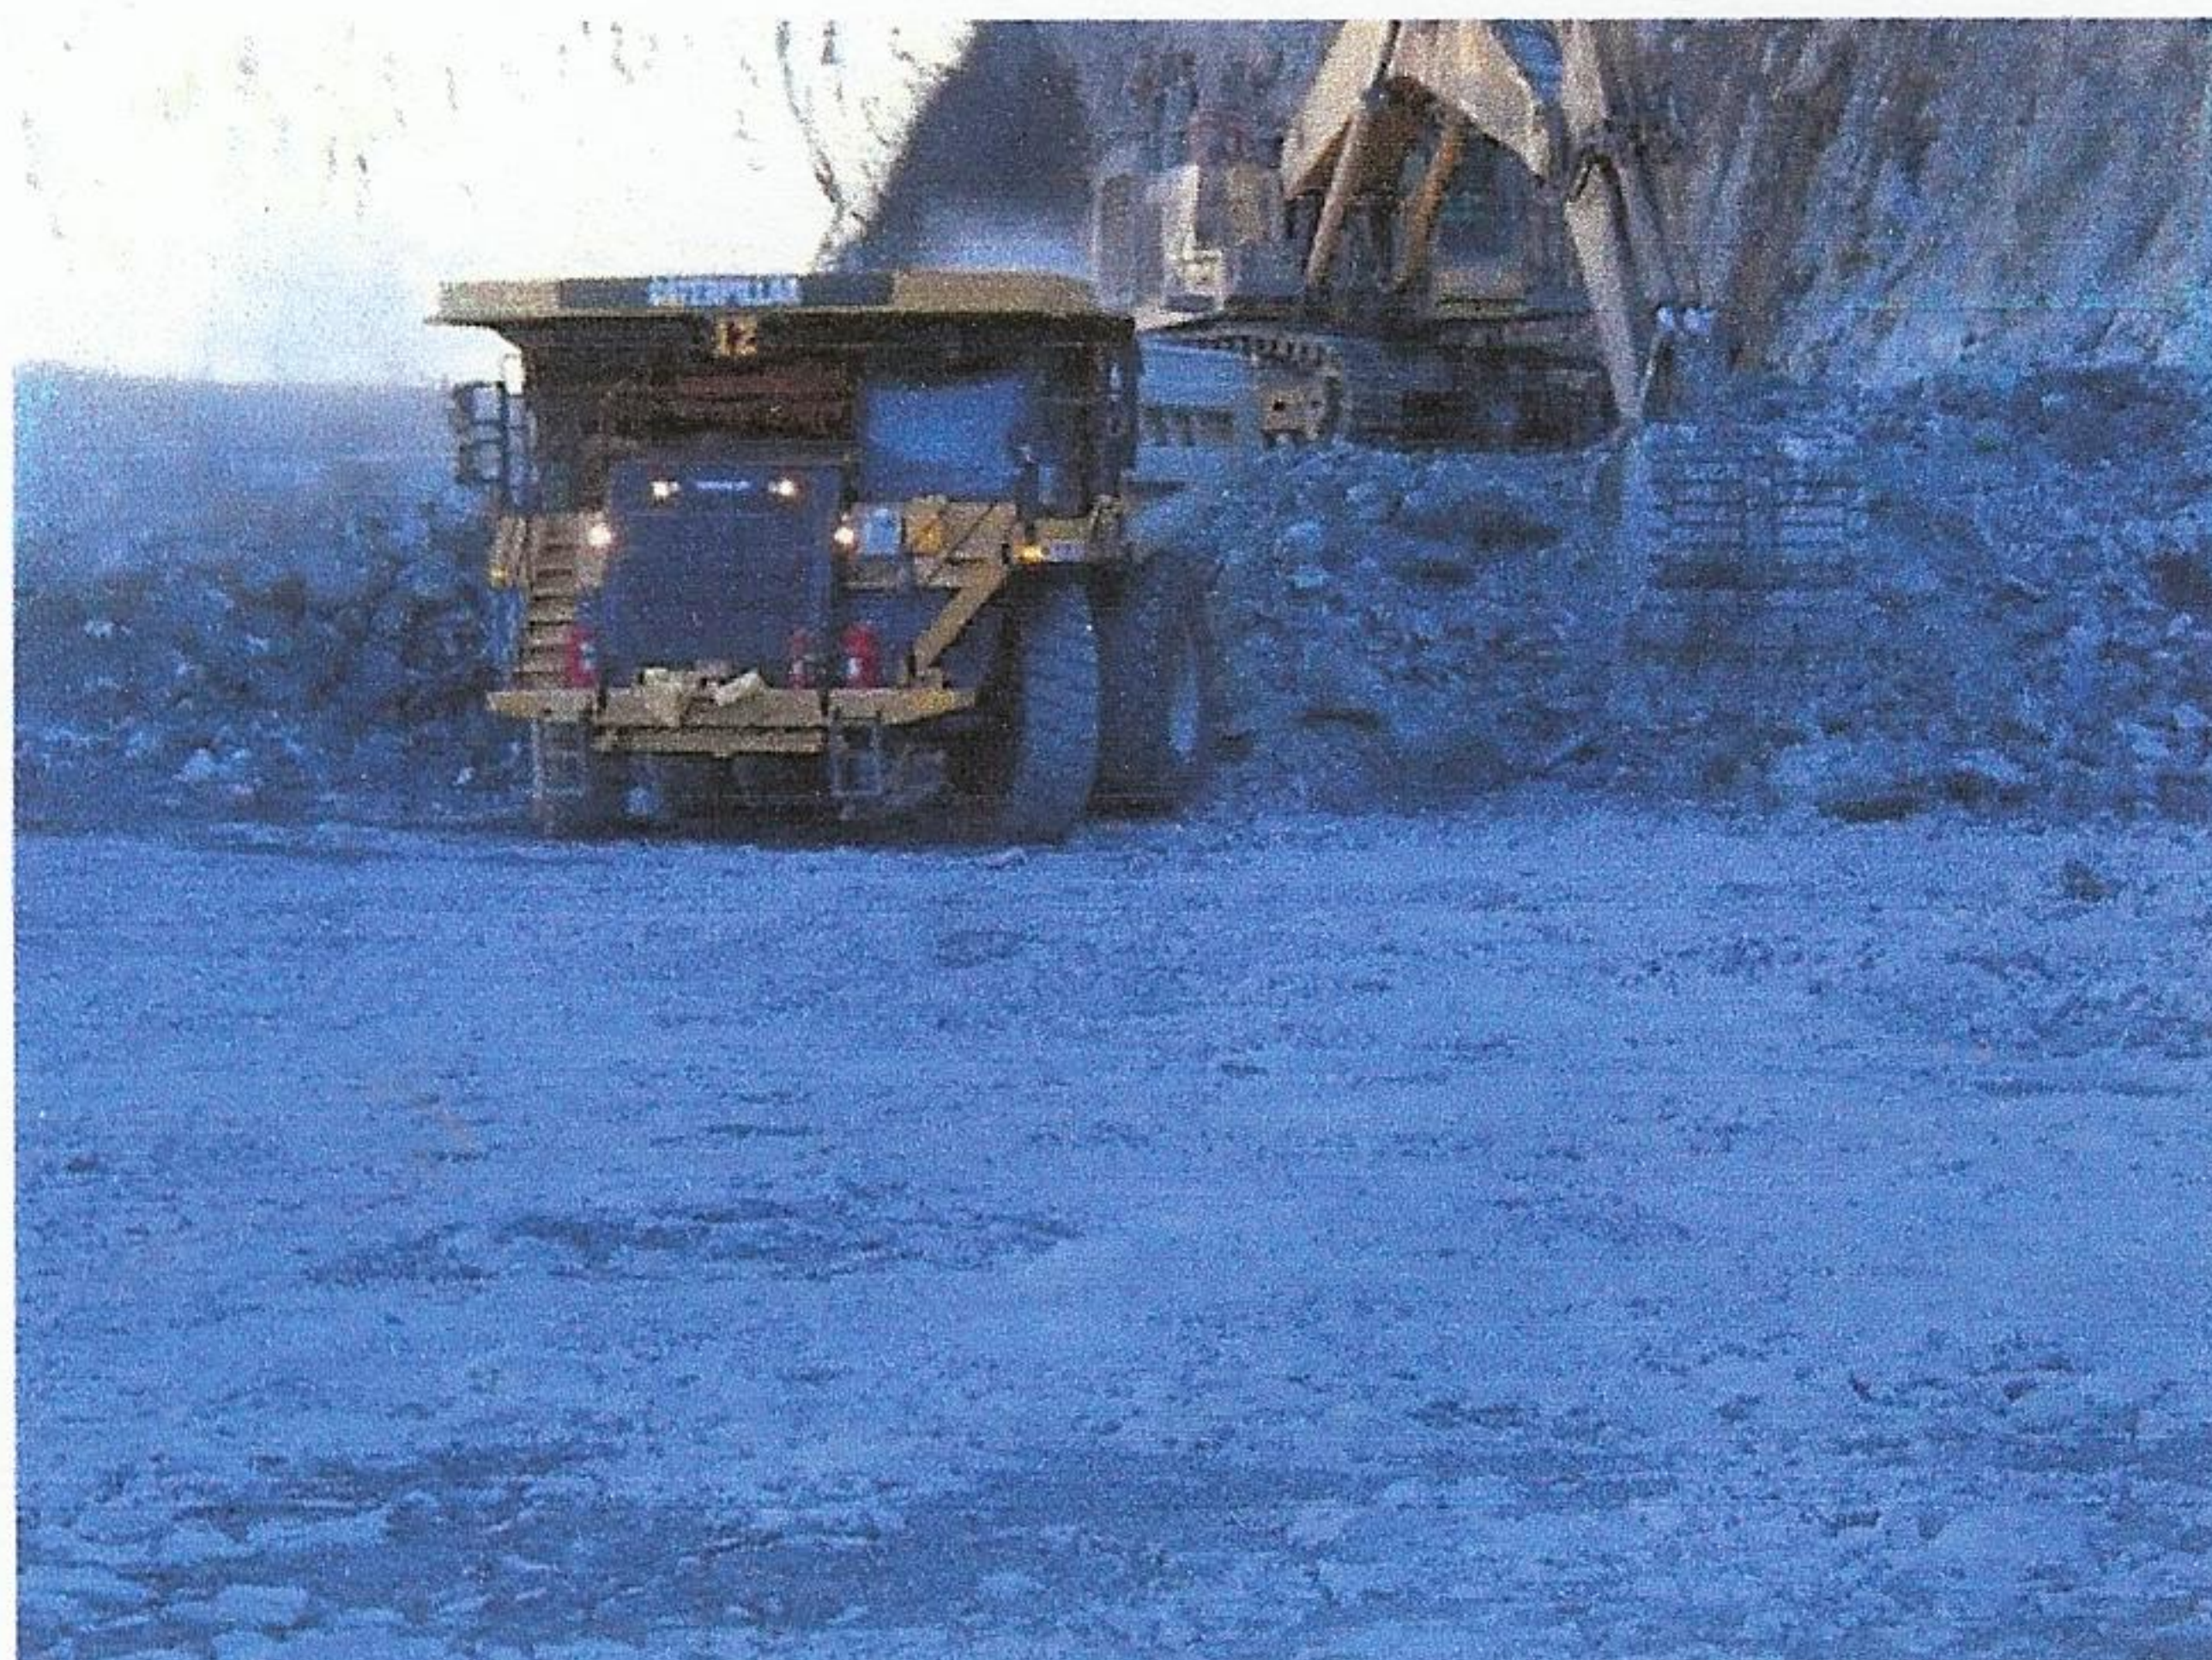
On June 23rd, during operations at Portage Pit A an O-ring broke on Backhoe #8 causing hydraulic oil to be spilled on the ground

Mechanical failure as the O-ring on a hose broke

Photo 1: after cleanup of contaminated soil

The machine was shut down immediately to prevent further spilling, placed absorbent pads on the ground to prevent further contamination on the ground. Absorbent pads were picked up and disposed of at the HAZMAT area and contaminated soil was removed and brought to the Landfarm
