## July 4<sup>th</sup>, 2016 MBK Laydown oil spill

Please find the following information as a follow up to the Spill report submitted July 4<sup>th</sup>, 2016 by Agnico Eagle Meadowbank division. This detailed report is submitted to the Inspector in compliance with the conditions under the Nunavut Water Board License 2AM-MEA1525, Part H, Item 8c.

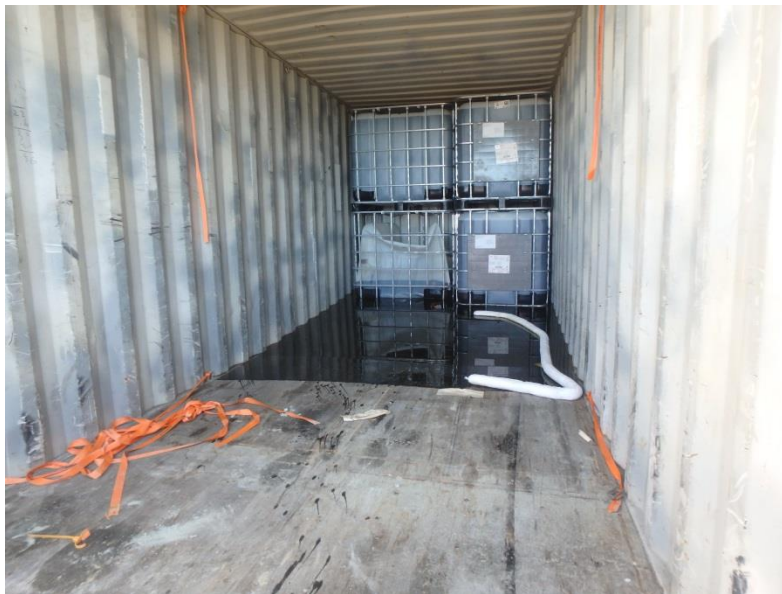
On July 4<sup>th</sup>, 2016, a warehouse operator was in the process of taking oil totes from a container in Laydown 3, when he noticed that he had punctured a tote located at the back.

The spill was caused when the forks of the zoom-boom used to move the tote could not slide inside their allocated slots, thus puncturing the tote.

After investigation, it was determined that the operator did not follow standard practices. When removing totes from the back of a container, when visibility is less, a spotter should be used to ensure forks are properly placed before lifting and that product being lifted is stable. The worker was reminded of work procedures, as well as warehouse crew made aware of importance of following procedures.

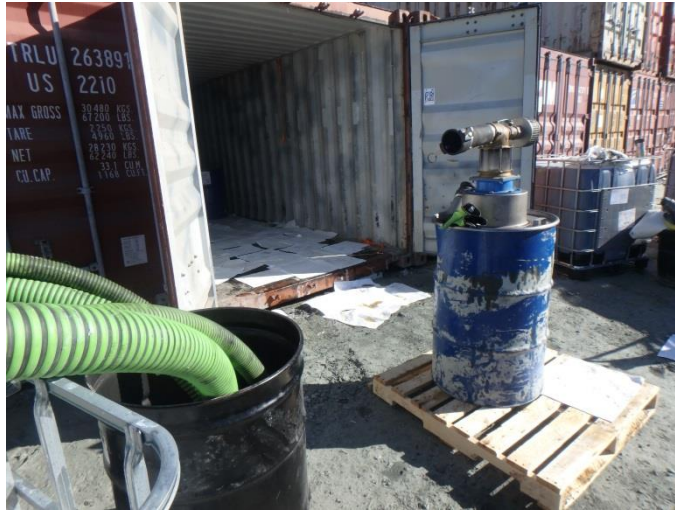
Spill was contained inside the container at first but leaked outside from the back side. A vacuum pump was used to collect oil left inside and absorbent pads were laid out to contain spill.

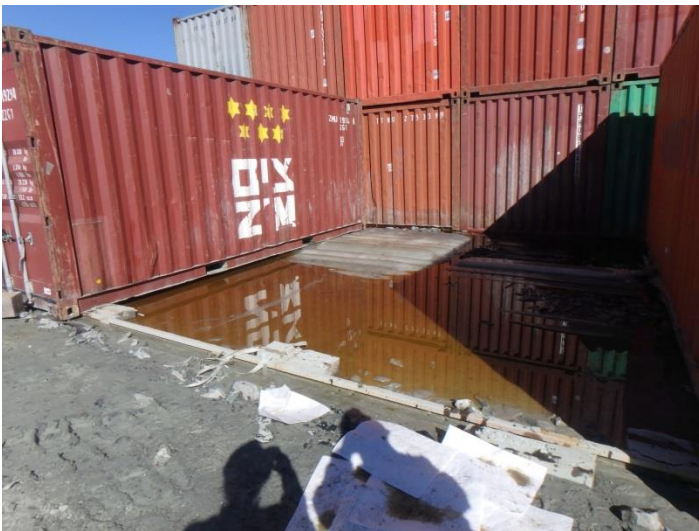
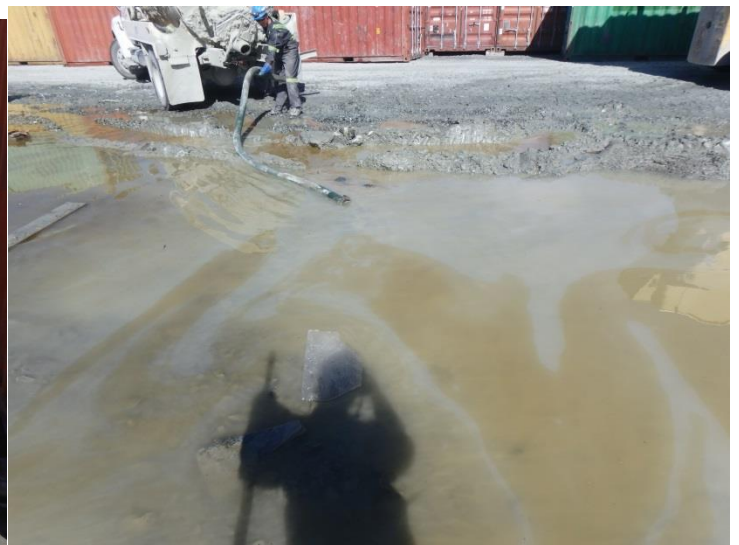
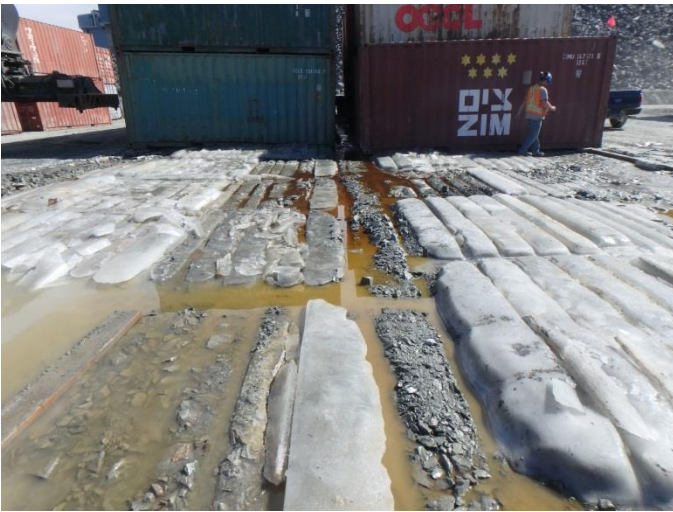
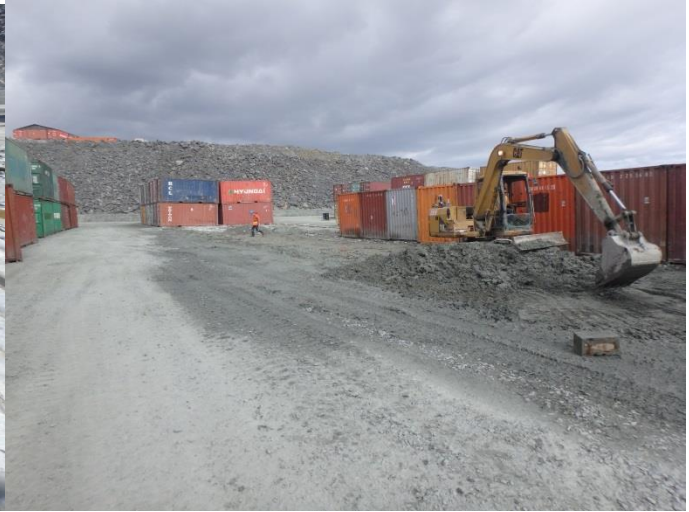
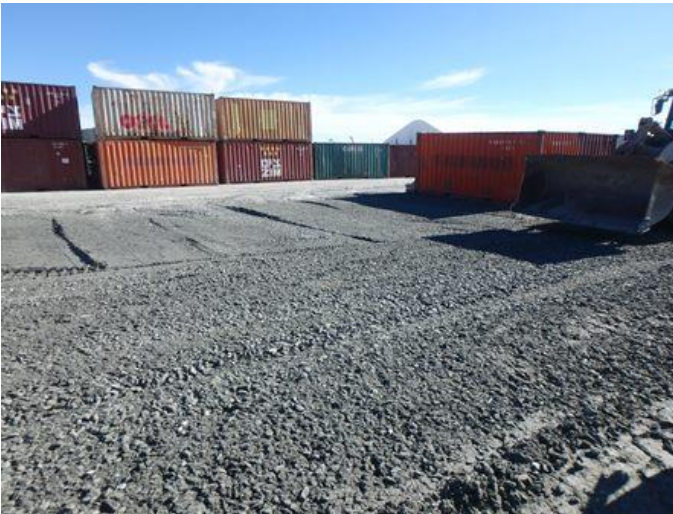
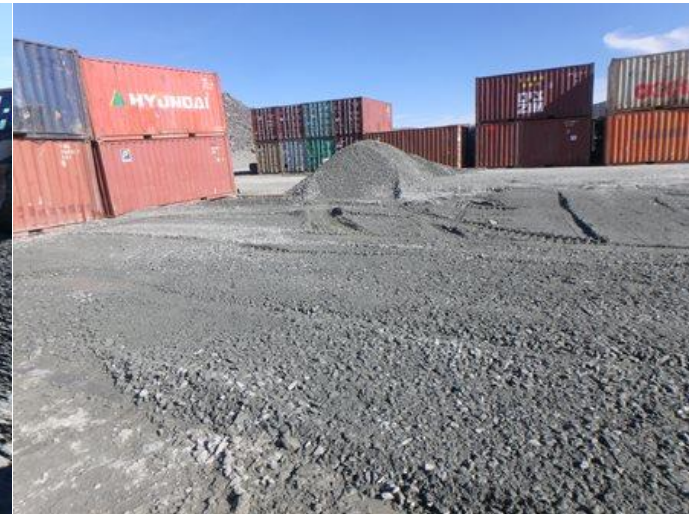
The c-can was then safely emptied, lifted and moved. Once the area was cleared, and the surrounding containers moved, remaining oil that had exited the container from the back was collected. Clean-up was made difficult by melt water and ice in the area. A vacuum truck was used to collect all the water in the area. The contaminated water was brought to the Tailings Storage Facility. All the neighboring c-can were also move to access the area. After water was collected and properly disposed of, the area was then scrapped clean with and backhoe. Depth of material collected varied with frozen ground. Soil and ice collected were put into a roll-off and brought to our landfarm area. Once the area was cleaned, fresh material was added and graded on the area.
