August 7th, 2016 MBK Transit Laydown spill

Please find the following information as a follow up to the Spill report submitted August 7th, 2016 by Agnico Eagle Meadowbank division. This detailed report is submitted to the Inspector in compliance with the conditions under the Nunavut Water Board License 2AM-MEA1525, Part H, Item 8c.

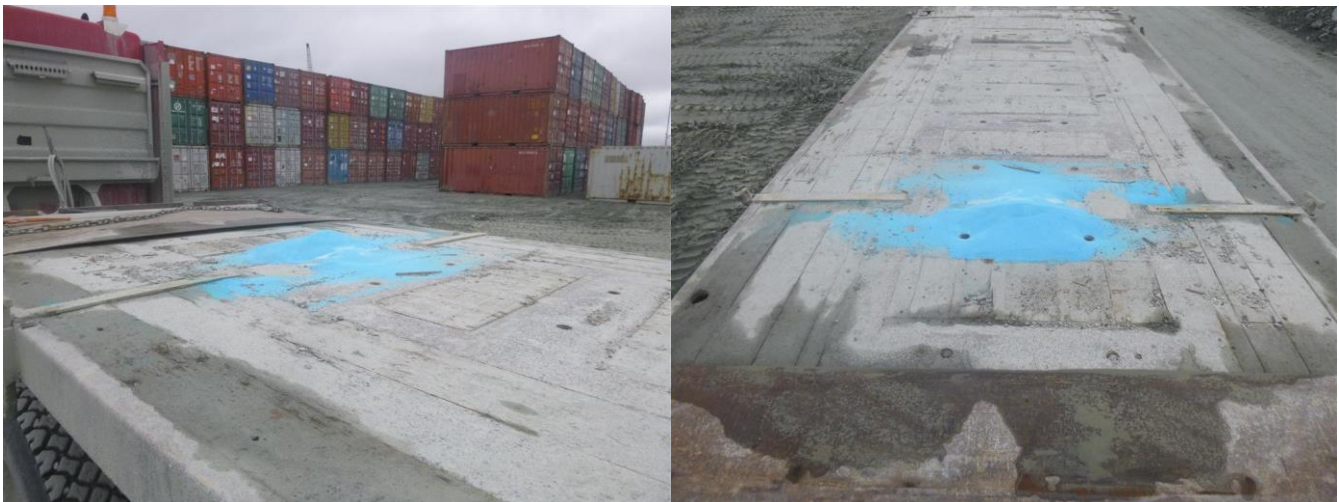
In the process of lifting a c-can in the transit area, product was noticed spilling from the bottom of the container. The operator immediately stopped work. Upon inspection product was identified as bulk bags of powdered copper sulfate.

After moving bags outside of container, it was noticed that one bag at the back had a small rip hole, probably caused during transportation.
