## September 19th, 2016 BAC 13 oil spill

Please find the following information as a follow up to the Spill report submitted September 19th, 2016 by Agnico Eagle Meadowbank division. This detailed report is submitted to the Inspector in compliance with the conditions under the Nunavut Water Board License 2AM-MEA1525, Part H, Item 8c.

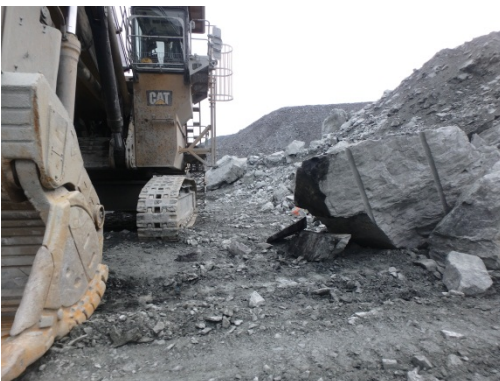
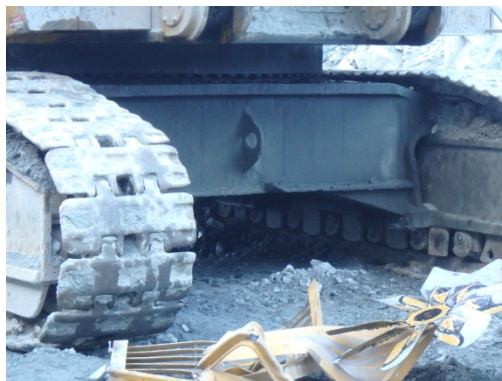
On September 19th, during operations at Pit A, a rock fell from the face where backhoe 13 was mucking and hit the hydraulic fan motor and cooler causing the oil spill.

A rock falling from a wall face hit the hydraulic fan motor.
