September 22nd, 2016 Pit A Back hoe 11 Spill

Please find the following information as a follow up to the Spill report submitted September 22, 2016 by Agnico Eagle Meadowbank Division. This detailed report is submitted to the Inspector in compliance with the conditions under the Nunavut Water Board License 2AM-MEA1525, Part H, Item 8c

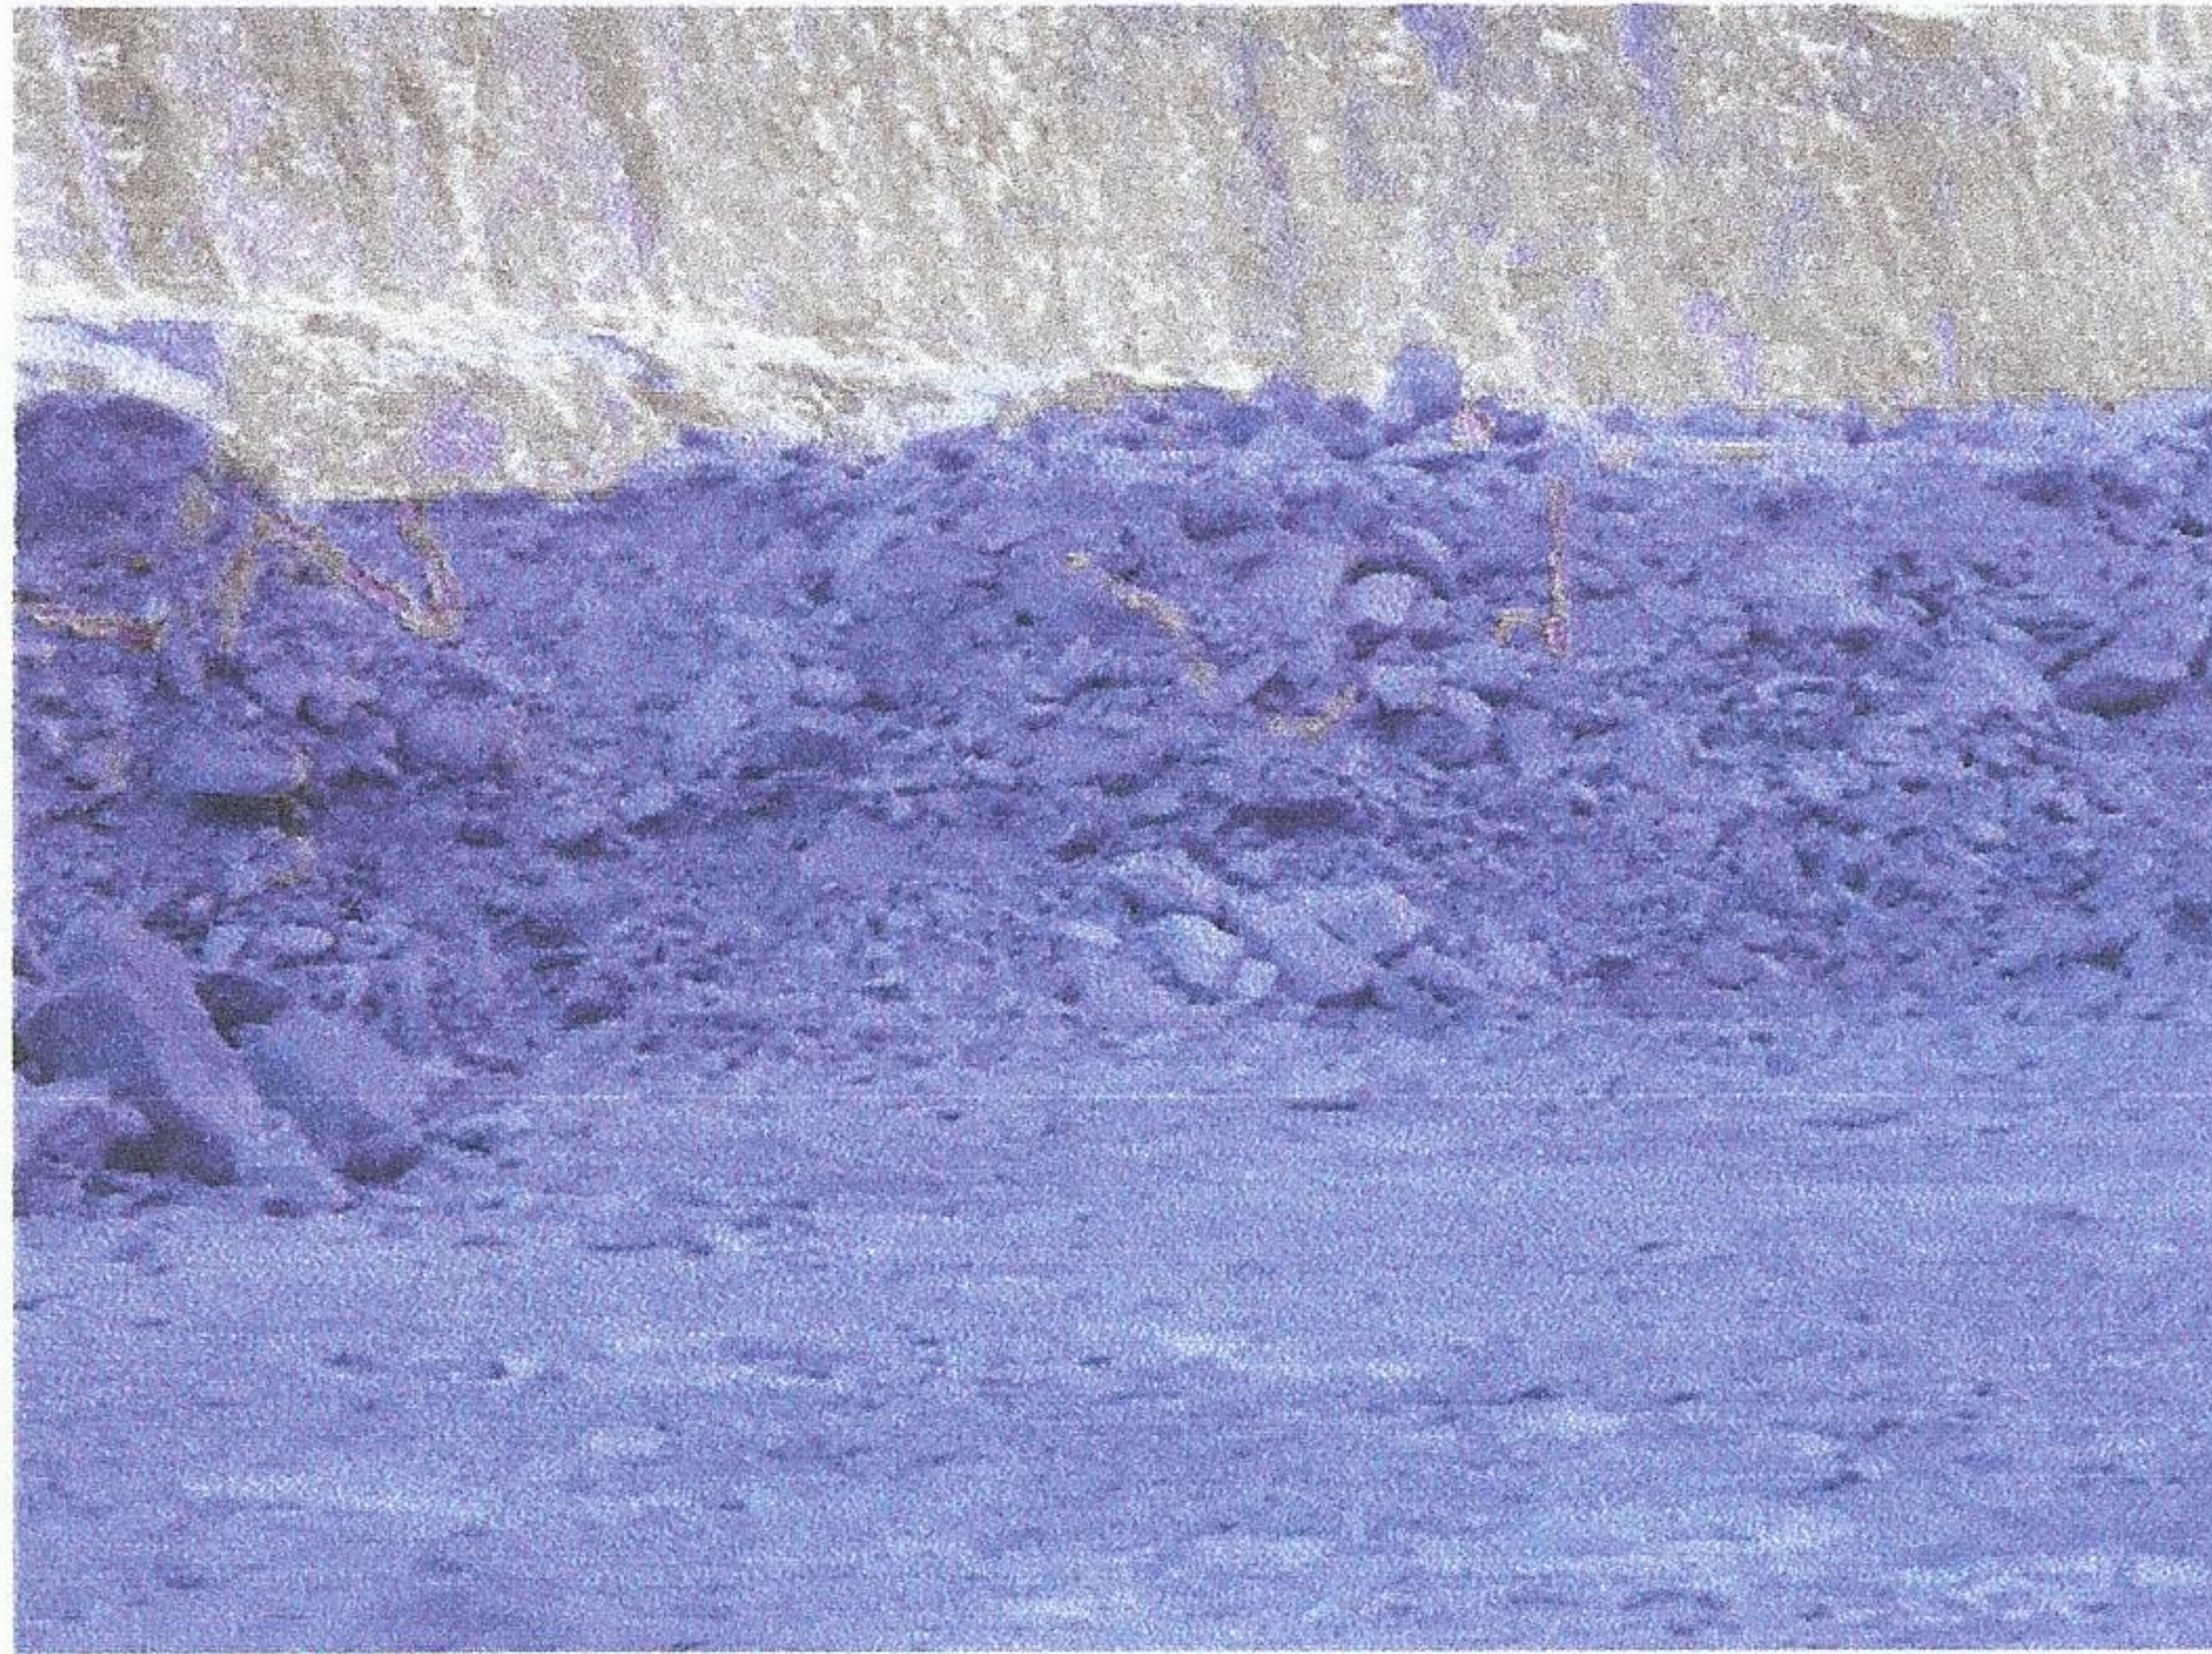
During operations in Pit A, a hydraulic hose failed on the Swing arm of the Back hoe while loading a haul truck. Operator of the equipment stopped the engine right away to prevent further spilling on to the ground. The operator contacted his supervisor immediately to have the equipment repaired.

Operator of the equipment called his supervisor immediately upon shutting off his equipment to be repaired. Once the repairs were completed, contaminated area was cleaned up using a 980 loader and material was placed in a yellow roll-off bin to be brought to the Land farm.
