October 19th, 2016 RBD 03 oil spill

Please find the following information as a follow up to the Spill report submitted October 19th, 2016 by Agnico Eagle Meadowbank division. This detailed report is submitted to the Inspector in compliance with the conditions under the Nunavut Water Board License 2AM-MEA1525, Part H, Item 8c.

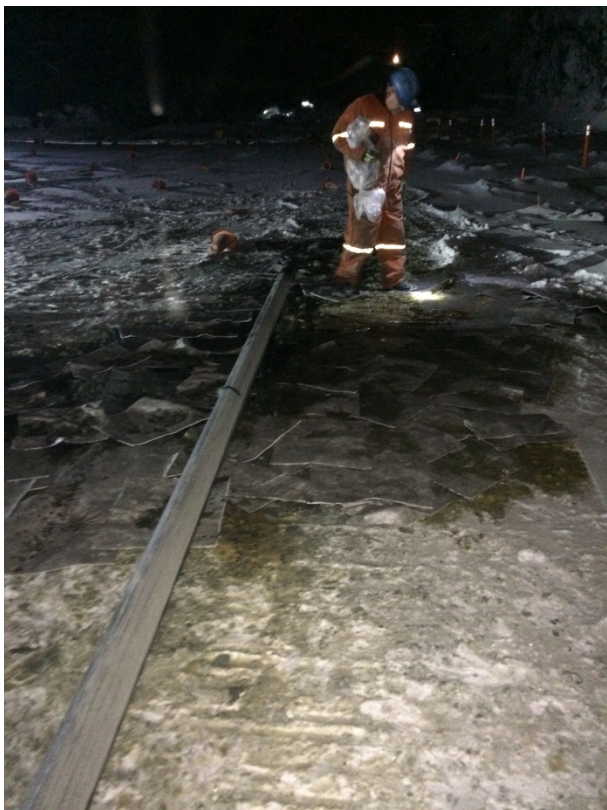
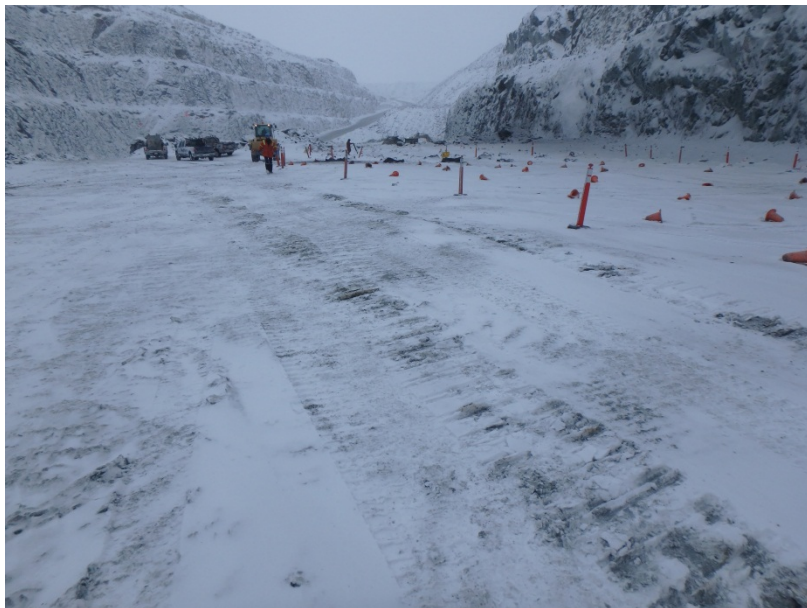
On October 19th, during operations at Pit E, a loose fitting caused by vibration was leaking while the drill was on standby, when it was called to the shop drill operator went to move drill to the tow haul and noticed the spill.

The spill was caused by a loose fitting on a hydraulic hose

The machine was stopped immediately. Mechanic came and tightened the fitting. Absorbent pads were put on the oil to absorb as much as possible. These pads were brought to the HAZMAT area and a loader collected the contaminated soil and brought it to the landfarm.
