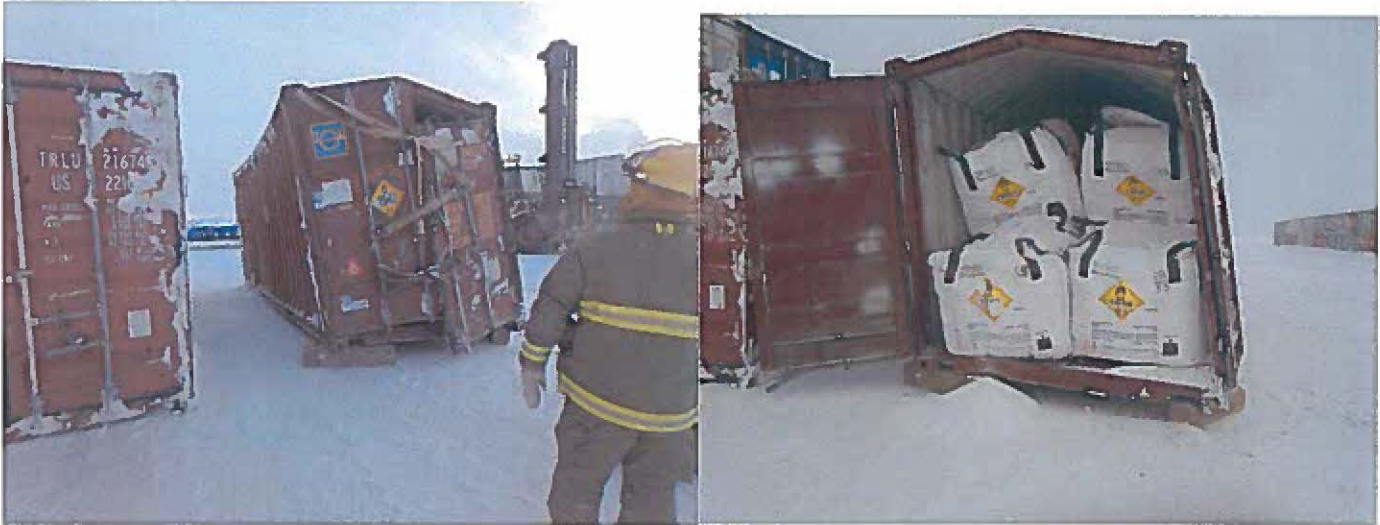
The recovered damaged containers were brought to the Emulsion plant for assessment and disposal of unusable product. Of the 2 recovered c-cans, only one had damaged bags. A total of 500 kg of product was recovered from the area, including product that spilled on the ground during handling and product that was contained within. This contaminated ammonium nitrate product, being unusable, was disposed by spreading on a loaded blast pattern. The remaining undamaged tote bags were transferred to other containers and will be used in normal emulsion processes.
