November 17th, 2016 Pit E Back hoe 8 oil spill

Please find the following information as a follow up to the Spill report submitted November 18th, 2016 by Agnico Eagle Meadowbank division. This detailed report is submitted to the Inspector in compliance with the conditions under the Nunavut Water Board License 2AM-MEA1525, Part H, Item 8c.

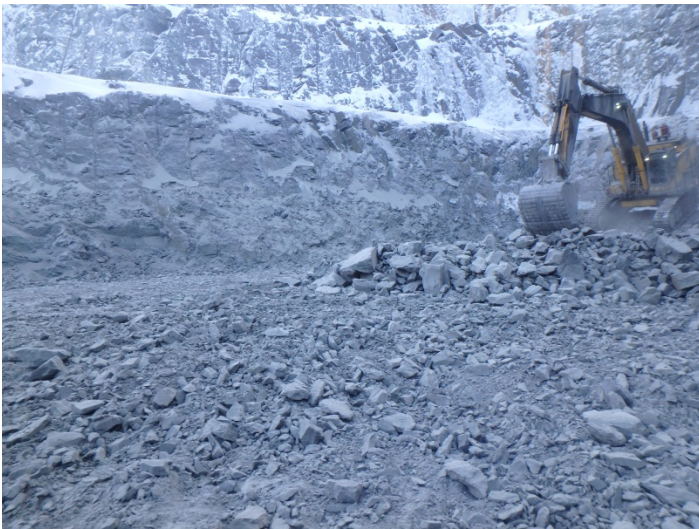
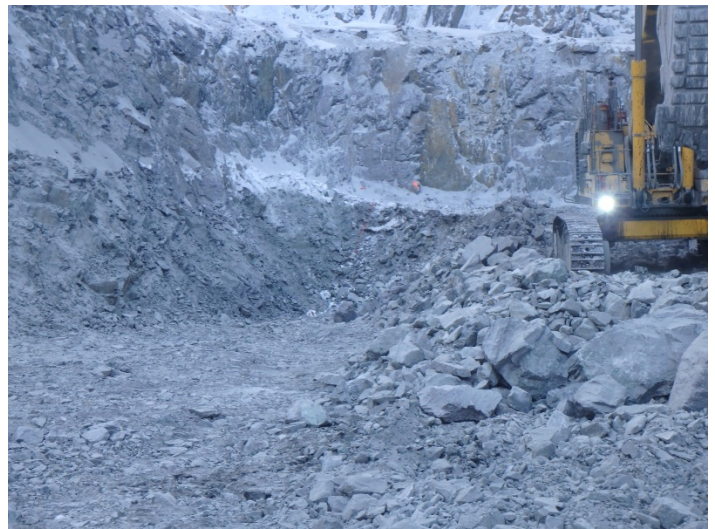
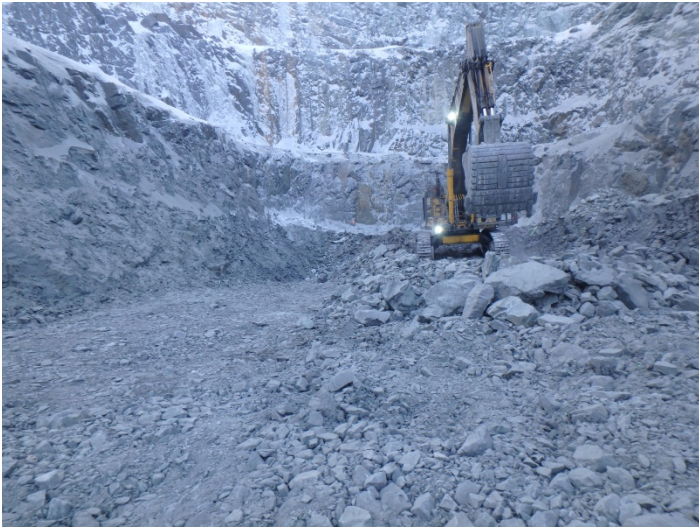
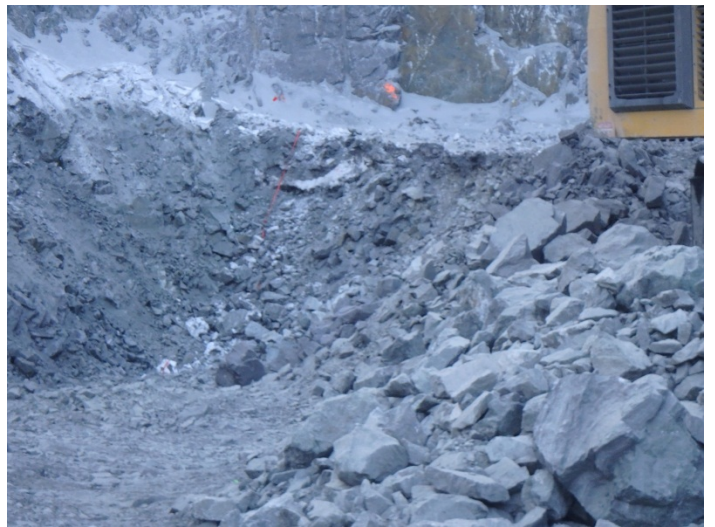
On November 17th, during operation at Pit E3, a hydraulic hose failed on back hoe 8 while mucking ore.

The spill was caused by a hose failure

All of the oil spilled on ore, which was moved to the Process Plant for processing. No contaminated material was taken to the Landfarm.
