December 23rd, 2016 Pit A Loader spill

Please find the following information as a follow up to the Spill report submitted December 23rd 2016 by Agnico Eagle Meadowbank division. This detailed report is submitted to the Inspector in compliance with the conditions under the Nunavut Water Board License 2AM-MEA1525, Part H, Item 8c.

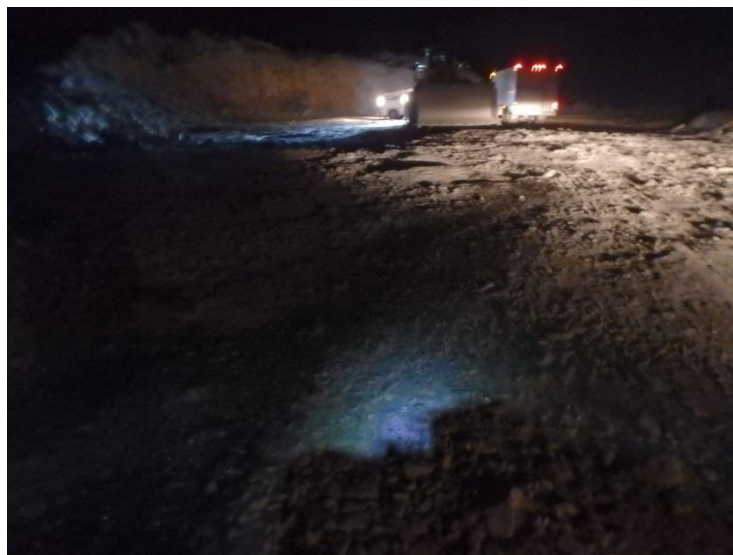
During operations at Pit A, the transmission on loader 04 failed causing transmission oil to be spilled on the ground.

Spill location: Easting 65'01'72" 96'02'91"

There were no off site impact or discharge to any receiving watercourses. The distance to the closest lake is estimated at 750 meters.

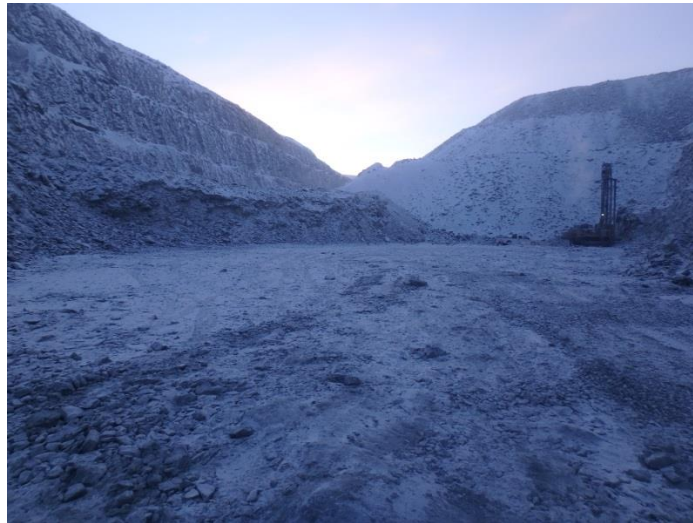
The spill was caused by transmission case failure of the loader. No clear visual evident was found on the equipment to identify the source of the break down.

The equipment was stopped immediately. Once the loader was repaired and could safely be removed, the area was cleaned. Since the location of the spill was part of an ore blast pattern, the material was brought to the mill for complete process.

Loading unit transmission inspection is part of preventive maintenance program done on site. It will be pursued with added attention put on cases.
