February 25th, 2017 STP Truck spill

Please find the following information as a follow up to the Spill report submitted February 26th, 2017 by Agnico Eagle Meadowbank division. This detailed report is submitted to the Inspector in compliance with the conditions under the Nunavut Water Board License 2AM-MEA1525, Part H, Item 8c.

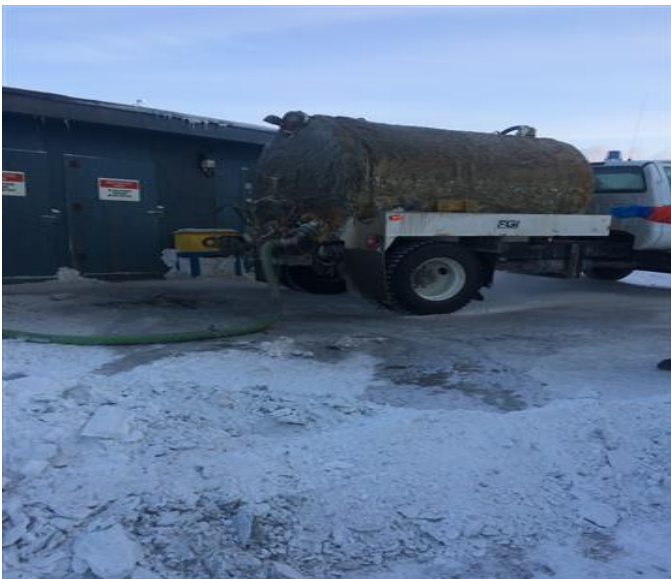
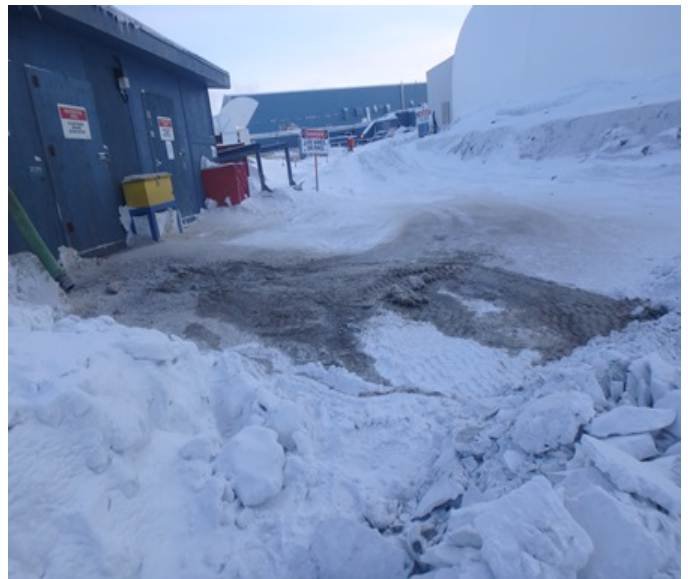
During the transfer of sewage from the sewage truck to the Sewage Treatment Plan (STP), the transfer hose broke, resulting in sewage spilling on the ground beside the STP.

The spill was caused by broken transfer hose on the sewage truck.

The transfer hose was replaced on the sewage truck. It will be visually inspected regularly for possible signs of fatigue and replaced and/or repaired, if necessary.

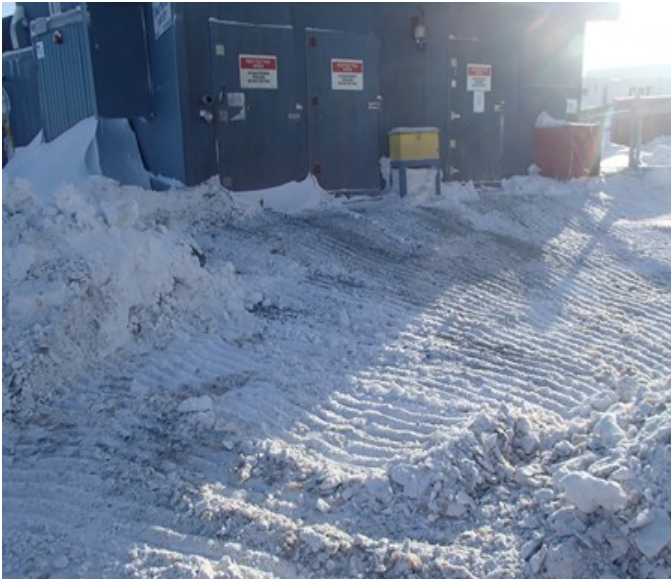
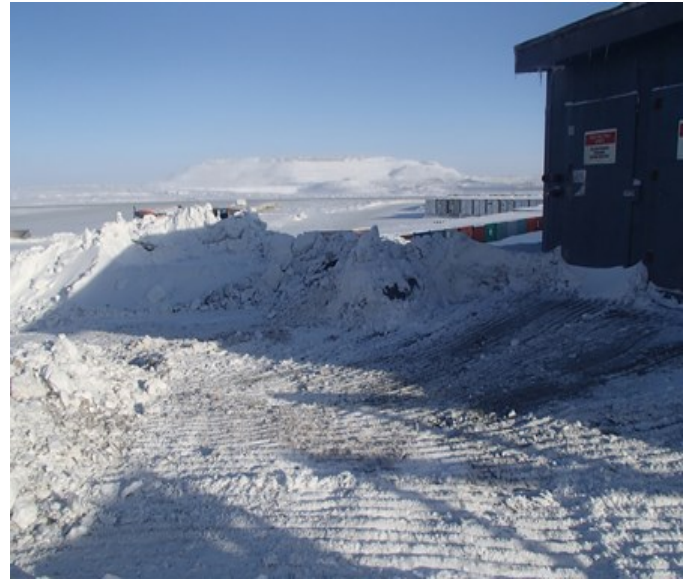
All the contaminated material and snow was excavated, picked up, and taken to the North cell tailings storage facility for disposal.
