## January 28<sup>th</sup>, 2017 LOA 12 oil spill

Please find the following information as a follow up to the Spill report submitted January 29th, 2017 by Agnico Eagle Meadowbank division. This detailed report is submitted to the Inspector in compliance with the conditions under the Nunavut Water Board License 2AM-MEA1525, Part H, Item 8c.

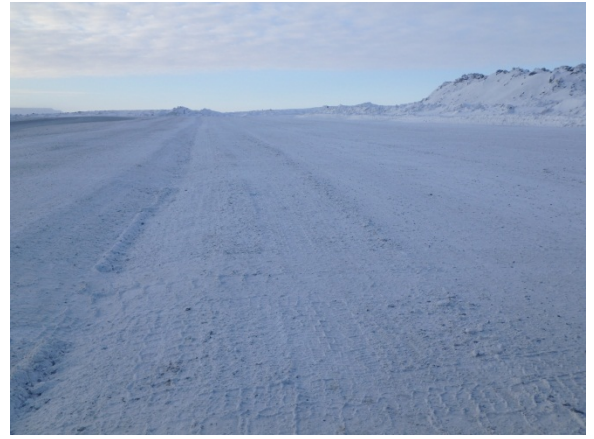
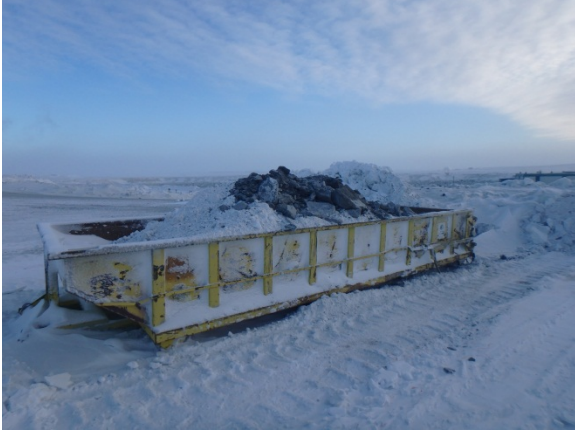
During operations at Vault, a hydraulic hose failed on Loader 12

Hose failure

Operator of the equipment stopped the engine right away to stop spilling more products on the ground. Operator contacted his supervisor immediately to have the equipment repaired.

All the contaminated material was graded and picked up with a 980 loader and taken to the Landfarm.
