March 13th, 2017 Pit E5 BAC13 spill

Please find the following information as a follow up to the Spill report submitted March 14th 2017 by Agnico Eagle Meadowbank division. This detailed report is submitted to the Inspector in compliance with the conditions under the Nunavut Water Board License 2AM-MEA1525, Part H, Item 8c.

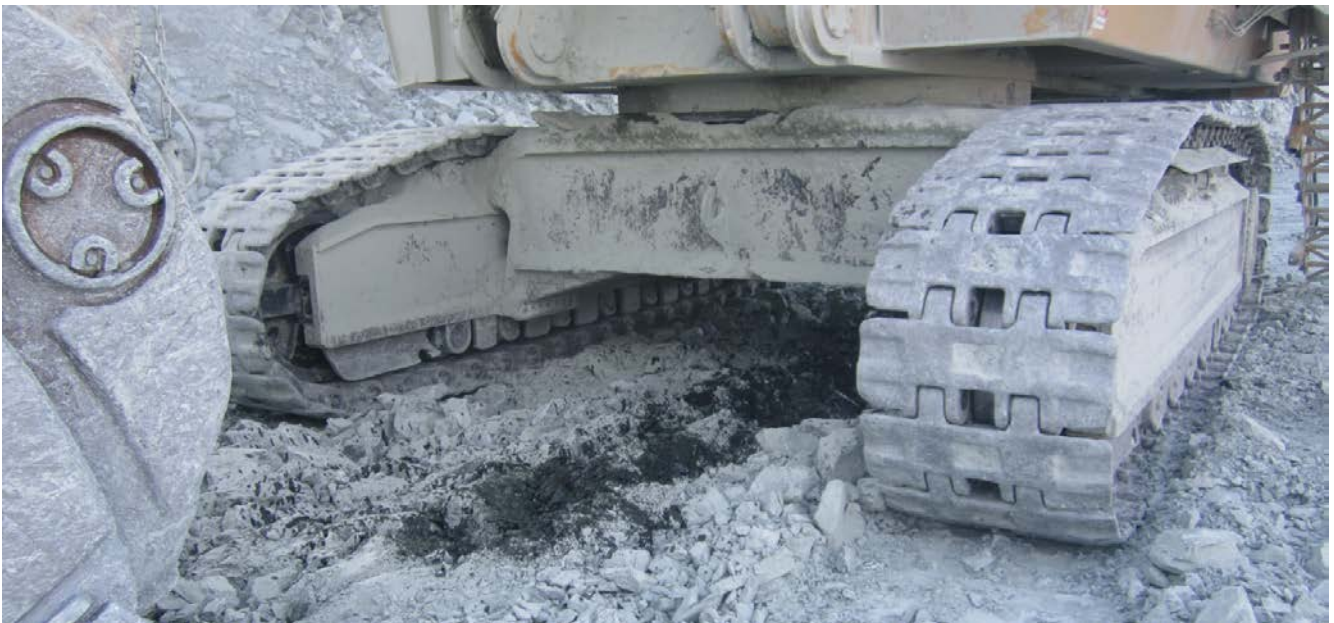
During operations at pit E5, a part of the backhoe swing pump failed causing hydraulic oil to spill on the ground.

Spill location: Easting 65'00'42" 96'03'04"

There were no off site impact or discharge to any receiving watercourses. The distance to the closest lake is estimated at 150 meters.

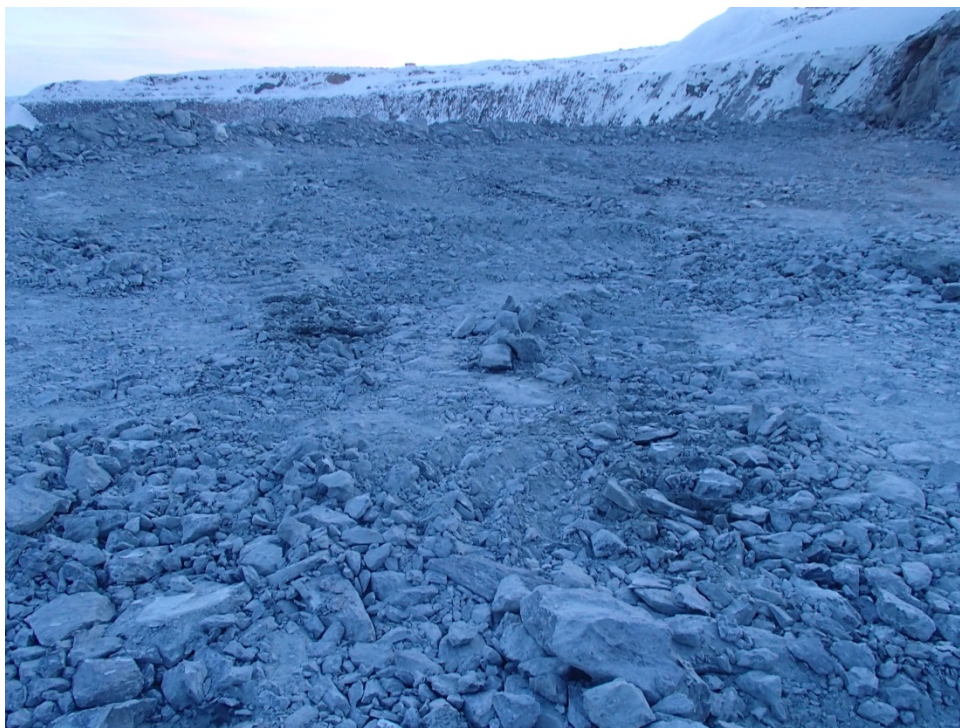
The spill was caused when the swing pump and a seal failed on the loading unit.

The equipment had to be moved to proceed to the field repair. This action caused some hydraulic oil to be spread in the movement zone. The surface of the affected area was cleaned, coarseness of the material making recovery difficult. The contaminated material removed was brought to the landfarm area.

The hydraulic system including hoses and fittings are inspected as part of the preventive maintenance program done on site. Routine visual inspection of the hydraulic system is also performed during pre-operations checks.
