## April 8<sup>th</sup>, 2017 Vault BAC13 spill

Please find the following information as a follow up to the Spill report submitted April 8<sup>th</sup> 2017 by Agnico Eagle Meadowbank division. This detailed report is submitted to the Inspector in compliance with the conditions under the Nunavut Water Board License 2AM-MEA1525, Part H, Item 8c.

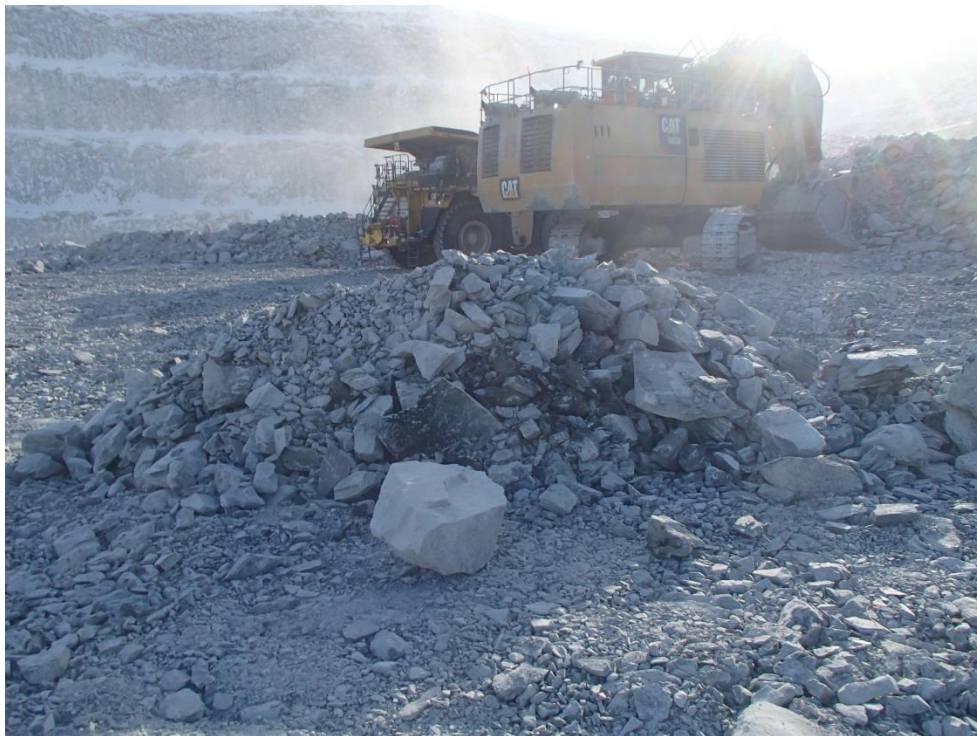
During operations at Vault pit, the backhoe operator noticed that hydraulic oil was leaking for the equipment causing oil to spill on the ground.

There were no off site impact or discharge to any receiving watercourses. The distance to the closest lake is estimated at 1050 meters.

The spill was caused by a failure of a bolt on the swivel manifold, causing an O-ring to fail on the travel valve to the swivel hydraulic hose
