# April 26<sup>th</sup>, 2017 Portage waste dump HTR 06 spill

Please find the following information as a follow up to the Spill report submitted April 26<sup>th</sup> 2017 by Agnico Eagle Meadowbank division. This detailed report is submitted to the Inspector in compliance with the conditions under the Nunavut Water Board License 2AM-MEA1525, Part H, Item 8c.

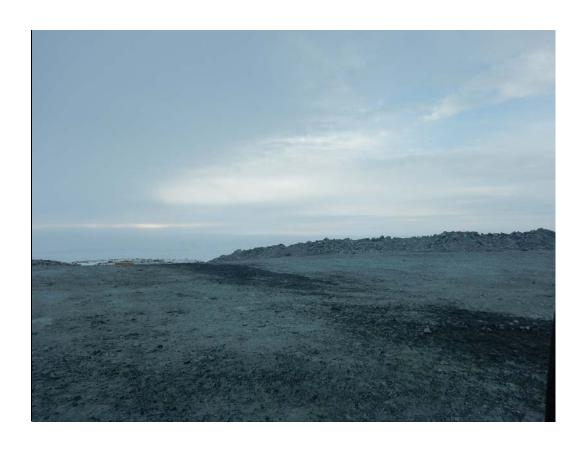
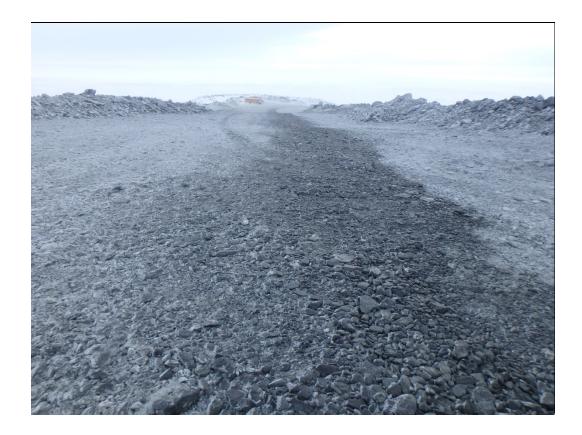
During operations at Portage pit waste dump, a hose failure on haul truck 06 occurred creating a spill

There were no off site impact or discharge to any receiving watercourses. The distance to the closest lake is estimated at 700 meters.

The spill was caused by a hose failure on the hauling unit.
