March 29th, 2017 km 77 tanker spill

Please find the following information as a follow up to the Spill report submitted March 29th 2017 by Agnico Eagle Meadowbank division. This detailed report is submitted to the Inspector in compliance with the conditions under the Nunavut Water Board License 2AM-MEA1525, Part H, Item 8c.

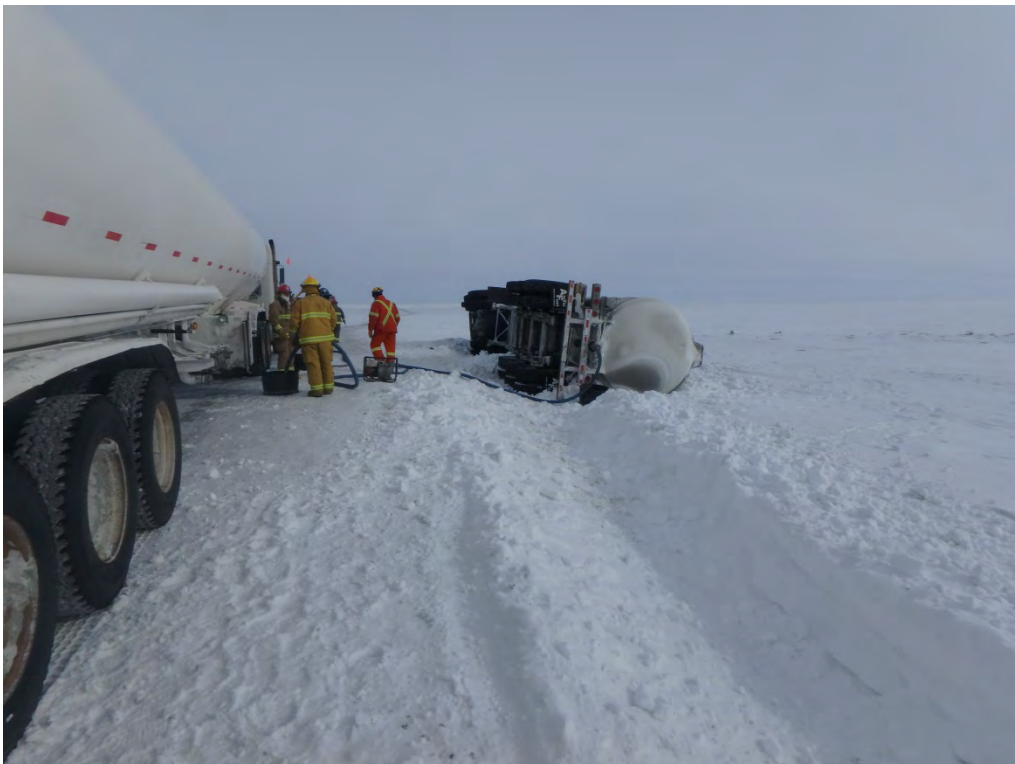
Hauling diesel fuel from Baker Lake to the Meadowbank site, a tanker from Arctic Fuel Services went off road and rolled-over at km 77 on the AWAR. The operator was uninjured and was taken out of the equipment.

After estimation on volumes collected and volumes initially filed into the tanker, the spill was estimated at 4885 liters of diesel fuel.

There were no off site impact or discharge to any receiving watercourses. The distance to the closest lake is estimated at more than 2000 meters.

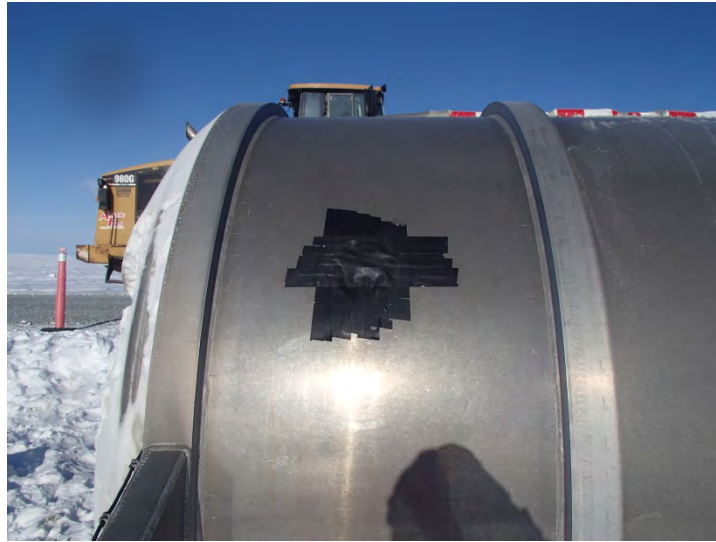
The incident occurred when the tanker moved on the side of the road for traffic coming in the opposite direction. What the driver thought was the side of the road was hardened snow and caused the tanker to roll over on its side. A leak was observed from the tank once responders arrived on location.

An investigation was completed with the current stakeholders and amongst contributing factors was: lack of communication, improper awareness of surroundings and inadequate work standards. The event was reviewed with the Arctic Fuel drivers to reinforce proper communication on the AWAR and the importance of training and comprehension of road procedures. An evaluation will also be done on the possibility of installing more reflectors along the road to Baker Lake.
