July 2nd, 2017 Pit E5 LOA12 spill

Please find the following information as a follow up to the Spill report submitted July 2nd 2017 by Agnico Eagle Meadowbank division. This detailed report is submitted to the Inspector in compliance with the conditions under the Nunavut Water Board License 2AM-MEA1525, Part H, Item 8c.

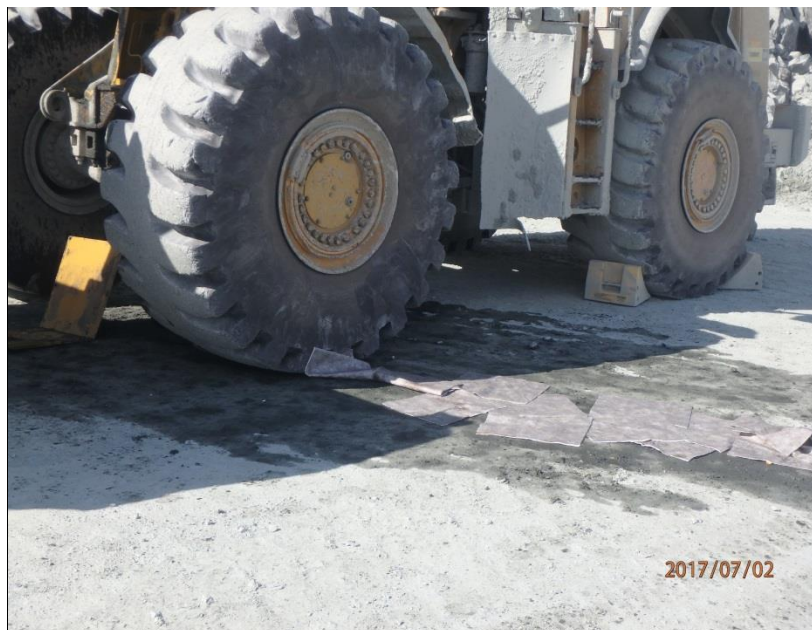
The loader was moving to and from pit E5 when a hydraulic hose failed causing hydraulic oil to be spilled on the ground.

Spill location: Easting 65'00'57" 96'03'24"

There were no off site impact or discharge to any receiving watercourses. The distance to the closest lake is estimated at 450 meters.

The spill was caused by a hose failure on the hydraulic system of the loading equipment.

Absorbent pads were laid on the ground to collect oil and the contaminated soil was scraped off the ground. The pads were brought to the Hazmat area for proper disposal and the material removed was brought to the landfarm area.

The hydraulic system including hoses and fittings on drilling equipment are inspected as part of the preventive maintenance program done on site. The specific PM inspection is also done on loading equipment in relation to the hydraulic system. Pre-operation checks also include visual inspection of the hydraulic system.
