# SPILL REMEDIATION AND RECLAMATION REPORT Meadowbank Tanker Spill, KM 77

Meadowbank, Nunavut

Agnico Eagle Mines Ltd.

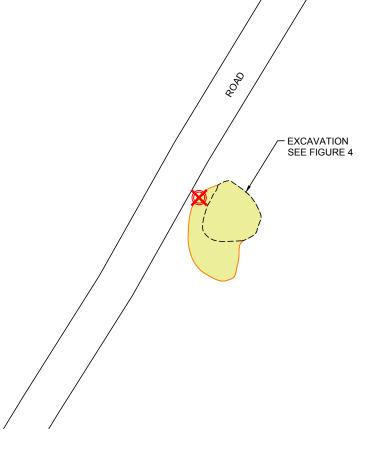
**INITIAL SOIL ASSESSMENT**

SWAT collected 4 soil samples from the walls of the excavation and 2 soil samples from the base of the south excavation (Figures 3 and 4). Soil analytical tables are attached. Final confirmatory results determined that all soil within the excavation met guidelines with the exception. The detection limit for Napthalene was above guideline due to moisture content in the sample.

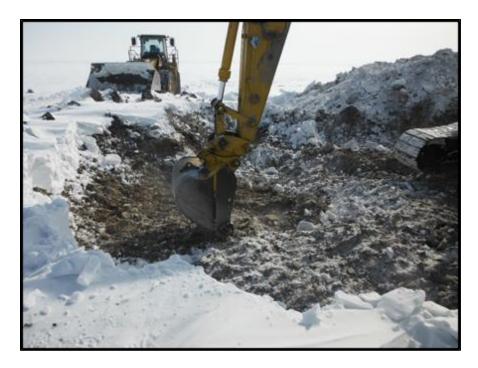
April 20: Excavation activities.

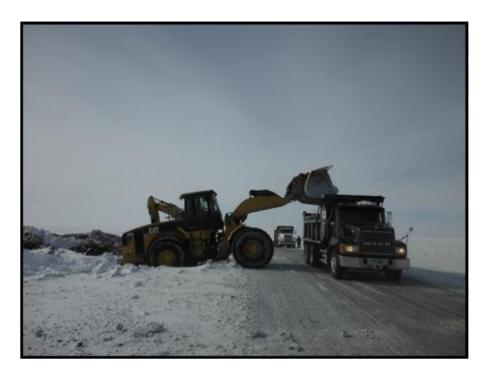
April 20: Loading trucks.

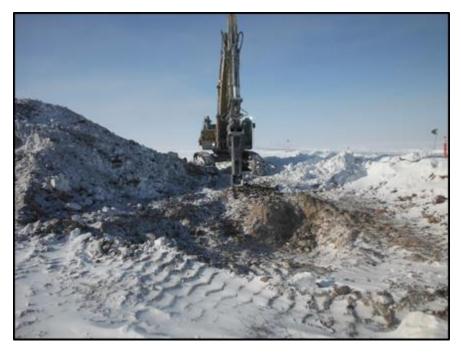
April 21: Using the hammer to remove material.

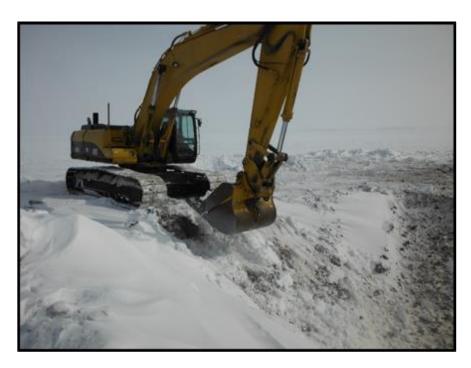
April 21: Removing snow from excavation for confirmatory sampling.

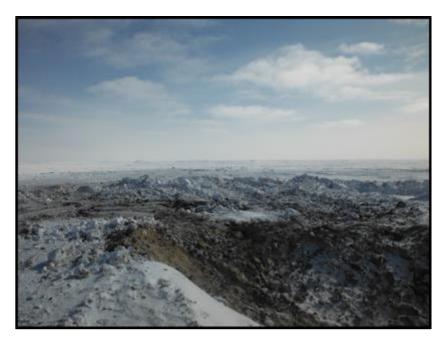
April 22: Stockpile removed from location.

Total estimated volume of 280 m<sup>3</sup> of impacted snow and soil removed from the spill area. This material is currently stockpiled at the Meadowbank Landfarm where it will undergo remediation.

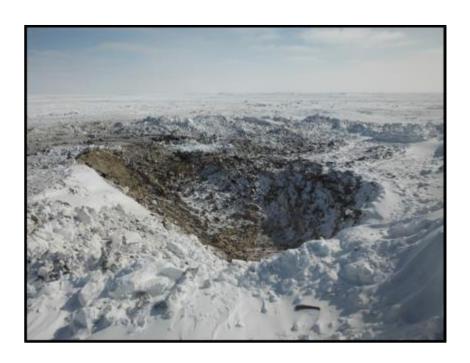
April 22: Final excavation boundary.
