## June 15<sup>th</sup>, 2017 Pit E5 RBD03 spill

Please find the following information as a follow up to the Spill report submitted June 15<sup>th</sup> 2017 by Agnico Eagle Meadowbank division. This detailed report is submitted to the Inspector in compliance with the conditions under the Nunavut Water Board License 2AM-MEA1525, Part H, Item 8c.

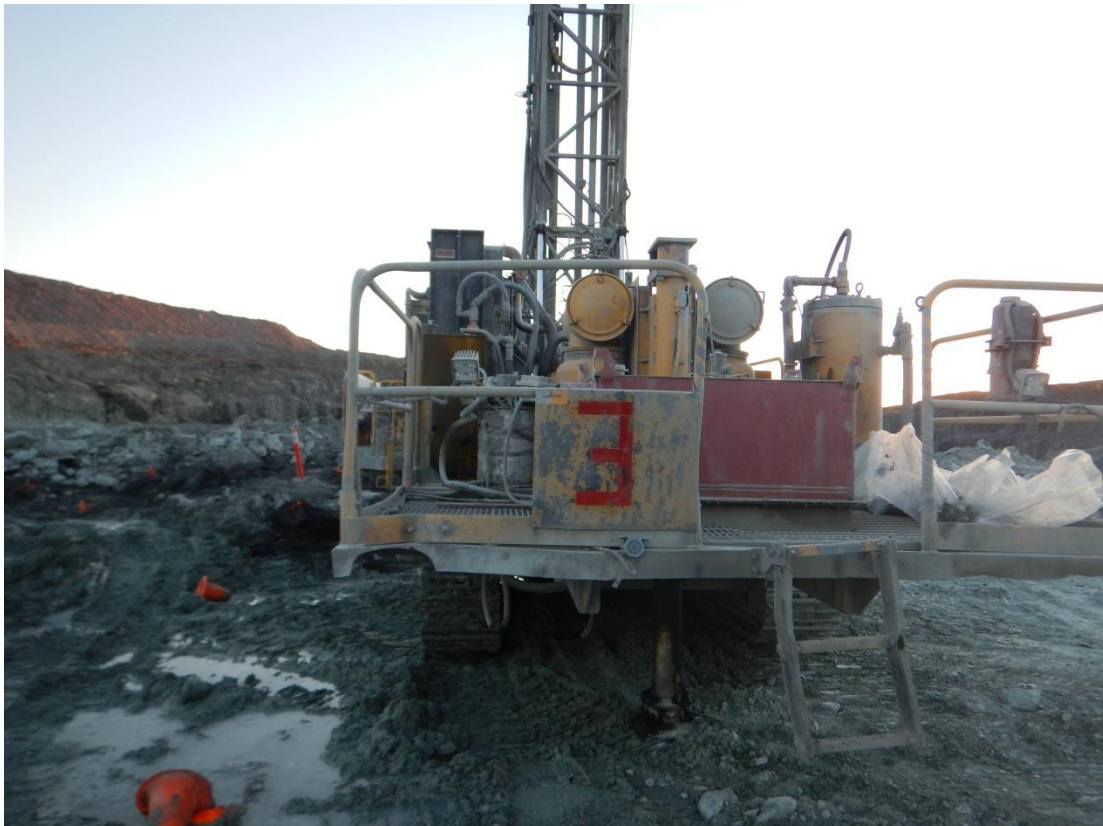
During drilling operations at pit E5, a hose on the drilling unit failed and caused hydraulic oil to be spilled.

There were no off site impact or discharge to any receiving watercourses. The distance to the closest lake is estimated at 150 meters outside of pit E5.

The spill was caused by a failure of an o-ring cause by wear on a hose of the hydraulic system of the drill.

The hydraulic system including hoses and fittings on drilling equipment are inspected as part of the preventive maintenance program done on site. Pre-operation checks also include visual inspection of the hydraulic system.
