August 7th, 2017 BAC13 Phaser Pit

Please find the following information as a follow up to the Spill report submitted August 7th 2017 by Agnico Eagle Meadowbank division. This detailed report is submitted to the Inspector in compliance with the conditions under the Nunavut Water Board License 2AM-MEA1525, Part H, Item 8c.

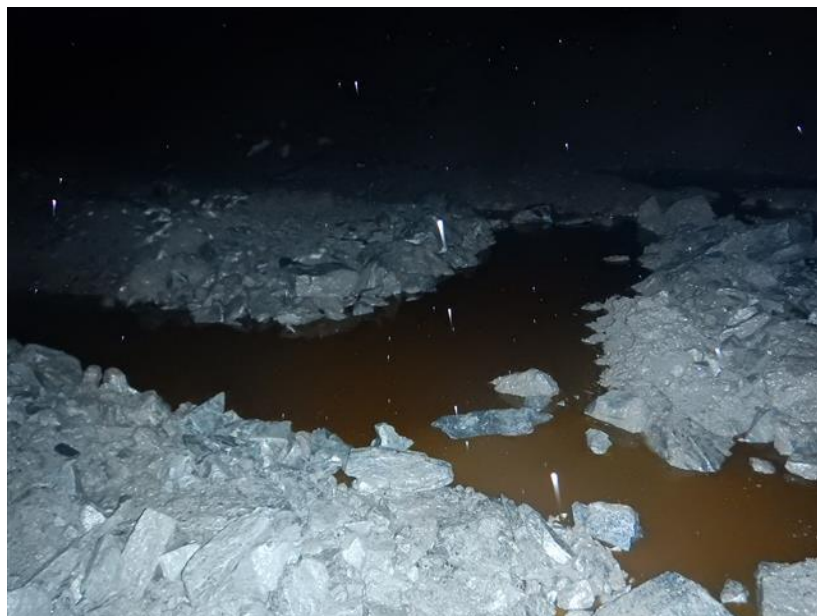
Scooping softer ground the bucket on the excavator unit dug too deep which caused a rock to get stuck and damage a valve on a hydraulic line.

Spill location: Easting 65'04'16" 96'00'43"

There were no off site impact or discharge to any receiving watercourses. The distance to the closest lake is estimated at 1000 meters.

The spill was caused when a rock pinched a valve under the loading unit's shovel, causing hydraulic oil to spill on the ground.
