August 9th, 2017 km 23 Tractor Trailer spill

Please find the following information as a follow up to the Spill report submitted August 9th 2017 by Agnico Eagle Meadowbank division. This detailed report is submitted to the Inspector in compliance with the conditions under the Nunavut Water Board License 2AM-MEA1525, Part H, Item 8c.

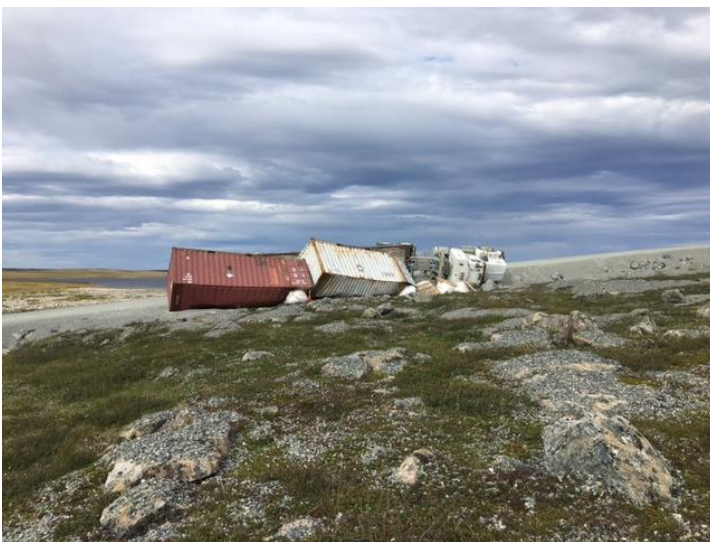
Tractor and trailer off-road

The incident occurred when the tractor trailer turned a curve at low speed. The load inside the containers shifted creating momentum towards one side. The equipment was thus carried off-road. The conclusion of the investigation indicates that the load of Sodium Hydroxide bags could have been moved on one side during the loading of the containers on the trailer in at least one sea can and caused the instability of the load. With the impact, some bags inside the trailer were damaged.

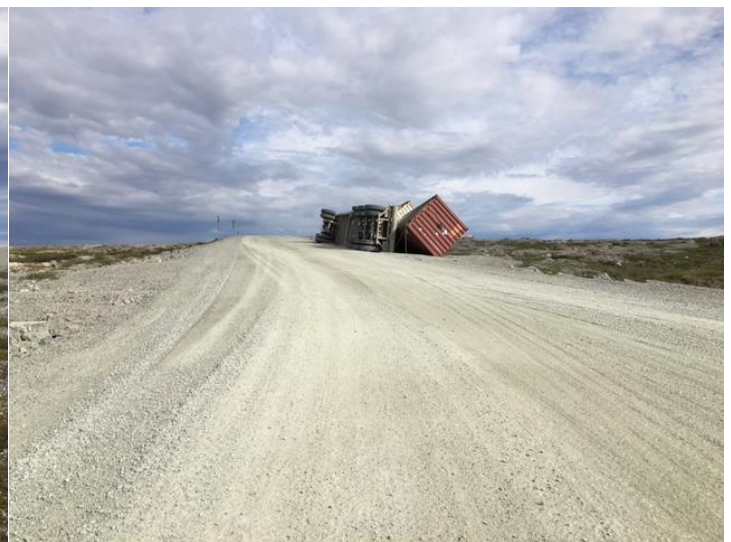
Tractor and trailer off-road

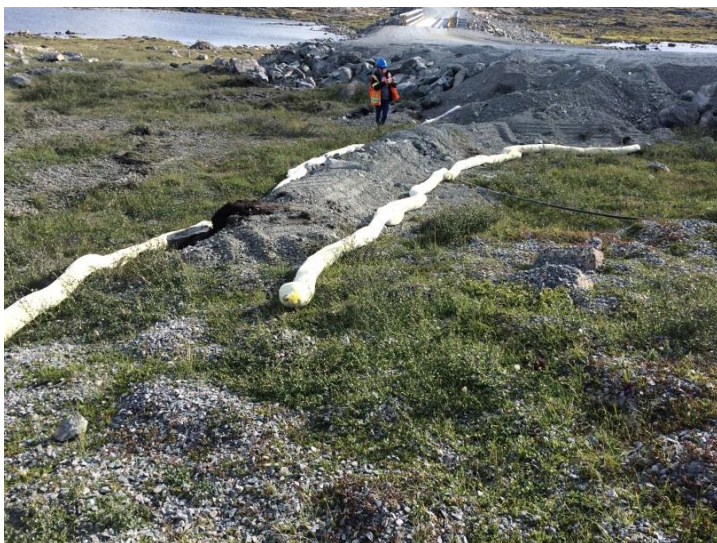
Berm and chemical booms

A berm was built to avoid any product from potentially seeping to any watercourse. Chemical booms were also put in place as a second protection barrier. The road was closed to all traffic during the management of the incident and recovery work. The ERT was present on site during recovery work in collaboration with the Environmental Department and Energy and Infrastructures Department. The first sea can was emptied, one bag at the time with a backhoe. All bags were removed and placed in a new sea can. The content of the punctured bags was transferred into a quatrex bag.

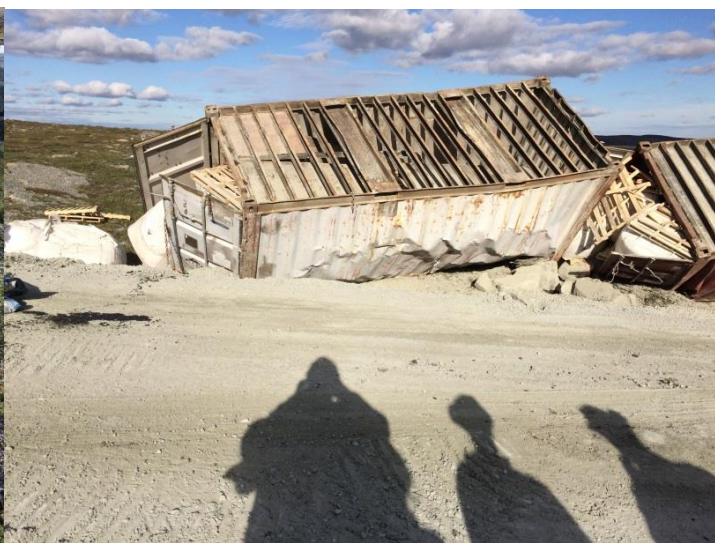
Bags outside the sea can

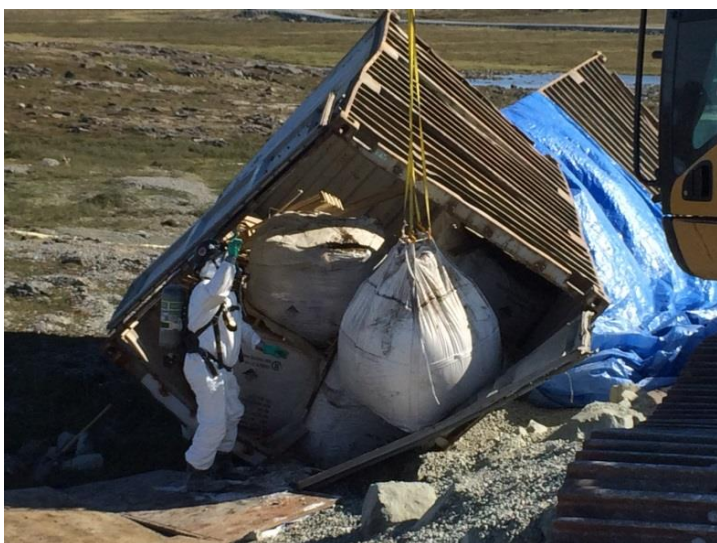
Bags recovery

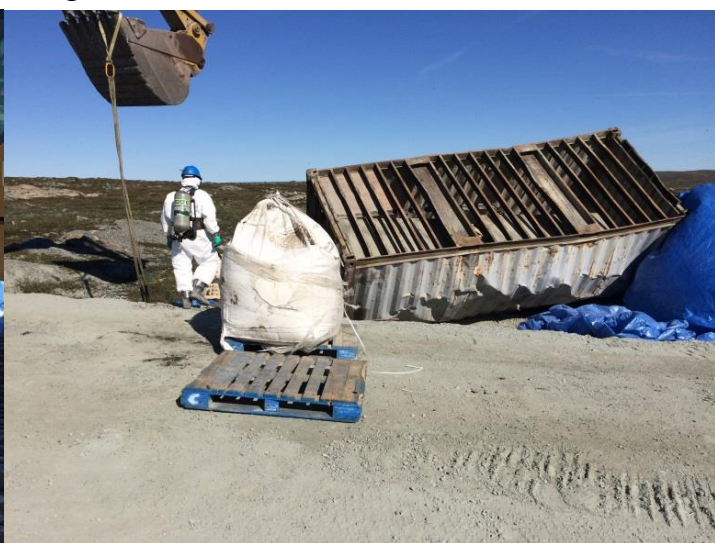
Bags recovery (2)

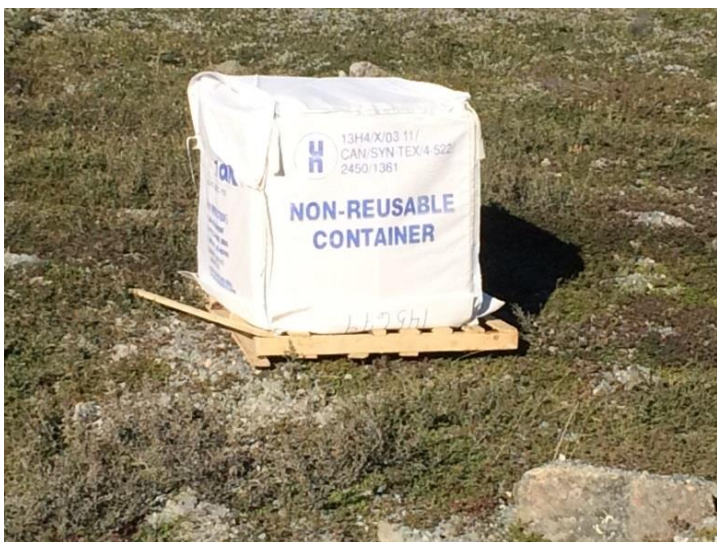
Products transferred in a quatex

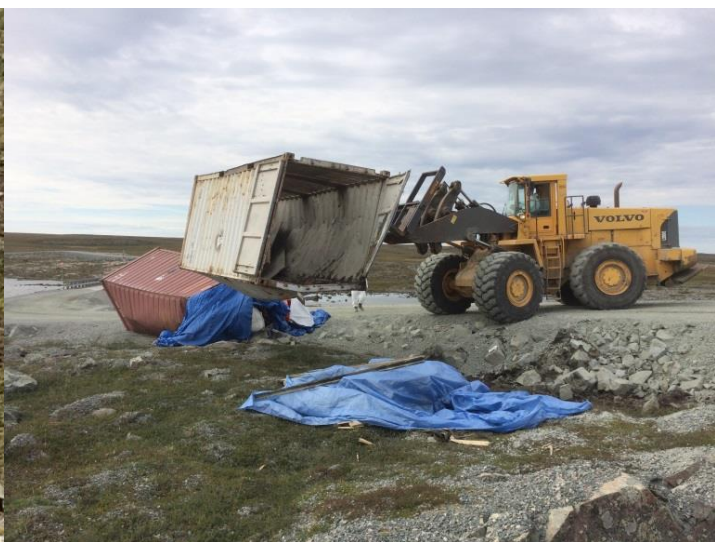
Empty sea can

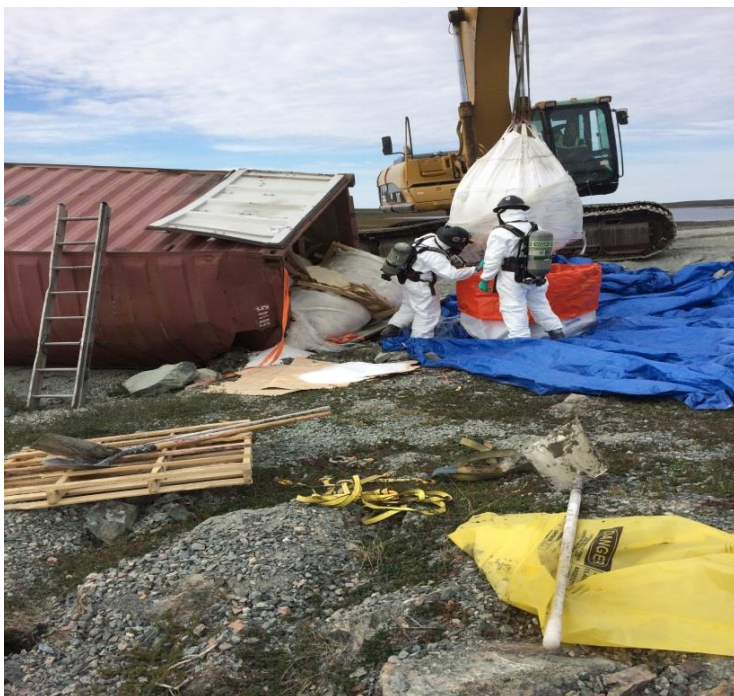
Bags recovery

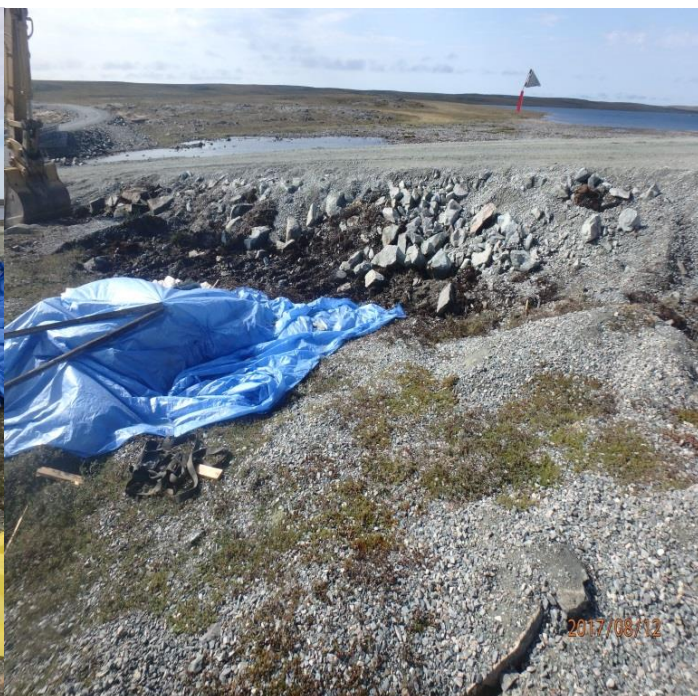
Clean-up progress

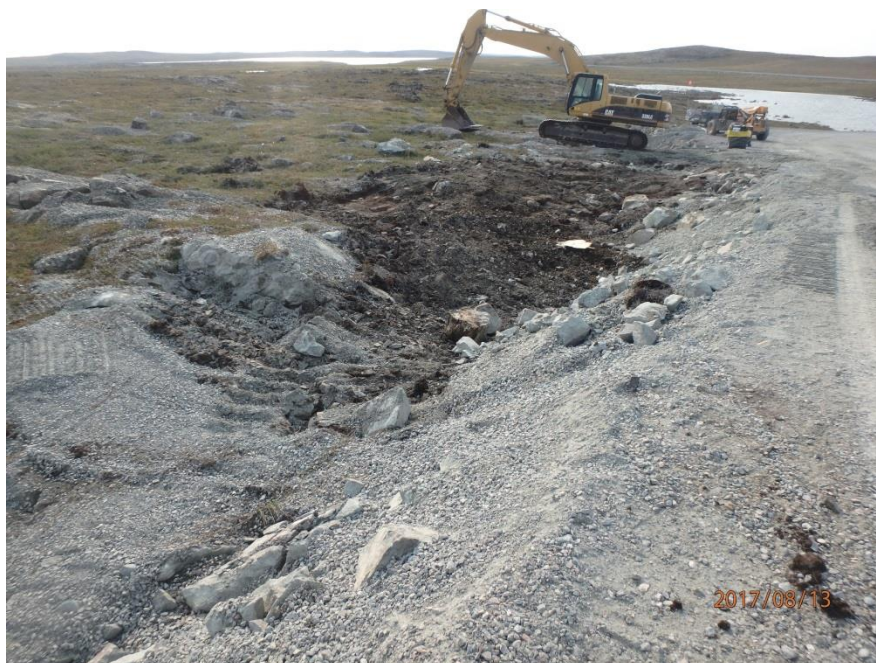
Clean-up completed

After all equipment was removed from the location, the area was scrapped and soil collected to prevent any possibility of contamination. All the contaminated soil was brought to the (TSF).
