## July 28<sup>th</sup>, 2017 Vault refuge genset spill

Please find the following information as a follow up to the Spill report submitted July 28<sup>th</sup> 2017 by Agnico Eagle Meadowbank division. This detailed report is submitted to the Inspector in compliance with the conditions under the Nunavut Water Board License 2AM-MEA1525, Part H, Item 8c.

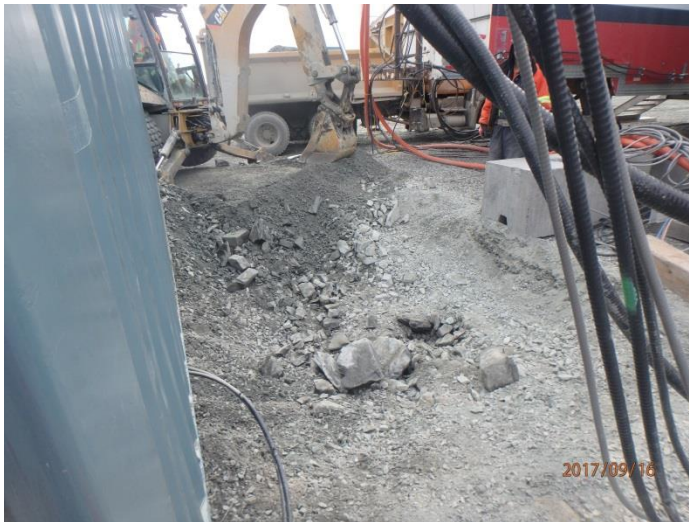
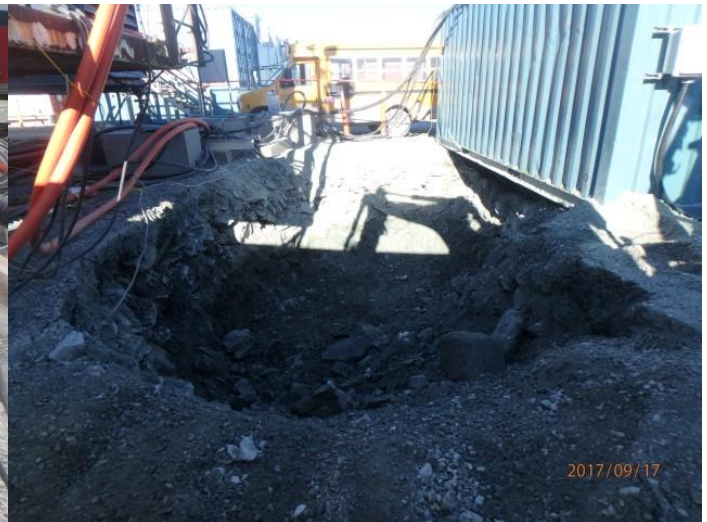
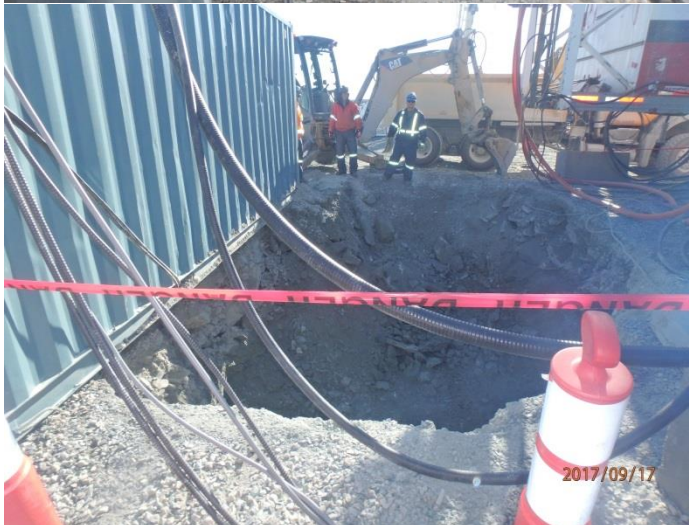
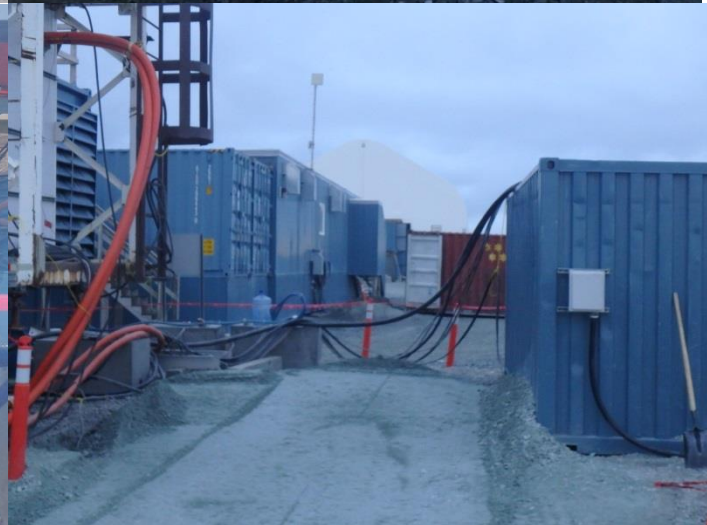
Being underneath the tank, the recovery work had to be planned and assessed with the Energy and Infrastructure and Mine Departments. Level of the tank had to be lowered to safely lift and remove from the location. As well the area is part of the electrical feed of the Vault refuge station, thus electrical cables around the area had to be identified and taken away for the planned clean-up work. A complete shut-down of the refuge had to be planned, delaying recovery work. A PID meter was used to assist in locating contaminated area. To ensure stability of the ground for the tank reset, the whole area was dug to a stable and level depth. Thus, more material was removed from the recovery work. All material removed was considered contaminated and disposed at the approved Landfarm. The area was backfilled with proper material and the tank reinstalled at the same location.

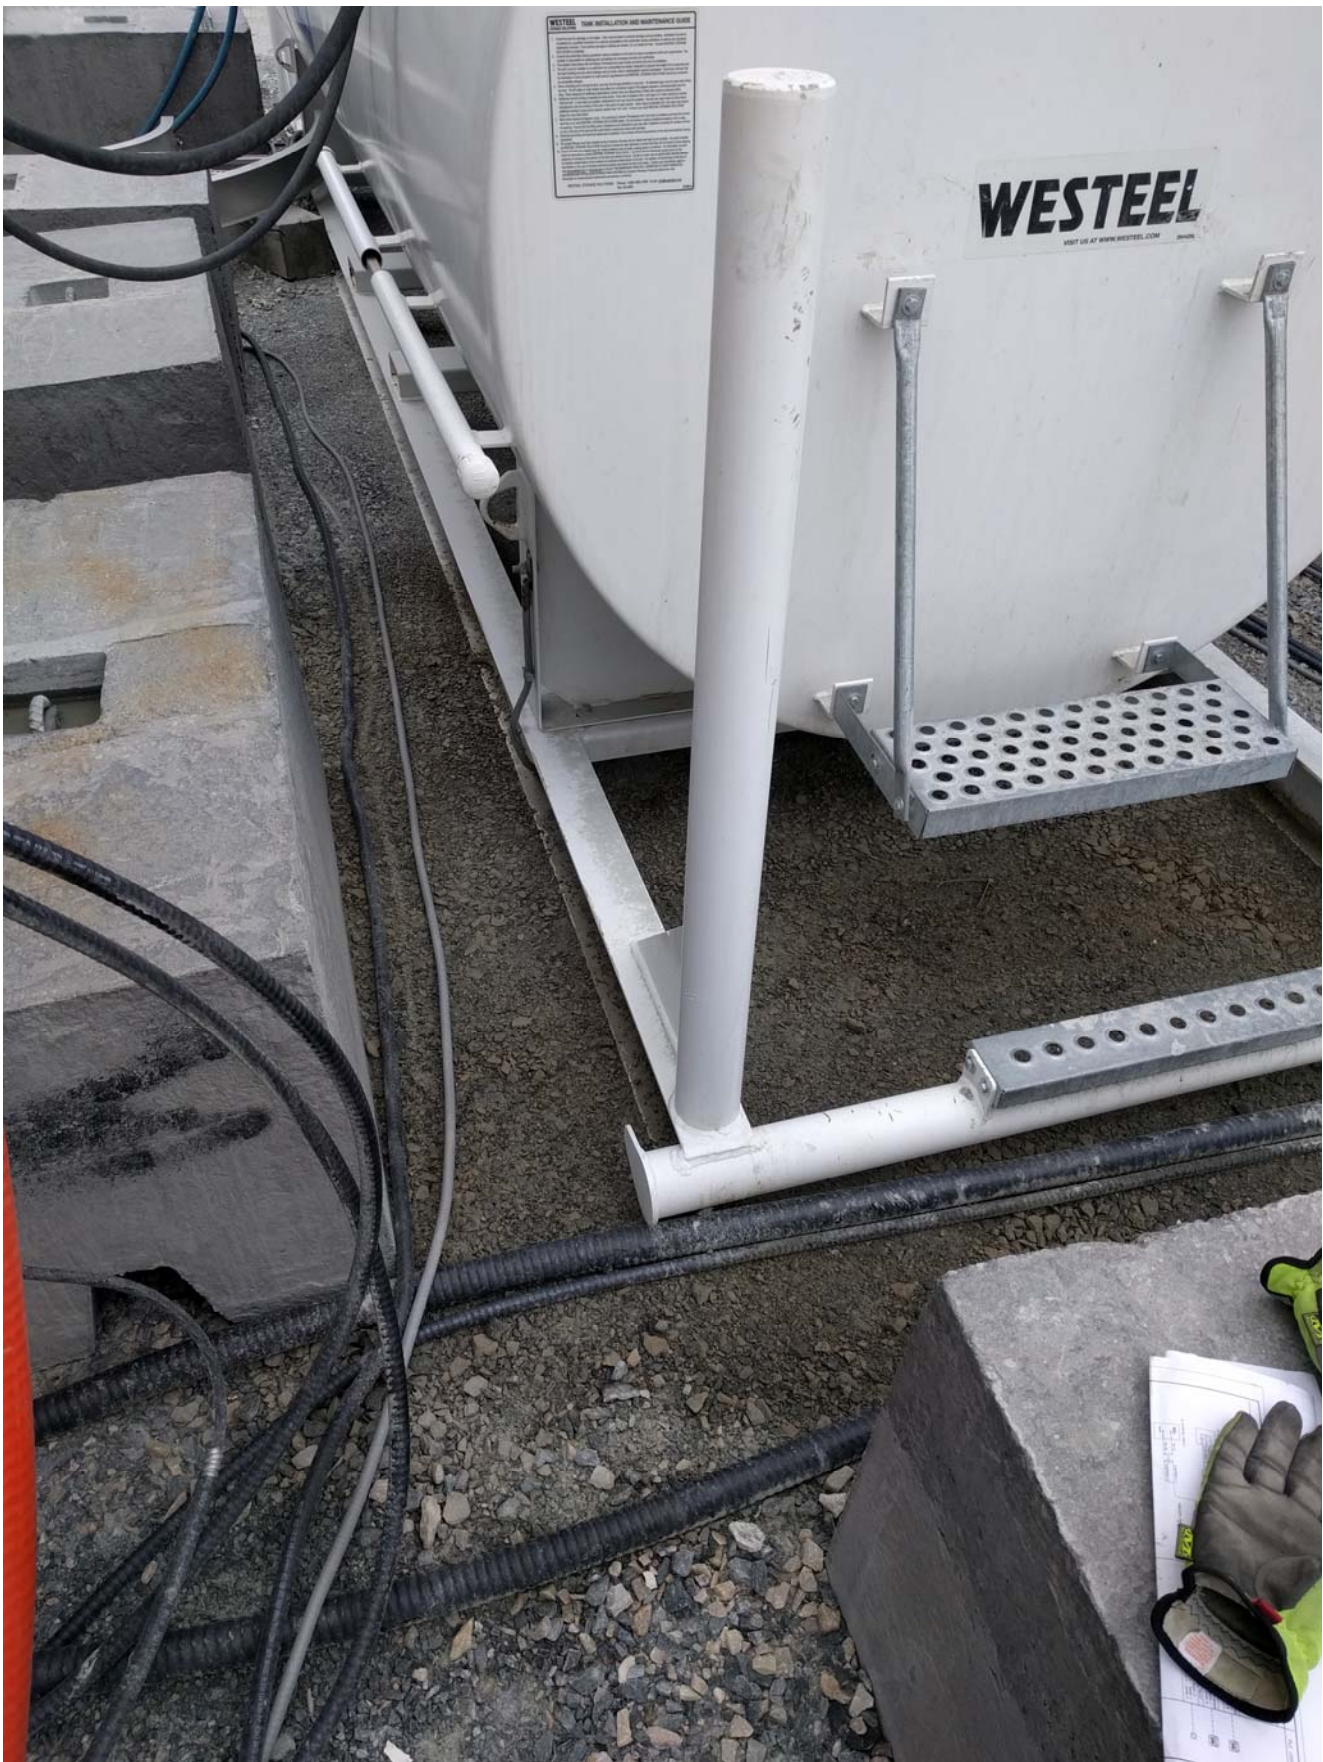
Fuel Truck and 11,000 L Fuel Tank

Approximatly 200 Liters of fuel spilled under the tank.

Improper loading: There is a possibility that the driver overfilled the tank which caused the spill. No one reported a spill in this area as it was found after the fact.

Inadequate inspection: The driver may not have inspected the tank level correctly before filling the tank.

Inadequate warning system: There is no level sensor in the tank to warn the driver of the percentage of tank level.

Temperature exposure: It is possible that the tank was filled to a high level and that the temperature caused an expansion in the tank causing the spill.

Inadequate engineering/ Inadequate tools/equipment: No level sensor or local level display on the fuel tank or automatic shut off on fuel truck.

Review and modify procedure if required with all fuel truck drivers and the facts of this incident. Review the responsibilities of the fuel truck drivers if a spill occurs while fueling and actions to be taken.

Research the options to provide the level reading of fuel tanks around site to the operator while filling them. Only tanks that have a potential for a spill of 100 liters or more should require the level reading.
