## September 14th, 2017 AFS Tanker spill at Baker Lake

Please find the following information as a follow up to the Spill report submitted September 15<sup>th</sup> 2017 by Agnico Eagle Meadowbank division. This detailed report is submitted to the Inspector in compliance with the conditions under the Nunavut Water Board License 2AM-MEA1525, Part H, Item 8c.

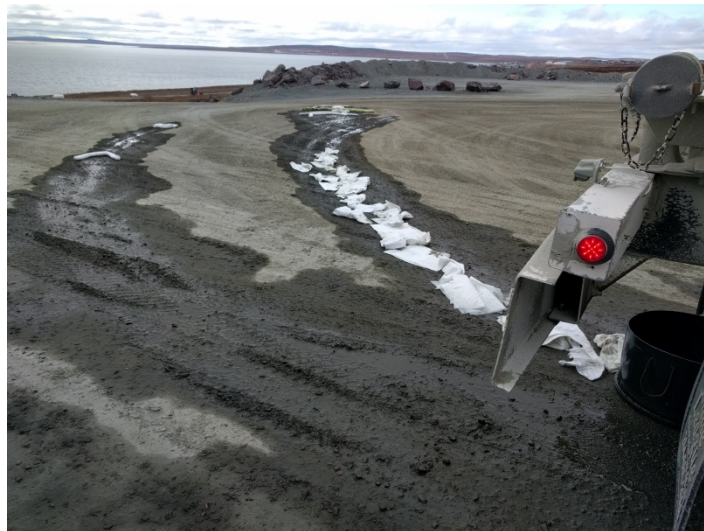
An AFS worker was filling up at Baker Lake when the operator saw that the tanker was overflowing. As soon as the worker realized that, he stopped the filling, starts to put absorbent pads and called his supervisor. A new flow meter was installed at the fuel station and the numbers showed by the meter were erroneous causing the operator to underestimate the amount of fuel in the tanker. The area where the spill occurred is lined. An investigation was completed and the corrective measures can be seen below. Upon the investigation, the quantity spilled was evaluated at a 1000L according to the flow and the time of the spill.

The incident occurred when the tanker overflow tank got overfilled. The wrong number on the flow meter caused the operator to underestimate the quantity and the preventive system in case of overflow didn't work as planned.

- Install a window in the fuel farm sea-can so the driver has a better view of his truck and the surrounding when he reaches inside to look at the meter.
- Improving our commissioning procedures for extra precaution when we test new equipments
- Re-design our spill control system connected to the overflow of the tanker.

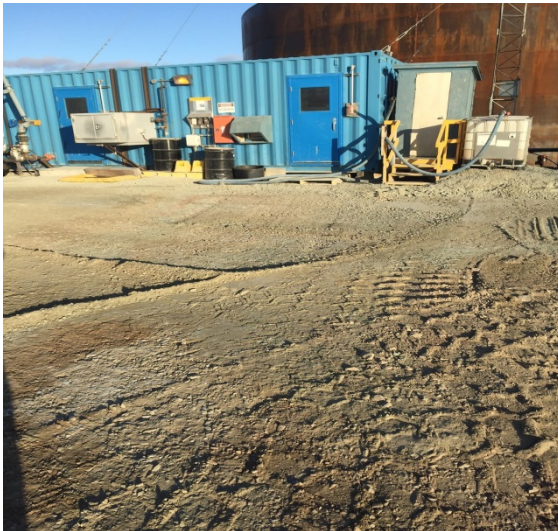
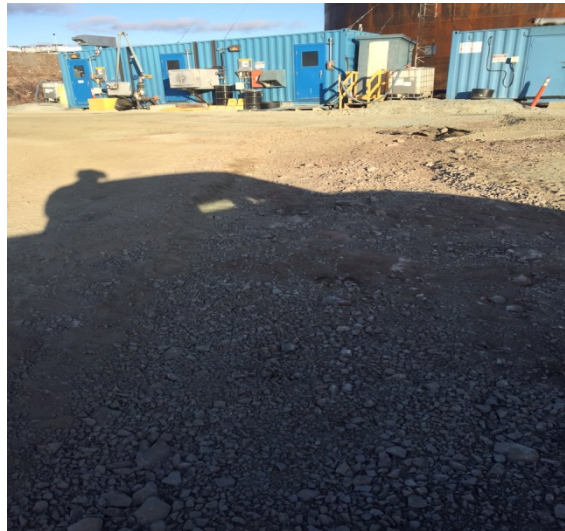
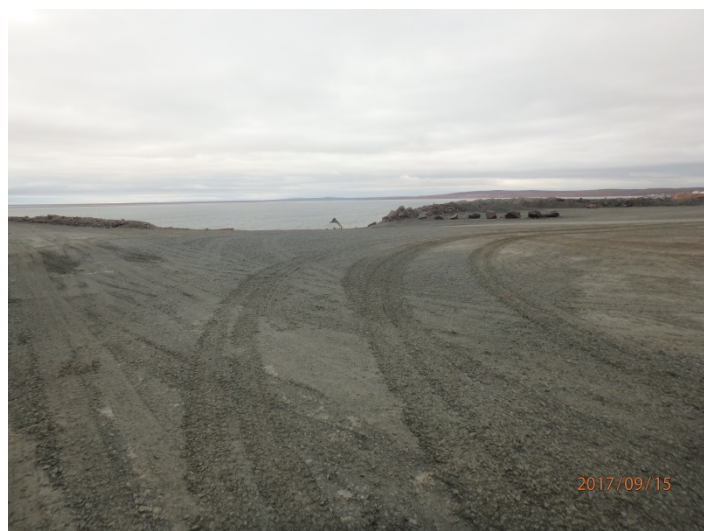
All the contaminated soil was scrapped and brought to the Meadowbank landfarm (about 22 m<sup>3</sup>). An investigation is under way to determine what went wrong with the new flow meter as well as the overflow preventive system.
