October 5, 2017 Phaser Pit RBD04 spill

Please find the following information as a follow up to the Spill report submitted October 10th 2017 by Agnico Eagle Meadowbank division. This detailed report is submitted to the Inspector in compliance with the conditions under the Nunavut Water Board License 2AM-MEA1525, Part H, Item 8c.

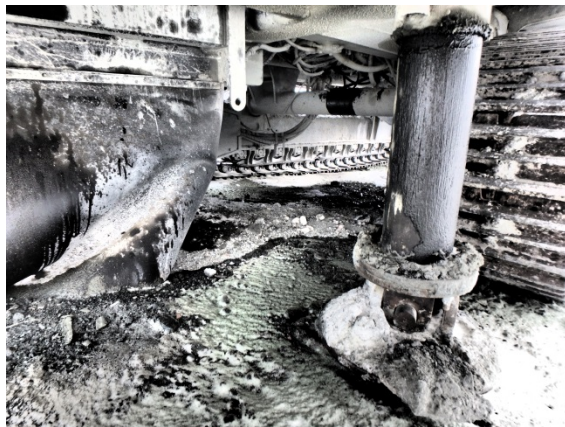
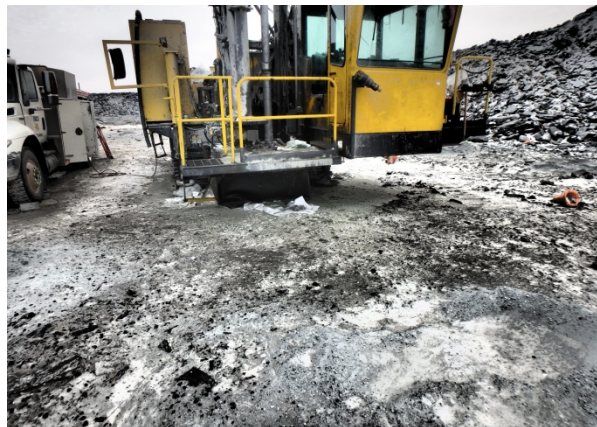
During the operation the drill head creep down and the hammer started percussing. At that time the hammer damaged hydraulic hose on the deck.

There were no off site impact or discharge to any receiving watercourses. The distance to the closest lake is over 800 m.

A hydraulic hose rupture was caused damage by the hammer movement on the hose.

The operator stopped the drill and placed the absorbents pads on the spill to contain it. A mechanic was called to repair the hose and the pump.

The contaminated material on the surface was collected and disposed to the landfarm. As the spill occurred on ore, another part was sent to the mill and processed.

Hydraulic hoses were changed and the pump was repaired. Everything was inspected and no other leaks were observed once inspection was completed.
