October 10th, 2017 Phaser Pit BAC13 spill

Please find the following information as a follow up to the Spill report submitted October 10th 2017 by Agnico Eagle Meadowbank division. This detailed report is submitted to the Inspector in compliance with the conditions under the Nunavut Water Board License 2AM-MEA1525, Part H, Item 8c.

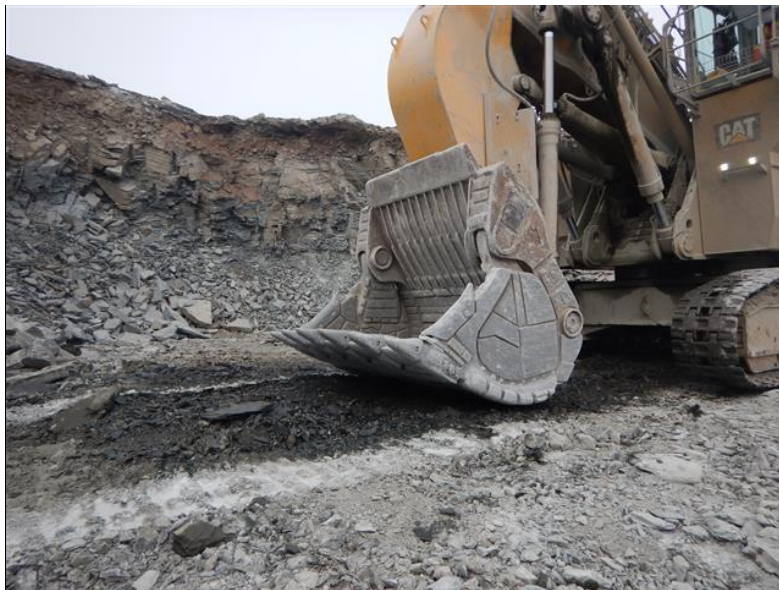
During operations, at Phaser pit, the operator of backhoe 13, noticed a leak of oil. He stopped immediately the engine.

Spill location: Northing 65°04'14.9'' W 96°00'45.1''

There were no off site impact or discharge to any receiving watercourses. The distance to the closest lake is estimated at 1000 meters.

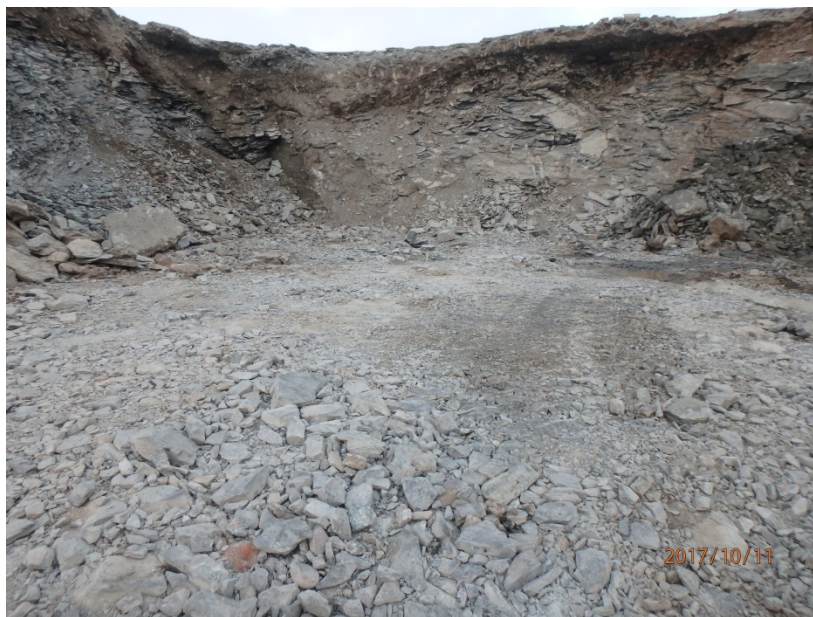
The spill was caused by hose failure on the loading unit.

The equipment engine was stopped immediately. The operator called mechanic department for the repair. A loader unit cleaned the surface affected and the contaminated material have been removed and brought to the landfarm area

The hoses and fittings are inspected as part of the preventive maintenance program done on site. Routine visual inspection of the hydraulic system is also performed during pre-operations checks.
