## October 28<sup>th</sup>, 2017 Pit E5 TRK21

GN reference # : 2017-400

Please find the following information as a follow up to the Spill report submitted October 28<sup>th</sup> 2017 by Agnico Eagle Meadowbank division. This detailed report is submitted to the Inspector in compliance with the conditions under the Nunavut Water Board License 2AM-MEA1525, Part H, Item 8c.

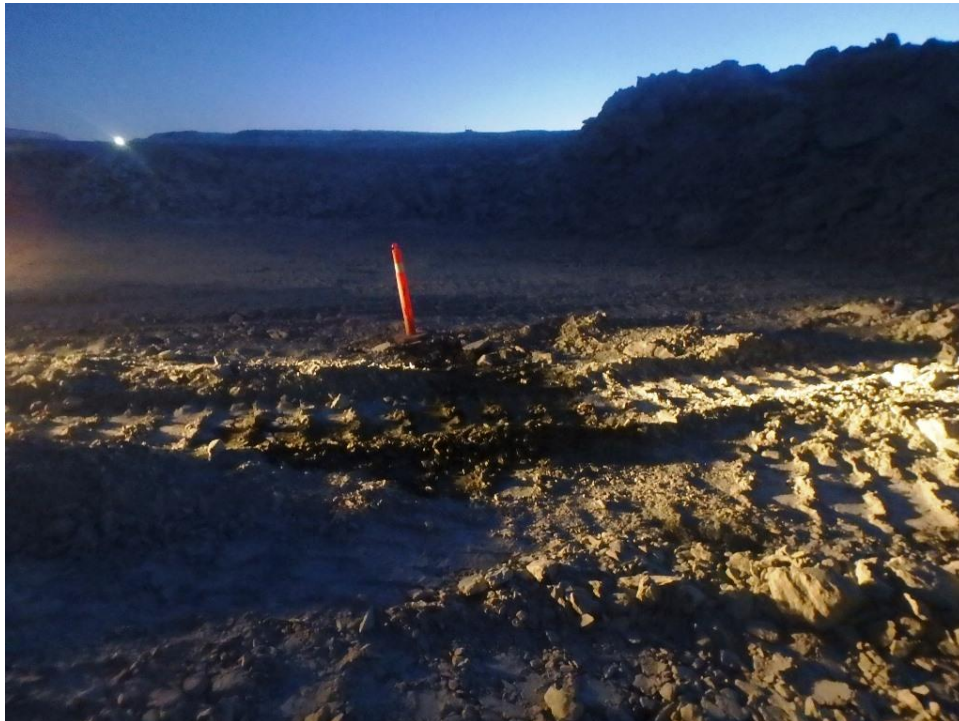
The fuel truck was refilling loading equipment in Pit E5 when upon finishing his filling work; the nozzle of the distributing hose froze.

Spill location: Easting 65'00'43" 96'03'20"

There were no off site impact or discharge to any receiving watercourses. The distance to the closest lake is estimated at 450 meters.

The spill was caused by freeze on the release system on the nozzle of the distributing hose of the fuel truck, during refilling operations.

Fuel nozzle is checked prior to starting refilling procedures, but can become frozen during operations with cold diesel fuel and operating conditions. A reminder was done concerning forecasting potential freeze on equipment by adapting practices and testing state of equipment.
