2018-02-25 MBK Vault Pit 600 liters Hydraulic Oil

(Report No 2018-055)

Please find the following information as a follow up to the Spill report submitted February 26th, 2018 by Agnico Eagle Meadowbank division. This detailed report is submitted to the Inspector in compliance with the conditions under the Nunavut Water Board License 2AM-MEA1525, Part H, Item 8c.

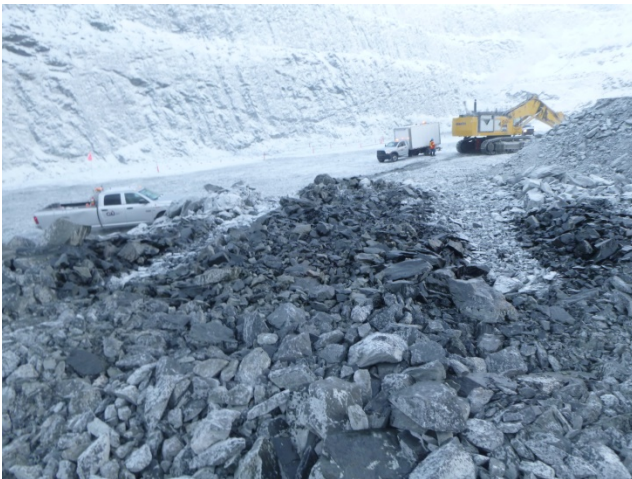
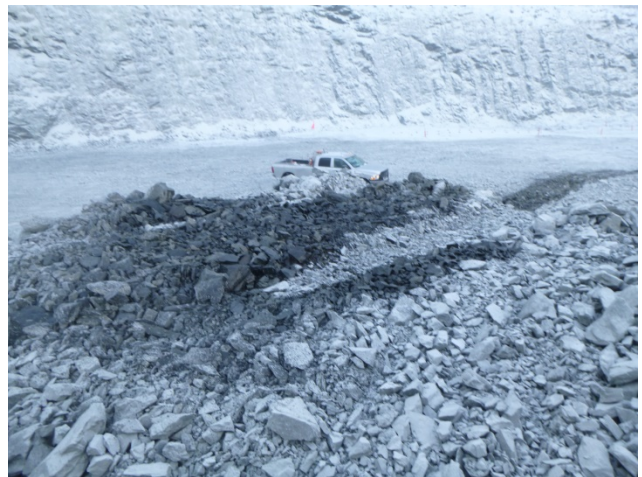
The shovel was mucking on a pad of marginal and the grade control technician saw some oil and smoke coming from the shovel. The operator saw it too and brought the shovel out of the pad for future repair. The oil made a major trail on the ground and the trail is probably on the waste material or marginal

The spill occurred after hydraulic "O"Ring failure on the equipment.

The hydraulic system including hoses and fittings are inspected as part of the preventive maintenance program done on site. Routine visual inspection of the hydraulic system is also performed during pre-operations checks.
