## **2018-02-27 MBK Phaser Pit 120 liters Hydraulic Oil**

**(Report No 2018-056)**

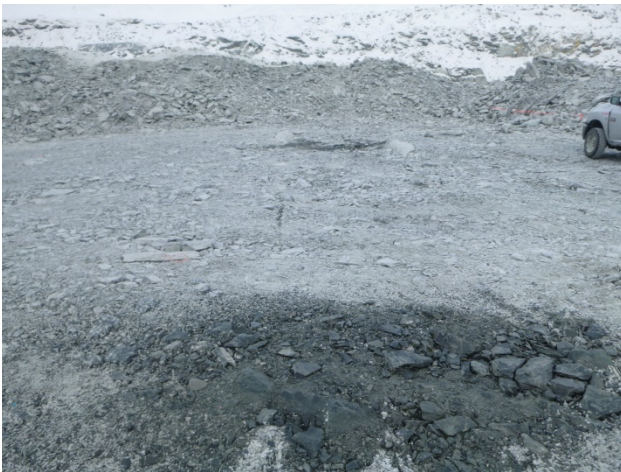
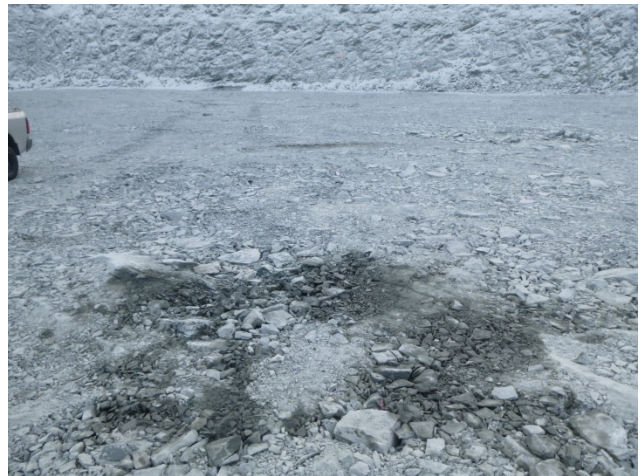
During the day shift, the stick had a small leak. But it was getting worst during a night shift and it the maintenance had decided to stop the shovel and brought it to the shop to fix the problem.

The spill occurred after hydraulic "O-ring failure on a cylinder of the equipment.

The hydraulic system including hoses and fittings are inspected as part of the preventive maintenance program done on site. Routine visual inspection of the hydraulic system is also performed during pre-operations checks.
