2018-08-09 LUBE SATATION 130 Liters Oil

GN reference # : 2018-318

Please find the following information as a follow up to the Spill report submitted May 29th 2018 by Agnico Eagle Meadowbank division. This detailed report is submitted to the Inspector in compliance with the conditions under the Nunavut Water Board License 2AM-MEA1525, Part H, Item 8c.

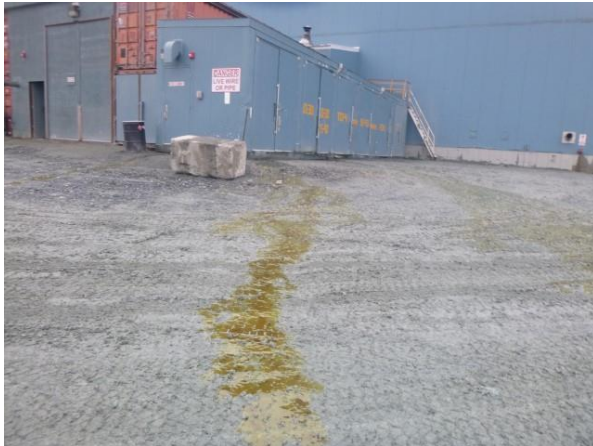
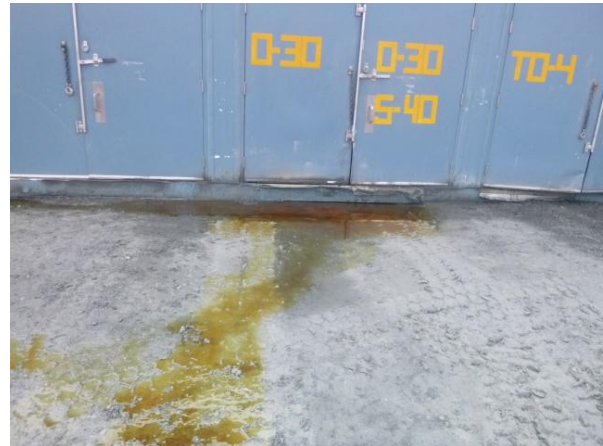
After they have changed one empty tote on the top of the second one, the worker forgot to put back the breather on the new tote. With this piece missing, the oil transferred to the bottom one and overflowing from the tote on the floor of the sea can and then after on the ground.

The spill was caused by a missing piece on the distribution equipment. The employee forgot to put back the breather on the tote.

After this incident it was decided to change the procedure. We stopped to connect the tote together to avoid this type of incident again.
