## 2018-09-11 MBK Vault Pit 550 Liters Hydraulic Oil

GN reference # : 2018-370

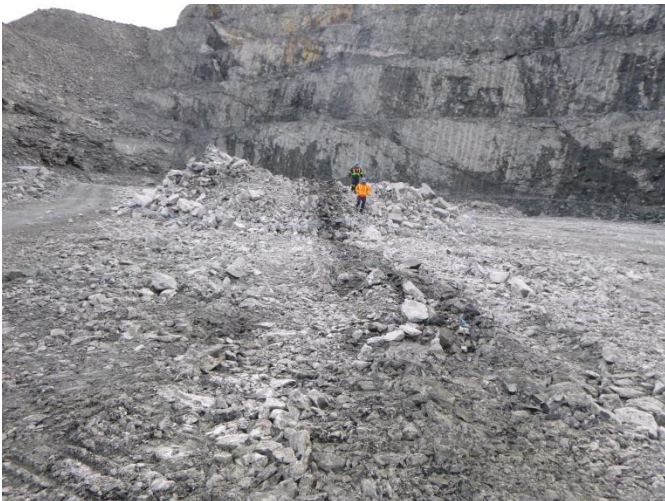
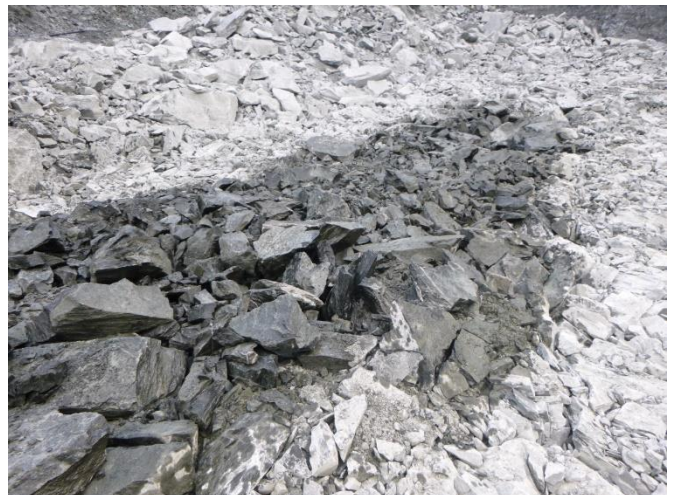
During operation in Vault pit, the stick hydraulic steel line near swing motor busted causing hydraulic oil leak. The operator stop the equipment and he advised the maintenance crew to fix the problem.

The spill was caused by busted line.

The hydraulic system is inspected as part of the preventive maintenance program done on site. Pre-operation checks also include visual inspection of the equipment.
