2019-03-14 MBK 250 Liters Waste Oil Tote

GN reference # : 2019-111

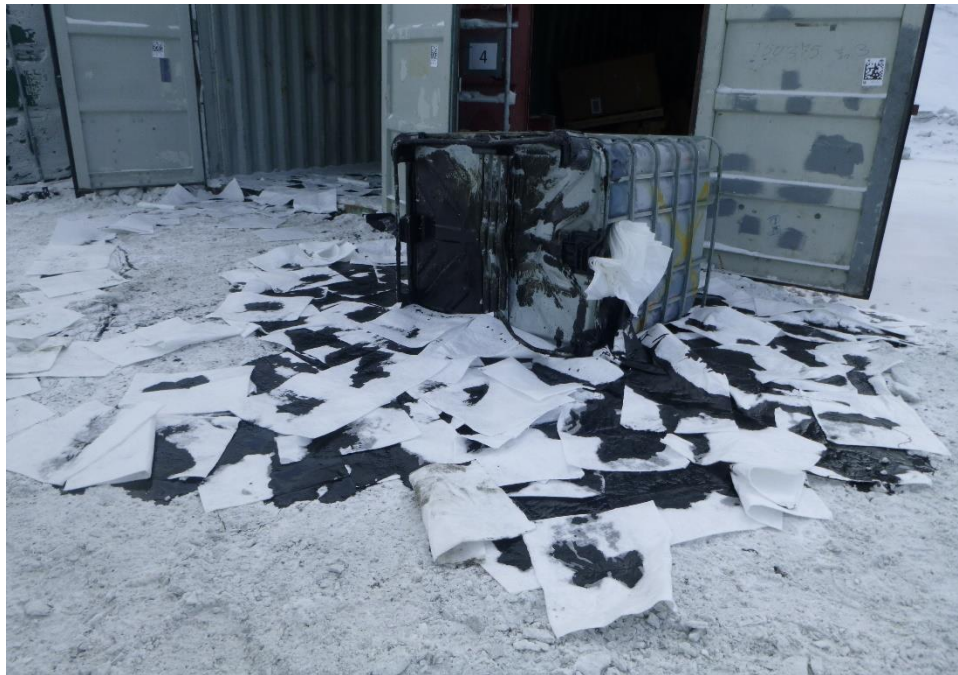
During operations at Meadowbank maintenance area, operator was moving a waste oil tote into a sea-can and did not have the forks of the zoom boom lined up properly. The forks punctured the tote and caused to spill inside the sea-can and on the ground.

Zoom boom forks puncturing the waste oil tote caused the spill.

Procedure for moving totes was reviewed by warehouse operators which also includes visual inspection of the equipment and work area.

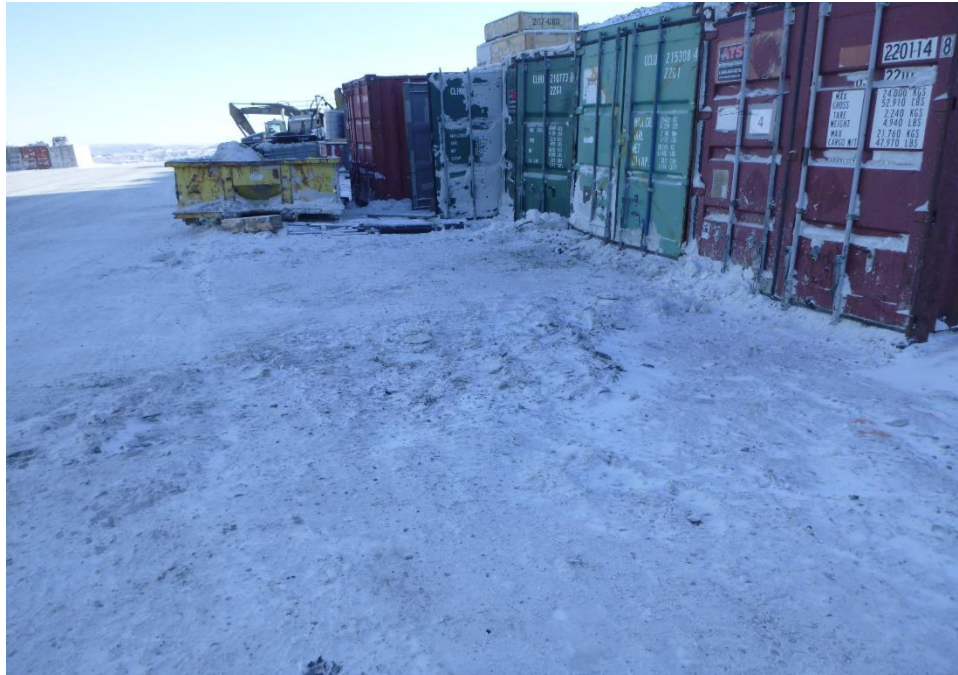
Spill pads were placed on the floor of the sea-can and on the ground, the pads were picked up and brought to the hazmat area and the ground was scraped clean. All the contaminated material was brought to the landfarm.
