2019-03-08 MBK 260 Liters Hydraulic Oil

GN reference # : 2019-098

Please find the following information as a follow up to the Spill report (2019-098) submitted March 8th, 2019 by Agnico Eagle Meadowbank division. This detailed report is submitted to the Inspector in compliance with the conditions under the Nunavut Water Board License 2AM-MEA1526, Part H, Item 8c.

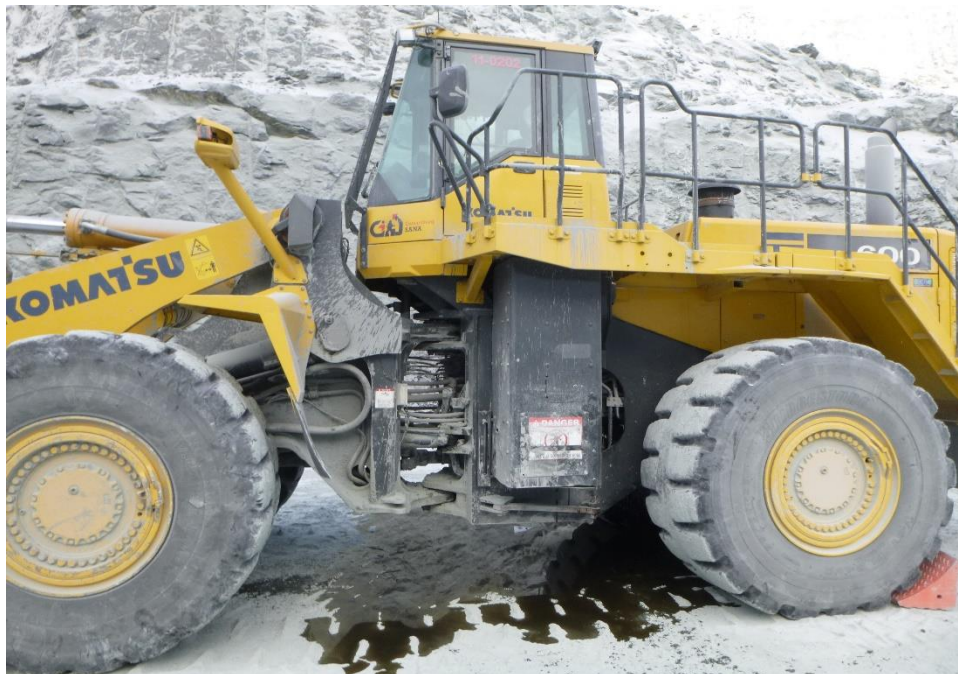
During operations at Pit E, a hydraulic line on the loader failed causing hydraulic oil to spill on the ground.

Location Coordinates of the spill: Northing 65°00'49", Easting 96°03'11" on IOL

There were no off site impact or discharge to any receiving watercourses. The distance to the closest lake is estimated at 150 meters.

Hydraulic line failure on loader

Equipment was shut down and maintenance was called to repair the hose. All the contaminated material was scraped up and brought to the landfarm.

The hydraulic system is inspected as part of the preventive maintenance program done on site. Pre-operation checks also include visual inspection of the equipment.
